JOINT INVESTIGATION REPORT FOR INCIDENT NO: • •

(Note: As practicable as possible the JIT re	port is to be signed in the fi	ield by all the participating parties)
A. GENERAL INFORMATION:		
1. Spill incident Number: 7056	.75 2.Type o	fincident* OIL SPILL
3. Name of Location 10 INCH U	TORUGU-UP	S TRUNKLING AT UGHEVUGHI
4. Name of nearest community <u>UGHE</u>	rughes. State: DE	LPA 6. LGA UGHELLI SOUTH
7. Type of Production facility/Installation		
B. INCIDENT INFORMATION:		
9. Details of incident a. Date of incident: 26/08 b. Date/Period of investigation 29	3/2011@1900 3/08/2011@)HRS 1230HRS
e Description of spill point environn		
✓Firmed soil	☐ Loose soil	☐ Previously excavated area
☐ Under water	□ Swampy	☐ Exposed pipe surface
☐ Well Platform (on Water)		□ Rig
d. Description of leak point (tick as a	pplicable);

JOINT INVESTIGATION REPORT FOR INCIDENT NO: 0041 705675

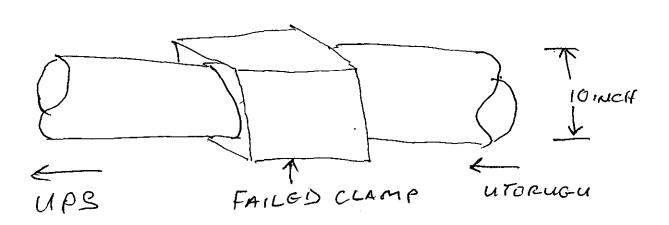
E. GRAPHIC DESCRIPTION OF LEAK POINT (Overview sketch of the site should be added as an appendix 1)

☐ Flare System/Bund wall Failure☐ Cold vent	☐ Valve Failure☐ Relief valve failure☐	□ com unit failure □ Others (specify) □ □ □ □ □ □ □ □ □ □ □ □ □ □ □ □ □ □ □	_UR
e.	Incident due to: ☐ Third party interference	□ Operational	Others (specify CLAMP FAILU	1 RE
f.	Spill point coordinates Measuring unit Northing: 164989M	NGTERS.	Easting: 387724 m
