THE SHELL PETROLEUM DEVELOPMENT COMPANY OF NIGERIA LIMITED

JOINT INVESTIGATION REPORT FOR INCIDENT NO: 0157 743458

- 1. Spill incident Number: 2011-743458 2. Type of incident* OIL SPILL
- 3. Name of Location 12" IMO RIVER I-EBUBU OGALE PIPELINE
- 4. Name of nearest community ODAGWA 5. State: RIVERS 6. LGA ETCHE
- 7. Type of Production facility/Installation OIL PIPELINE 8. Asset owner/District MPE/PH2

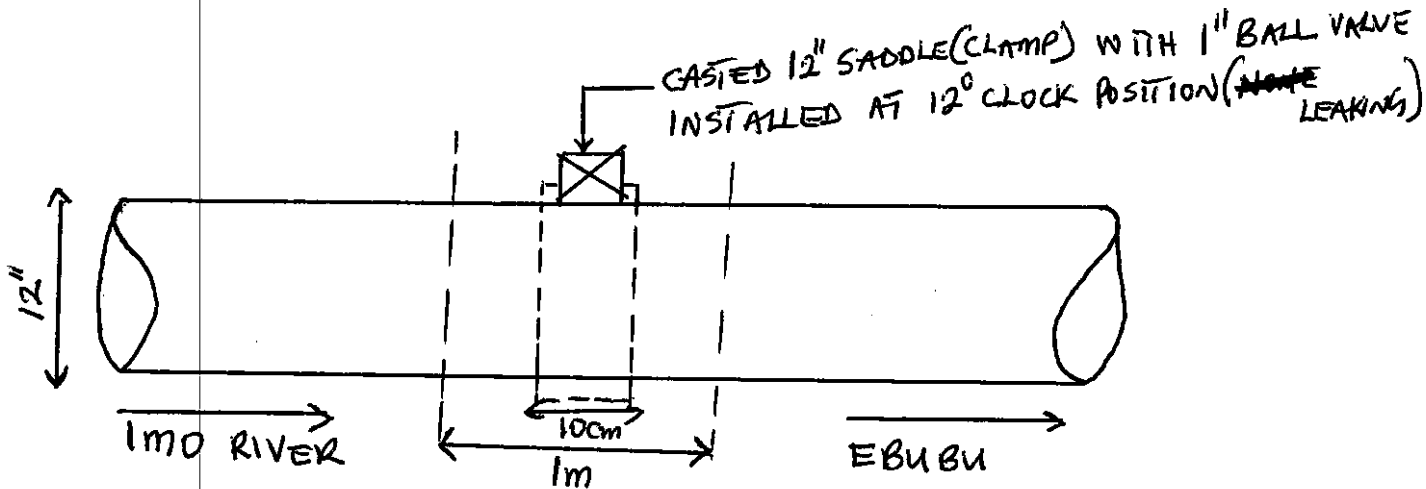
E. GRAPHIC DESCRIPTION OF LEAK POINT (Overview sketch of the site should be added as an appendix 1)

- Drilled hole Hack saw cut Explosive tear,
- Complete Rupture Inward dent, Well head tampering
- Failed Weld-on illegal hot tap valve, Missing Pipeline/Flowline)
- Crude oil theft (illegal bunkering) point, Third party tampering with Clamp
- Third party tampering with valve setting, Third party tampering with flange,
- External Corrosion Internal Corrosion
- Saver-pit over flow, Surge vessel overflow, Outward dent
- Flare System/Bund wall Failure Valve Failure com unit failure
- Cold vent Relief valve failure Others (specify) NOT APPLICABLE

- Third party interference Operational Others (specify) NOT APPLICABLE

SECTION OF 12" IMO RIVER - EBUBU PIPELINE AT ODASWA, SHOWING LOCATION OF 1 NOS, CRUDE OIL THEFT FITTINGS INSTALLED AT 12° CLOCK POSITION.

A. Joint investigation of the incident site found that there is no residual impact After the initial response and therefore recommend that the site be closed out <input checked="" type="checkbox"/>
B. Investigation of the incident site showed that there is residual impact on site requiring further works <input type="checkbox"/>
