THE SHELL PETROLEUM DEVELOPMENT COMPANY OF NIGERIA LIMITED

JOINT INVESTIGATION REPORT FOR INCIDENT NO: 0141 737787

1. Spill incident Number: 737787 2. Type of incident* SPILL
 3. Name of Location 16" EGBEMA-ASSA PIPELINE
 4. Name of nearest community ASSA 5. State: IMO 6. LGA OHAIJI/EGBEMA
 7. Type of Production facility/Installation OIL PIPELINE 8. Asset owner/District NESP/LAND 1

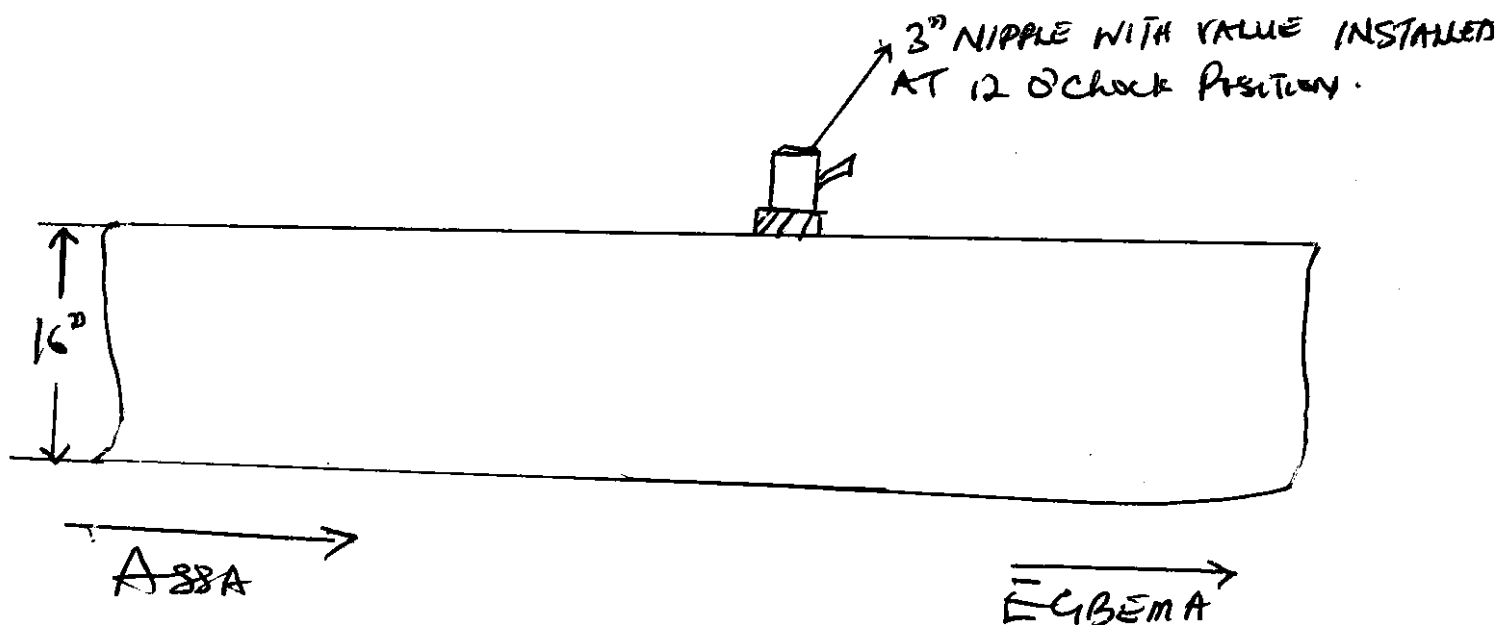
E. GRAPHIC DESCRIPTION OF LEAK POINT (Overview sketch of the site should be added as an appendix 1)

d. Description of leak point (tick as applicable);
 Drilled hole Hack saw cut Explosive tear,
 Complete Rupture Inward dent, Well head tampering
 Failed Weld-on illegal hot tap valve, Missing Pipeline/Flowline)
 Crude oil theft (illegal bunkering) point, Third party tampering with Clamp
 Third party tampering with valve setting, Third party tampering with flange,
 External Corrosion Internal Corrosion
 Saver-pit over flow, Surge vessel overflow, Outward dent
 Flare System/Bund wall Failure Valve Failure com unit failure
 Cold vent Relief valve failure Others (specify) _____

e. Incident due to:
 Third party interference Operational Others (specify) _____

A SECTION OF 16" ECIBEMA-ASSA PIPELINE AT ASSA SHOWING ILLEGAL BUNKERING POINT AT 12 O'CLOCK POSITION

A. Joint investigation of the incident site found that there is no residual impact After the initial response and therefore recommend that the site be closed out <input checked="" type="checkbox"/>
B. Investigation of the incident site showed that there is residual impact on site requiring further works <input type="checkbox"/>
