JOINT INVESTIGATION REPORT FOR INCIDENT NO: ... 0026 709916

A. GENERAL INFORMATION:					
1. Spill incident Number: 709916 2. Type of incident* OL SPILL					
3. Name of Location 18" ASSA -	Rumurkae P	IPELINE			
4. Name of nearest community ELELE	ALIMINI 5. State: RIVE	ERS 6. LGA AttoDA WEST

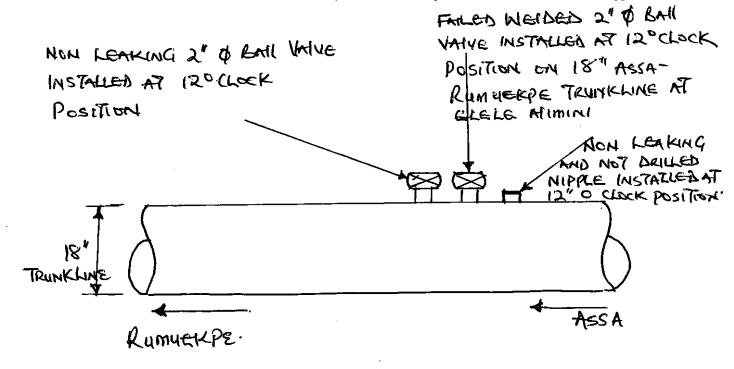
E. GRAPHIC DESCRIPTION OF LEAK POINT (Overview sketch of the site should be added as an appendix 1)

d. Description of leak point (tick as a □ Drilled hole 	* -	B			
	☐ Hack saw cut	☐ Explosive tear,			
Complete Rupture	☐ Inward dent,	☐ Well head tampering			
Failed Weld-on illegal hot tap v		☐ Missing Pipeline/Flowline)			
Crude oil theft (illegal bunkerin		☐ Third party tampering with Clamp			
☐ Third party tampering with valv	e setting,	☐ Third party tampering with flange,			
□ External Corrosion		☐ Internal Corrosion			
☐ Saver-pit over flow,	☐ Surge vessel overflow,				
☐ Flare System/Bund wall Failure		com unit failure			
□ Cold vent	☐ Relief valve failure	☐ Others (specify)

e. Incident due to:					
Third party interference	☐ Operational	□ Others (specify			
f. Spill point coordinates					
Measuring unit Merces	- DIG ANNIG				
Northing:		asting:			
121558. 47m	7	+73529·12m

A SECTION OF 18" ASSA- RUMULKEE PIPELINE AT ELECE ALIMINI
