# THE SHELL PETROLEUM DEVELOPMENT COMPANY OF NIGERIA LIMITED JOINT INVESTIGATION REPORT FOR INCIDENT NO: 0286 834048

3. Name of Location 4" 0	BELE - IBA	A PIPELINE
	•	JERS 6. LGA EMDHUA
7. Type of Production facility/Installation	on OIL PIPELINES.	Asset owner/ District NPE / PH

JOINT INVESTIGATION REPORT FOR INCIDENT NO: 0286 834 048

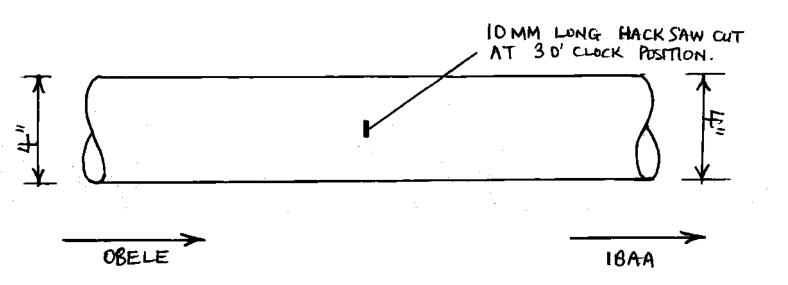
E. GRAPHIC DESCRIPTION OF LEAK POINT While detail report of the leak point should be contained in the Leak report, overview sketch of the site should be added as an appendix 1)

e. Description of leak point (tick		
Drilled hole	Hack saw cut	☐Explosive tear,
Complete Rupture	∐Inward dent,	☐ Well head tampering
Failed Weld-on illegal hot t	-	☐ Missing Pipeline/Flowline)
☐ Crude oil theft (illegal) but	<del></del>	☐ Third party tampering with Clamp
☐Third party tampering with		☐ Third party tampering with flange,

SECTION OF 4" OBELE - IBAA PIPELINE AT IBAA SHOWING POSITION OF HACK SAW CUT.
