JOINT INVESTIGATION REPO	RT FOR INCIDENT NO	0279824763
(Note: As practicable as possible the JIT re	port is to be signed in the	field by all the participating parties)

A. GENERAL INFORMATION:		
1. Spill incident Number: 8247	63 2.Type o	of incident * OIL SPILL
3. Name of Location 10 01 E	SU CREEK	PifeLine
4. Name of nearest community ONYO n	1 A 5. State: <b>RA</b>	1 ELSA 6. LGA SOUTHERN IJAM

7. Type of Production facility/Installation C	ML PIPELINE 8.A	sset owner/ District NESP/SWAMM 1
B. INCIDENT INFORMATION:		
9. Details of incident  a. Date of incident: 7th 520  b. Start date/time of investigation: 2  c. Investigation End date: 23 RD  d. Description of spill point environm	340 JUNE 2012	n2
☐Firmed soil	Loose soil	Previously excavated area
Under water	$\square_{\text{Swampy}}$	Exposed pipe surface
☐ Well Plateform (on Water)  e. Description of leak point (tick as a)	onlicable):	$\square_{Rig}$
Drilled hole	Hack saw cut	☐Explosive tear,
Complete Rupture	☐ Inward dent,	☐ Well head tampering
☐Failed Weld-on illegal hot tap v	alve,	☐ Missing Pipeline/Flowline)
Crude oil theft (illegal) bunkeri	ng) point,	☐ Third party tampering with Clamp
☐Third party tampering with val-	ve setting

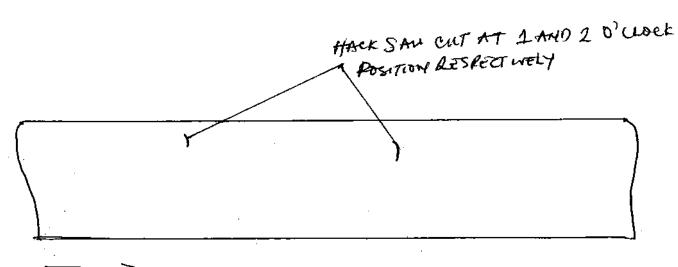
□Valve Failure	com unit failure	☐ Cold vent
Relief valve failure	Others (specify)	
f. Incident caused by:  Third party interference	Поi1	Път
M nird party interference	☐ Operational	□Mystery

A SECTION OF 10 DIEBU CREEK PIPELINE AT ONYOMA SHOWING TWO NUMBER HACK SAM CUT AT I AND 2 O'CLOCK POSITION RESPECTIVELY.
