THE SHELL PETROLEUM DEVELOPMENT COMPANY OF NIGERIA LIMITED 0230 825366 JOINT INVESTIGATION REPORT FOR INCIDENT NO: (Note: As practicable as possible the JIT report is to be signed in the field by all the participating parties) A. GENERAL INFORMATION: 1. Spill incident Number: 2.Type of incident * 011 3. Name of Location 4. Name of nearest community RERA 5. State: RIVERS 6. LGA GOKANA 7. Type of Production facility/Installation DI PIPELINE 8. Asset owner/ District NPE **B. INCIDENT INFORMATION:** 9 Details of incident a. Date of incident:__ b. Start date/time of investigation: 2012. c. Investigation End date: 974 d. Description of spill point environment Firmed soil Loose soil Previously excavated area Under water □ Swampy ☐Exposed pipe surface Well Plateform (on Water) \square Rig e. Description of leak point (tick as applicable); Drilled hole Hack saw cut ☐Explosive tear, Complete Rupture ☐ Inward dent, ☐ Well head tampering ☐Failed Weld-on illegal hot tap valve, ☐ Missing Pipeline/Flowline) □Crude oil theft (illegal) bunkering) point, ☐ Third party tampering with Clamp ☐Third party tampering with valve setting, ☐ Third party tampering with flange, □Corrosion ☐Saver-pit over flow,

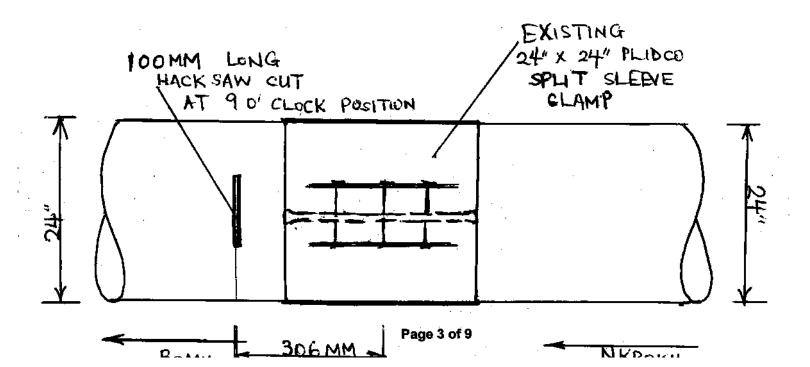
SECTION OF 24" NKPOKU-BOMU PIPELINE AT BERA SHOWING POSITION OF HACKSAW CUT.
