### THE SHELL PETROLEUM DEVELOPMENT COMPANY OF NIGERIA LIMITED

Note: As practicable as possible the JIT report is to be signed in the field by all the participating parties)				
A. GENERAL INFORMATION:				
l. Spill incident Number: 8741	16 2.Type	of incident * TL SPILL

3. Name of Location 28" Bomy -	- BONNY TRANS	NIGER PIPELINE!		
4. Name of nearest community OK	5. State: R	Asset owner/ District NESP SWAMP		
7. Type of Production facility/Installation	OIL PIPELING 8	Asset owner/ District NESP SWAMP

### THE SHELL PETROLEUM DEVELOPMENT COMPANY OF NIGERIA LIMITED 0359-874116 JOINT INVESTIGATION REPORT FOR INCIDENT NO: C. RISK ASSESSMENT 10. Type of environment: Water Swamp ☐ Land ☐ Seasonal swamp i. Type of environment to which oil has spread: Water Swamp □ Land ☐ River (identify) ii. Weather condition **⊠** Raining Sunny 11. Distance from the nearest sensitive habitat ☐ Government reserved and designated protected area ,m] ☐ Drinking water source ,m] ☐ Built up area ToM ,m] ☐ Farmlands ,m] ☐ Fish Farm/Pond ,m] ☐ Fishing net ☐ Others (specify). 12. Containment measures put in place; Booms ☐ Trench □ Dyke \_ ToN APPLICABLE 13. Any pictures or video coverage? $[Y] \checkmark [N]$ 14.

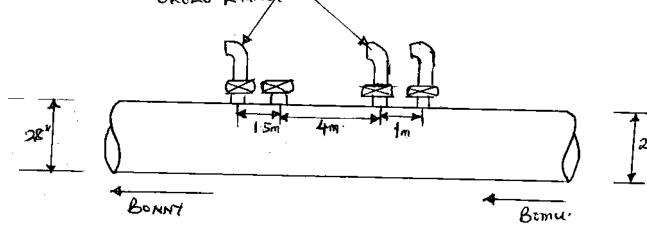
GRAPHIC SKETCH OF LEAK POINT ON 28" BOMU- BONNY TRANS NIGHE

# PIPELINE AT OKOLO SHOWING LEAK CAUSE. FOUR (4) 6" BUNKERING FITTING INSTALLED ON

TOUR (4) 6" BUNKERING FITTING INSTALLED OF 28" BEMU-BONNY TRANS NIGER PIPELINE AT DKELE LAUNCH AT 12 CLOCK PESITION.
