THE SHELL PETROLEUM DEVELOPMENT COMPANY OF NIGERIA LIMITED.

JOINT INVESTIGATION REPORT FOR INCIDENT NO: 1383445 JIV report S/N: 00854

1. Spill incident Number: 1383445 2. Type of incident* FIRE/OIL SPILL
 3. Name of Location 20" KOLO CREEK - RUMUEKPE PIPELINE
 4. Name of nearest community ORUMA 5. State: BAYELGA 6. LGA OGBIA
 7. Type of Production facility/Installation OIL PIPELINE 8. Asset owner/District PIPELINE/LAND

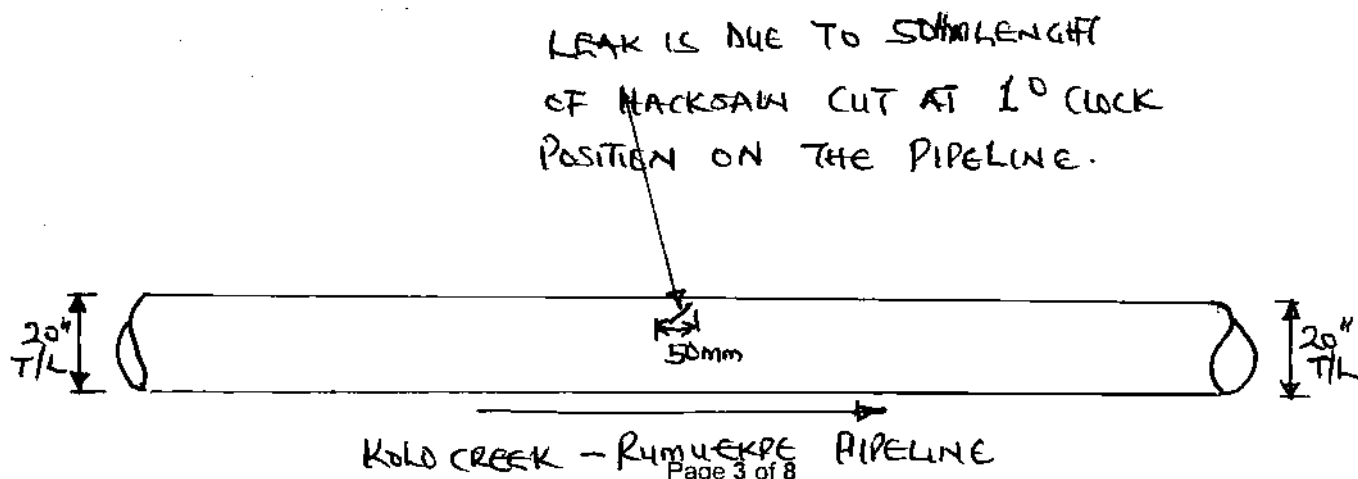
Additional observations around the spill point: A HACKSAW SUSPECTED TO HAVE BEEN USED IN CUTTING THE PIPE WAS FOUND IN THE PIT IN THE PROCESS OF EXCAVATION, OF THE INCIDENT POINT.

| <input type="checkbox"/> Drilled hole | <input checked="" type="checkbox"/> Hack saw cut | <input type="checkbox"/> Tear (_____). |

SECTIONAL VIEW OF 20" KOLO CREEK - RUMUEKPE PIPELINE AT OR
SHOWING CAUSE OF FIRE AND SPILL TO BE HACKSAW CUT.

RECOVERY AND REPAIR WORK BY
CLAMPING COMPLETED.
