THE SHELL PETROLEUM DEVELOPMENT COMPANY OF NIGERIA LIMTED. JOINT INVESTIGATION REPORT FOR INCIDENT NO: 1382396 JIV report SIN: 00872 (Note: As practicable as possible the JIT report is to be signed in the field by all the participating parties) A. GENERAL INFORMATION: 1. Spill incident Number: 1382396 2. Type of incident* OIL SPILL 3. Name of Location 28" Borny - BORNY TRANS NIGER PIPELINE 4. Name of nearest community BODO WEST. 5. State: RIVERS 6. LGA GO KANA 7. Type of Production facility/Installation OIL PIRELINE 8. Asset owner/District PIRELINE SWAMP B. INCIDENT INFORMATION: 9. Details of incident a. Date of incident: 30^{Tel} MARCH, 2015 b. Start date/time of investigation: 29 TH KPEIL, 2015 c. Investigation End date: 29 TH APRIL 2015 Actual investigation duration, days: ONE DAT d. Description of spill point environment Recently excavated area Firmed soil Exposed pipe surface Under water Drill Rig ☐ Well Platform (on Water) Additional observations around the spill point: NOT APPLICABLE e. Description of leak point (tick as applicable); Tear (Hack saw cut Drilled hole ☐ Well head tampering Inward dent, Complete Rupture Failed Weld-on illegal hot tap valve, Failed Clamp ☐ Missin

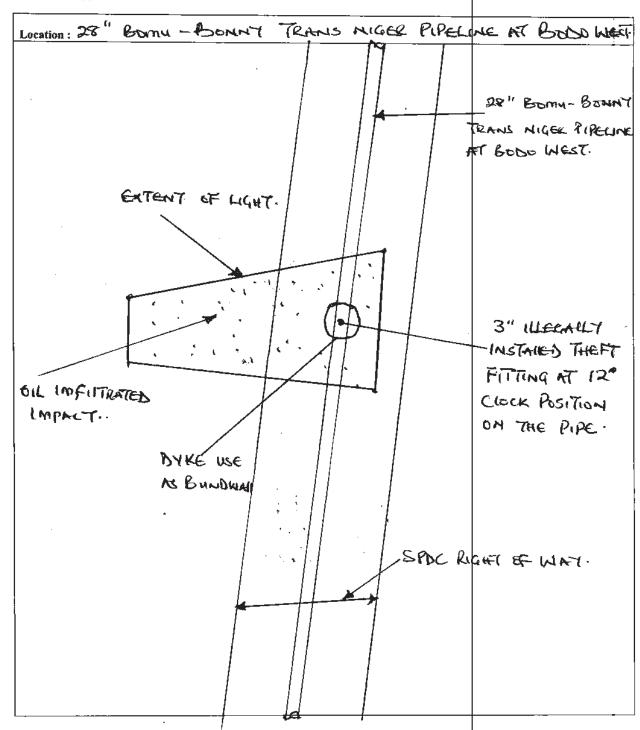
25. Appendix 1: Overview sketch of the site

E. GRAPF leak report	HC DESCRIPTION (, overview sketch of the	OF LEAK POI e site should be	NT (while deta added as an ap	ul report of the leak po pendix 1)	int should be contained in the	
ECTIONAL VIEW	of 28" 8	Somu - J	BENNY	TRANS N	HOER PIPELINE AT	
Bobo					L THEFT POINT	
			3	" ILLGEALLY	INSTALLED	
	÷ *		īt	"ILLGEALLY IEFT POINT (FREE PHASE	
			/ 1	MPACT FOUND	S AROUND THE	
			~ F	POINT DUE	to Brinkerz	
				Activities)		
78" THP					28'TH?	
	В	omu-Bo	Page 3 of 8	PELINE	*
