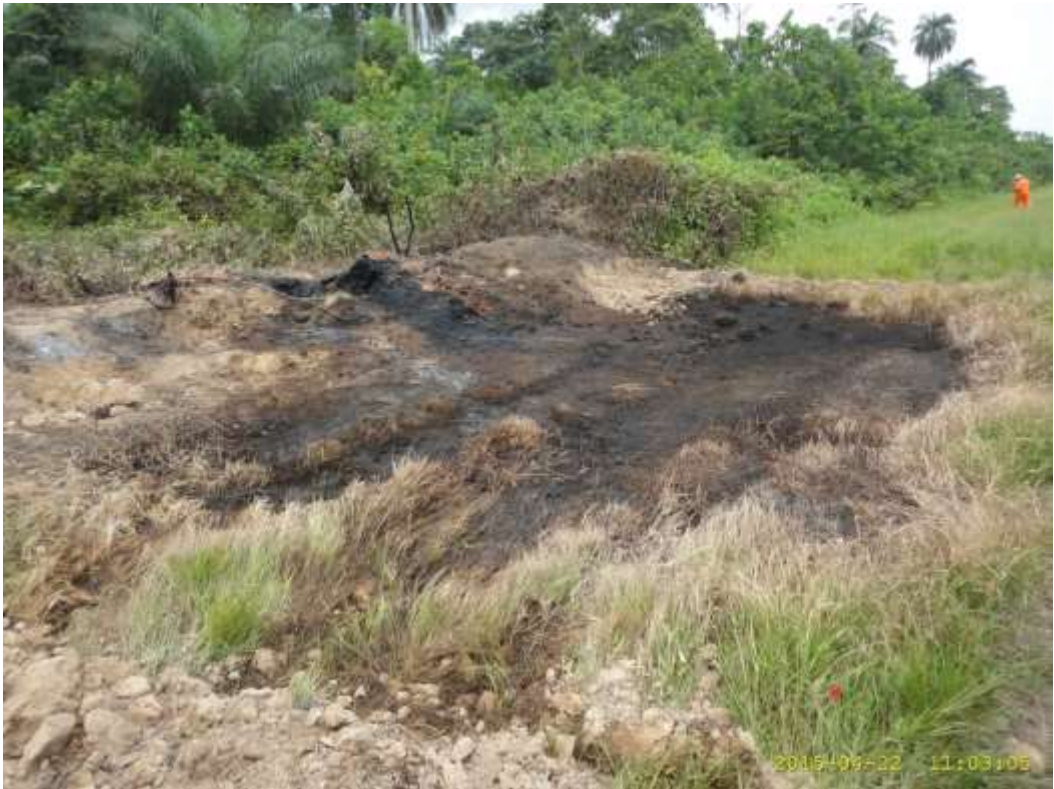
Overview: Part of spill impact on 20" Kolo Creek – Rumuekpe Pipeline Right of Way at Oruma. Picture was taken during Joint Investigation of 22nd of April 2015.

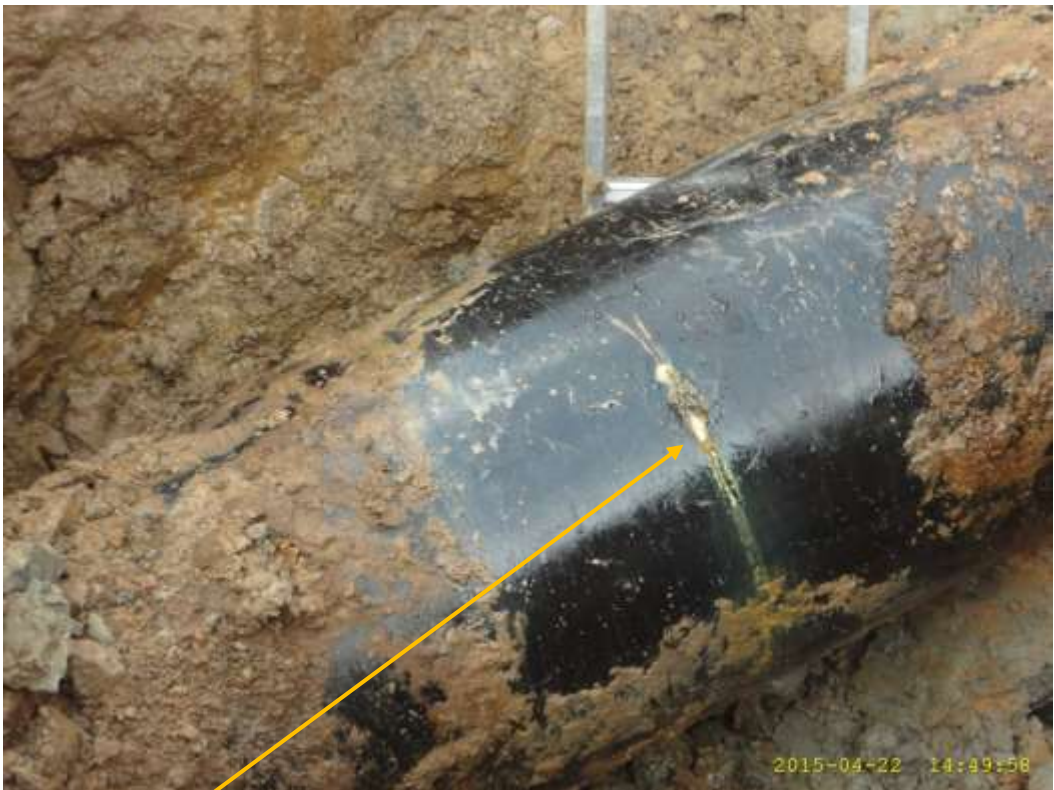
Close-up: Hacksaw Cut on 20" Kolo Creek – Rumuekpe Pipeline at Oruma. Picture was taken during Joint Investigation of 22nd of April 2015.
