JOINT INVESTIGATION REPORT

INCIDENT NO: 1416832 JIV report S/N: Nº 000024

1. Spill incident Number: 1416832 2. Type of incident* OIL SPILL
3. Name of Location 28" NKPOKU - BOMU PIPELINE
4. Name of nearest community B-DERE 5. State: RIVERS 6. LGA GOKANA
7. Type of Production facility/Installation OIL PIPELINE
8. Asset owner/District THE SHELL PETROLEUM DEVELOPMENT COMPANY OF NIGERIA LTD

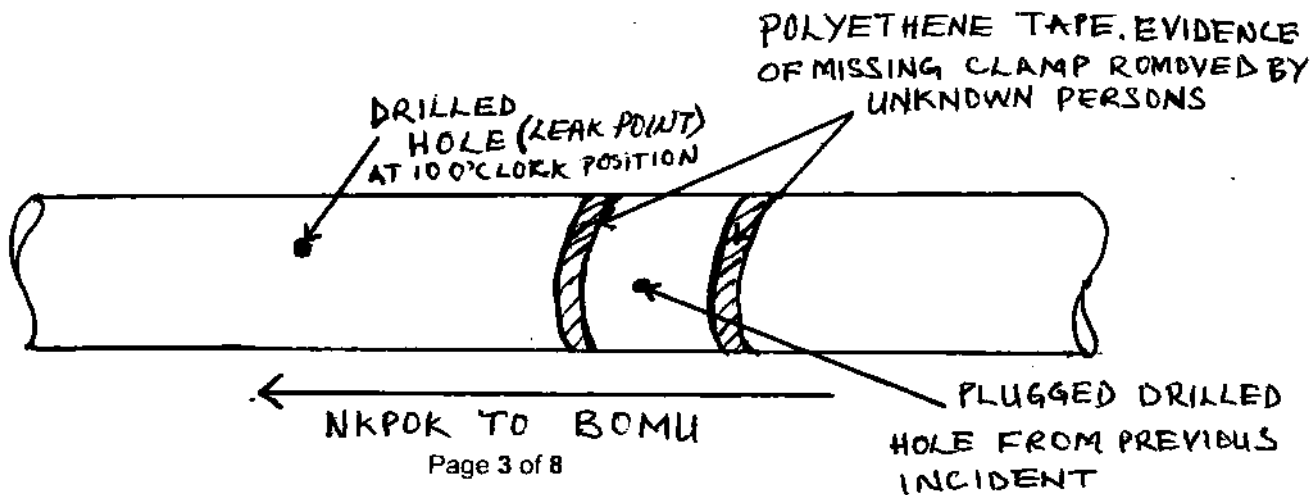
E. GRAPHIC DESCRIPTION OF LEAK POINT (while detail report of the leak point should be contained in the leak report, overview sketch of the site should be added as an appendix 1)

Additional observations around the spill point: THE TEAM OBSERVED POLYETHENE TAPE ON THE PIPELINE AS EVIDENCE OF MISSING CLAMP REMOVED BY UNKNOWN PERSONS. BETWEEN THE TAPE THE JIT OBSERVED A PLUGGED DRILLED HOLE AT 9 O'CLOCK POSITION, FROM PREVIOUS INCIDENT.

SECTION OF 28" NKPOKU-BOMU PIPELINE AT B-DERE SHOWING THE SPILL POINT (DRILLED HOLE) AND EVIDENCE OF MISSING CLAMP.

REPAIR BY CLAMPING
