JOINT INVESTIGATION REPORT

INCIDENT NO: 1429731 JIV report S/N: Nº 0000016

1. Spill incident Number: 1429731 2. Type of incident* OIL SPILL
3. Name of Location BONNY TERMINAL SLOT JETTY
4. Name of nearest community BONNY 5. State: RIVERS 6. LGA BONNY.
7. Type of Production facility/Installation BONNY OIL AND GAS TERMINAL
8. Asset owner/District THE SHELL PETROLEUM DEVELOPMENT COMPANY (NIG) LIMITED

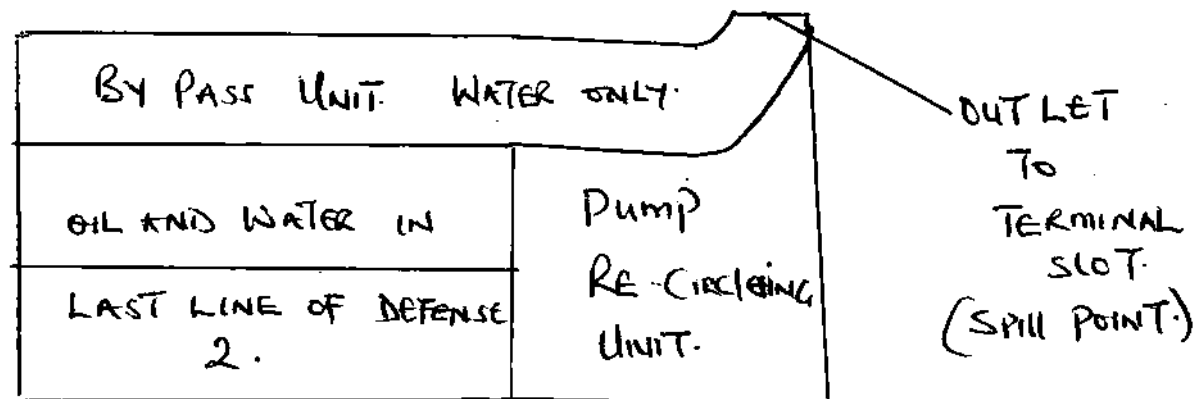
Others (specify) MAN (OPERATIONAL) FAILURE OF AOG (ACCIDENTAL OIL CONTAINMENT) WHICH RESULTED TO OVERFLOW INTO THE OPEN DRAIN.

SECTIONAL VIEW OF BONNY TERMINAL SLOT JETTY LAST LINE OF DEFENCE 2. SHOWING OPERATIONAL FAILURE OF AOC

AOC (MEANS ACCIDENTAL OIL CONTAINMENT.)

FACILITY REPAIR BEFORE JIV
