JOINT INVESTIGATION REPORT

INCIDENT NO: 1832519 JIV report S/N: Nº 0000271

1. Spill incident Number: 1832519 2. Type of incident* OIL SPILL
3. Name of Location BONNY OIL AND GAS TERMINAL EMULSION TANK (T12018)
4. Name of nearest community BUNNY 5. State: RIVERS 6. LGA BONNY
7. Type of Production facility/Installation OIL TANK
8. Asset owner/District THE SHELL PETROLEUM DEVELOPMENT COMPANY OF NIGERIA LIMITED

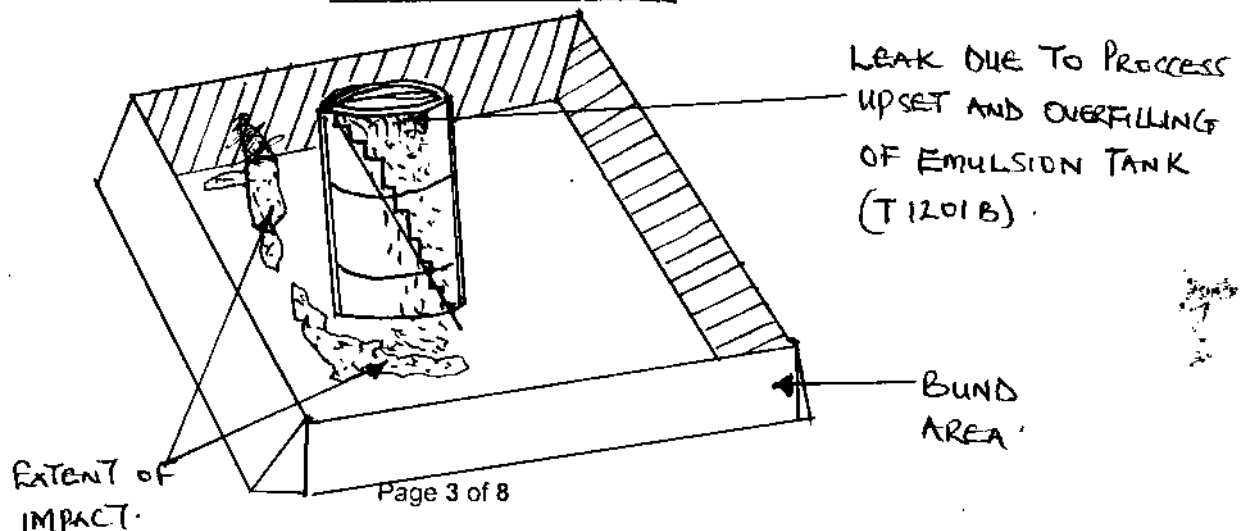
Additional observations around the spill point: THE JOINT INVESTIGATION TEAM OBSERVED THE SPILL WAS DUE TO PROCESS UPSET AND OVERFILLING OF EMULSION TANK (T12018) FROM STATIC HEAD OF DRAINING TANK DUE TO POWER OUTAGE AT BONNY OIL AND GAS TERMINAL.

SECTIONAL VIEW OF BONNY OIL AND GAS TERMINAL EMULSION TANK (T1201B) AT BONNY SHOWING OPERATIONAL SPILL PROCESS UPSET AND OVERFILLING OF EMULSION TANK

EMISSION TANK (201B) WAS ISOLATED, WHILE BUNDWALL SLUICE GATE WAS CLOSED. POWER RESTORED TO BONNY TERMINAL.

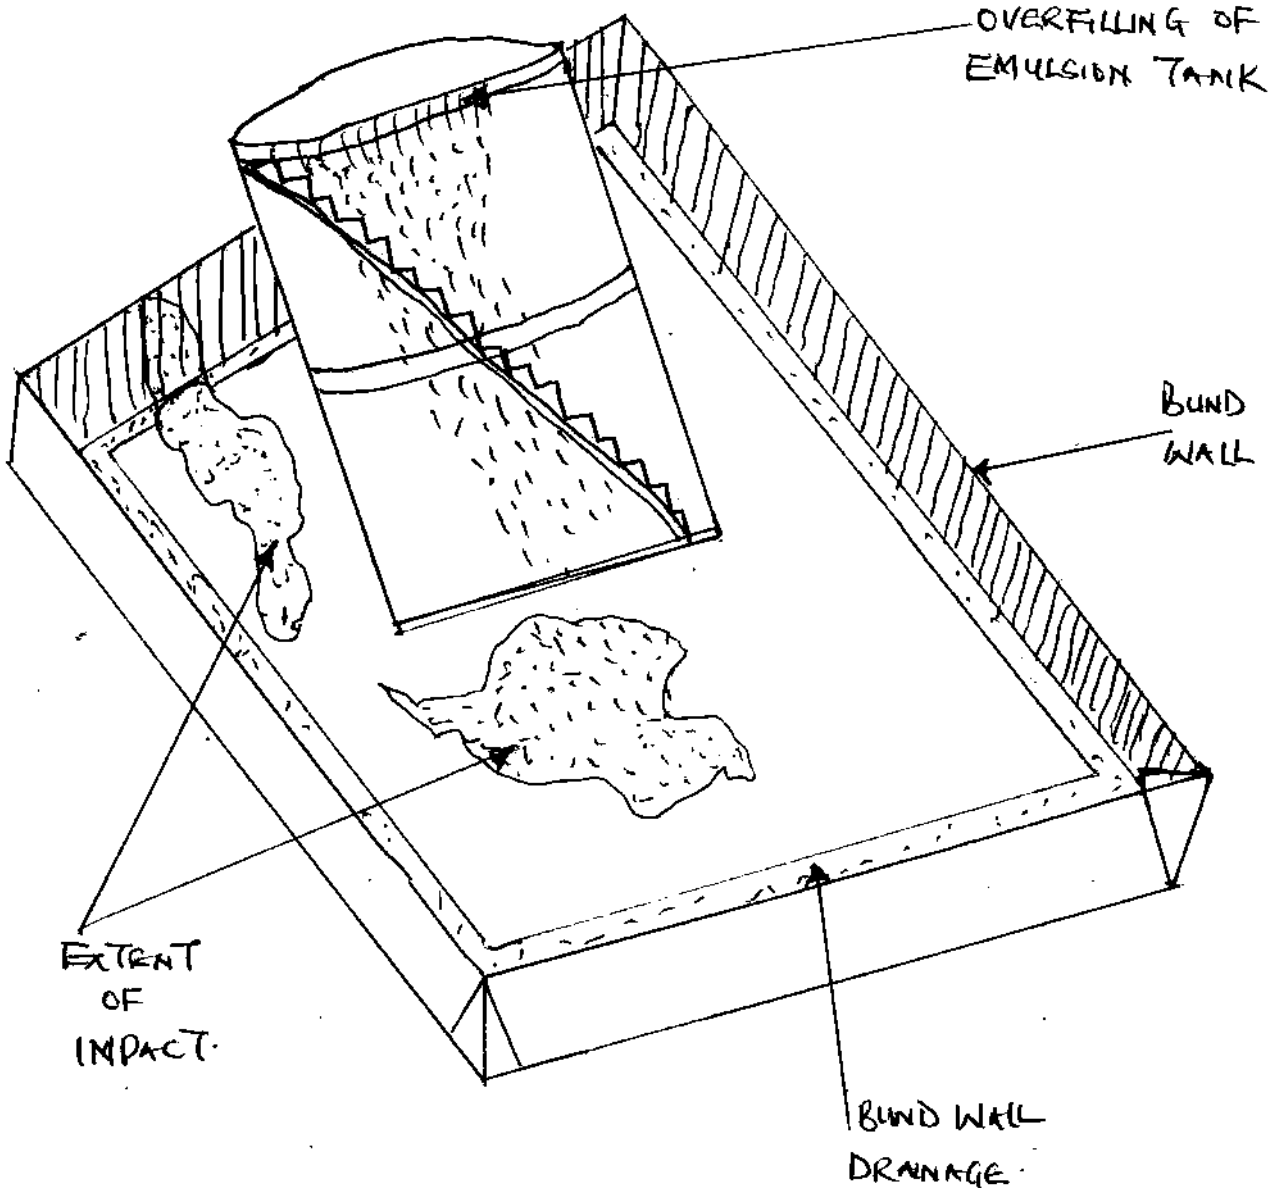
f. Appendix 1: Overview sketch of the site

Location: BONNY OIL AND GAS TERMINAL EMULSION TANK (T12018) AT BONNY.
