# JOINT INVESTIGATION REPORT

INCIDENT NO: 1834545 JIV report S/N: NO 0000309

1. Spill incident Number: 1834545 2. Type of incident\* OIL SPILL  
3. Name of Location 4" OTUMARA WELL - 9T FLOWLINE  
4. Name of nearest community UGBOEGUNGU State: DELTA 6. LGA WARRI SOUTH-WEST  
7. Type of Production facility/Installation FLOWLINE  
8. Asset owner/District THE SHELL PETROLEUM DEVELOPMENT COMPANY OF

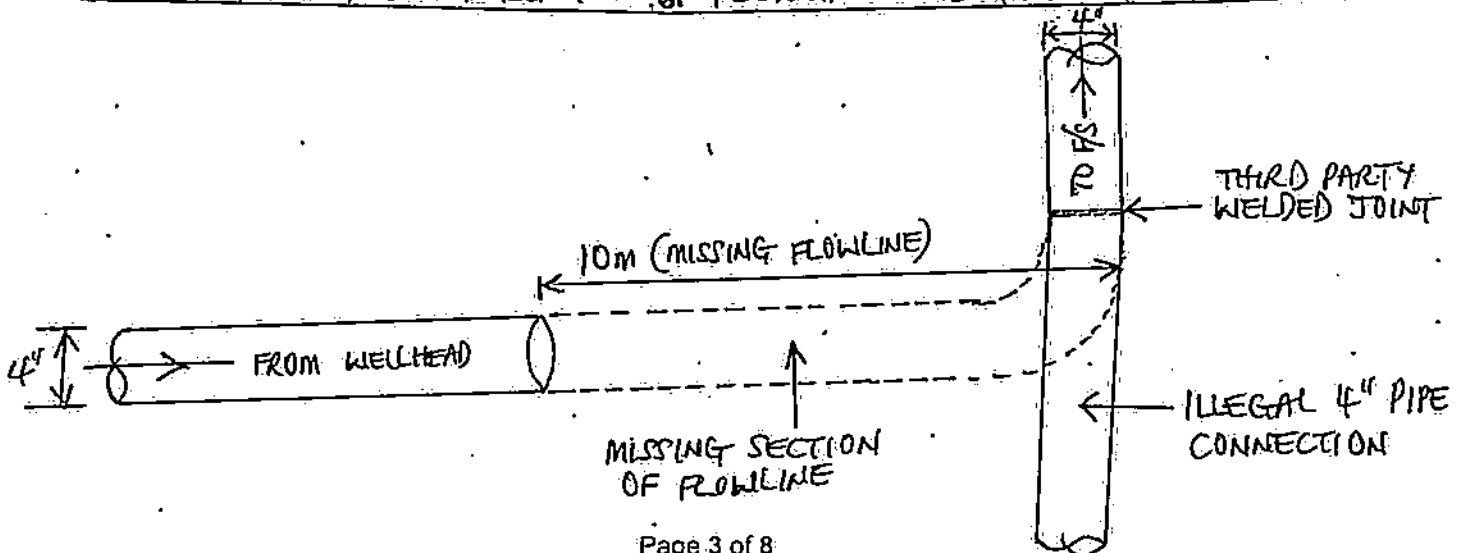
**E. GRAPHIC DESCRIPTION OF LEAK POINT** (while detail report of the leak point should be contained in the leak report, overview sketch of the site should be added as an appendix 1)

Additional observations around the spill point: ON EXCAVATION, THE JOINT INVESTIGATION TEAM OBSERVED A 10m MISSING LENGTH OF FLOWLINE REMOVED BY UNKNOWN PERSON(S), WITH A 4" ILLEGAL PIPE CONNECTION AT ONE OF THE TWO CUT ENDS. THE THIRD PARTY PIPELINE CONNECTION COULD NOT BE TRACED DUE TO POOR/UNCLEARED ACCESS.

SECTION OF 4" OTUMARA WELL-9T FLOWLINE AT UGBOEGUNGUN  
SHOWING; 10m MISSING LENGTH OF FLOWLINE AND 4" ILLEGAL PIPE CONNECTION
