# JOINT INVESTIGATION REPORT

INCIDENT NO: 1838972 JIV report S/N: Nº 0000280

1. Spill incident Number: 1838972 2. Type of incident\* OIL SPILL  
3. Name of Location AFAM WELL 27T AND 25T FLOWLINE  
4. Name of nearest community AYAMA 5. State: RIVERS 6. LGA OTIGBO  
7. Type of Production facility/Installation OIL FLOWLINE  
8. Asset owner/District SPDC / LAND EAST HUB

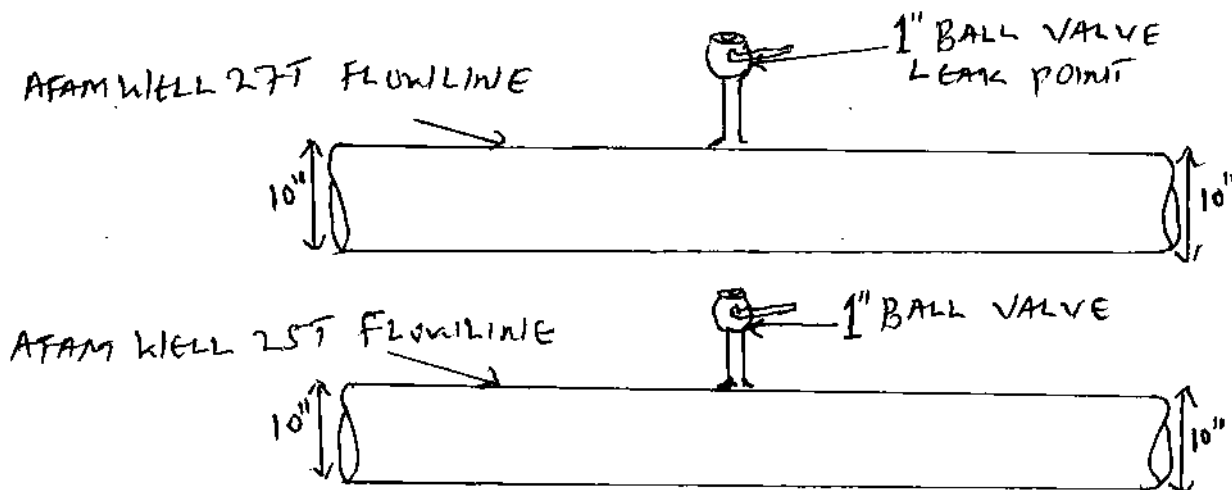
DURING THE INITIAL SITE INSPECTION BY THE JOINT INVESTIGATION TEAM, RECENTLY EXCAVATED SOIL ON TOP OF CANOPY AND OPEN DITCH WAS OBSERVED.

| <input checked="" type="checkbox"/> Failed Weld-on illegal hot tap valve | <input type="checkbox"/> Failed Clamp, | <input type="checkbox"/> Missing Pipeline/Flowline |
| <input checked="" type="checkbox"/> Crude oil theft (illegal bunkering) point. | <input type="checkbox"/> Saver-pit over flow | <input type="checkbox"/> Third party tampering with Clamp |

SECTION OF AFAM WELL 27T AND 25T FLOWLINE AT AYAMA SHOWING POSITION OF CRUDE OIL THEFT POINTS AT 12 O'CLOCK POSITIONS.
