# JOINT INVESTIGATION REPORT

INCIDENT NO: 1867352 JIV report S/N: Nº 0000243

1. Spill incident Number: 1867352 2. Type of incident\* OIL SPILL  
3. Name of Location 28" BOMU - BONNY TRANS NIGER PIPELINE  
4. Name of nearest community PATRICK WATER SIDE 5. State: RIVERS 6. LGA CEKANA  
7. Type of Production facility/Installation OIL PIPELINE  
8. Asset owner/District THE SHELL PETROLEUM DEVELOPMENT COMPANY OF NIGERIA LIMITED

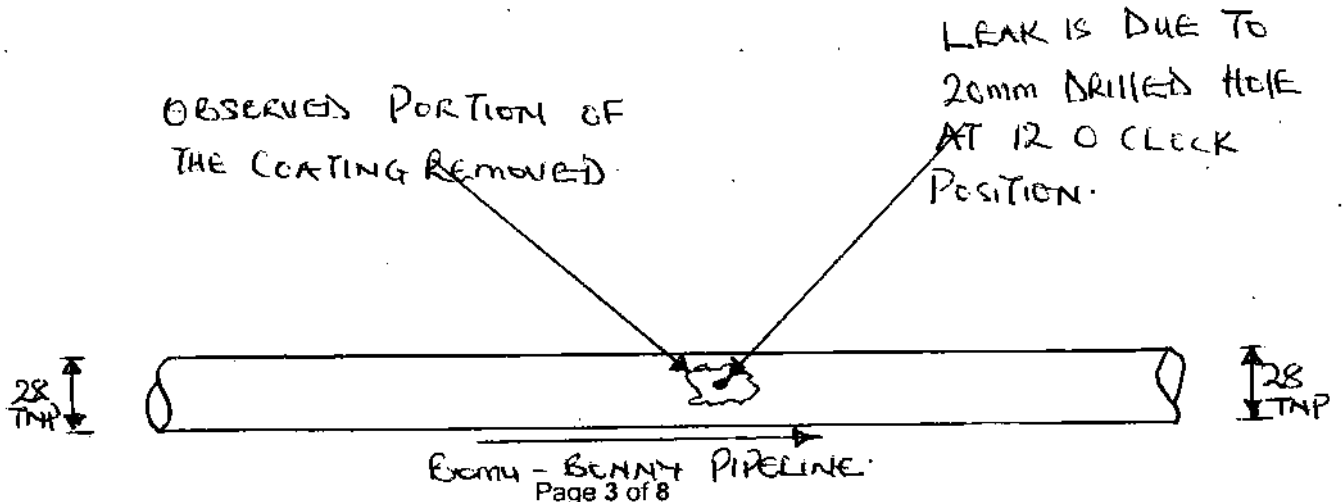
**E. GRAPHIC DESCRIPTION OF LEAK POINT** (while detail report of the leak point should be contained in the leak report, overview sketch of the site should be added as an appendix 1)

| <input checked="" type="checkbox"/> Drilled hole | <input type="checkbox"/> Hack saw cut | <input type="checkbox"/> Tear (_____) |

SECTIONAL VIEW OF 28" BOMU - BONNY TRANS NIGER PIPELINE AT PATRICK WATER SIDE. SHOWING 20mm DRILLED HOLE

REPAIR WORK BY CLAMPING AND CRUDE OIL RECOVERY  
WORK ONGOING.
