JOINT INVESTIGATION REPORT

INCIDENT NO: 1872118

1. Spill incident Number: 1872118 2. Type of incident* OIL SPILL
 3. Name of Location 20" OPUKUSHI - BRASS CREEK PIPELINE
 4. Name of nearest community TAMOGBENE 5. State: BAYELSA 6. LGA EKEREMOR
 7. Type of Production facility/Installation OIL PIPELINE
 8. Asset owner/District THE SHELL PETROLEUM DEVELOPMENT COMPANY OF

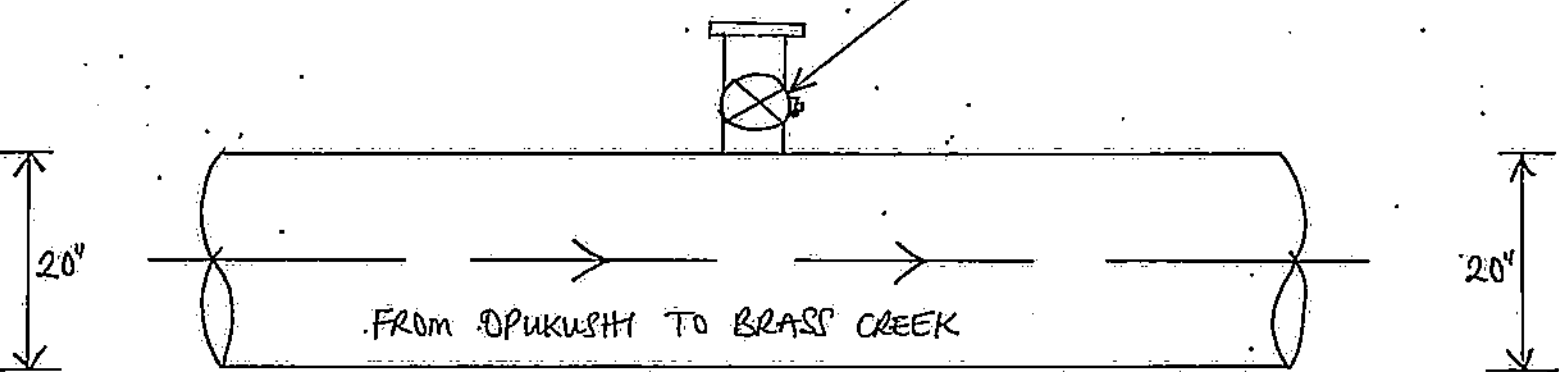
ON EXCAVATION, THE JOINT INVESTIGATION TEAM OBSERVED A FAILED 4" VALVE ILLEGALLY ATTACHED TO THE 20" OPUKUSHI - BRASS CREEK PIPELINE AT 12 O' CLOCK POSITION. THE LEAK HAS STOPPED AS AT THE TIME OF THIS INVESTIGATION.

SECTION OF 20" OPUKUSHI - BRASS CREEK PIPELINE AT TAMDEBENE AXIS
SHOWING: A FAILED 4" VALVE ILLEGALLY ATTACHED AT 12 O' CLOCK POSITION

FAILED 4" VALVE ILLEGALLY ATTACHED
 AT 12 O' CLOCK POSITION
