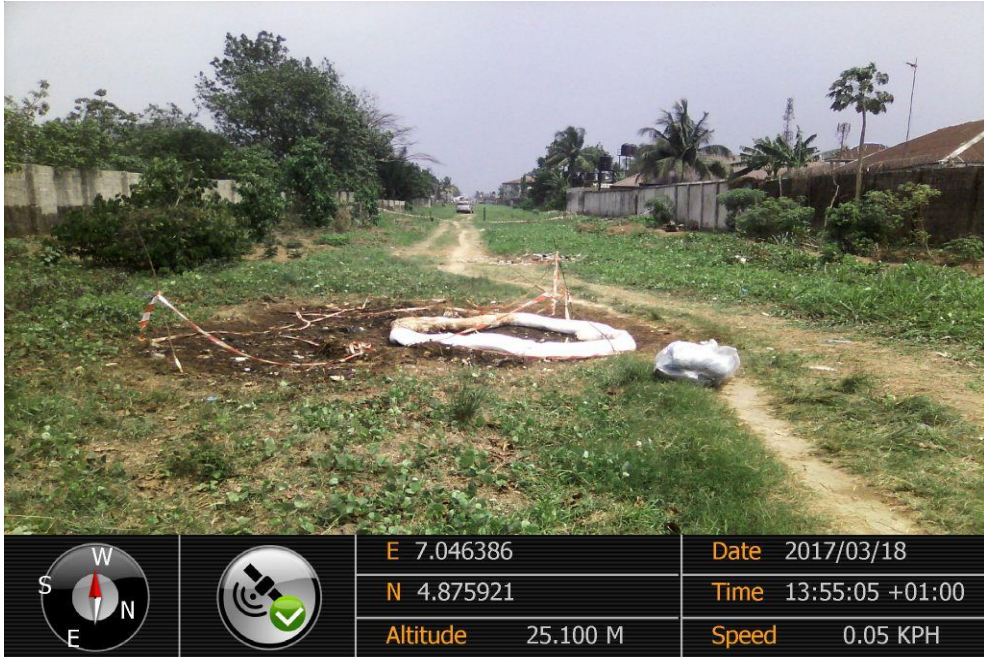
Overview: Part of spill impact on 28" Nkpoku-Bomu Pipeline at Elimgbu. Picture was taken during Joint Investigation of 18<sup>th</sup> March 2017.

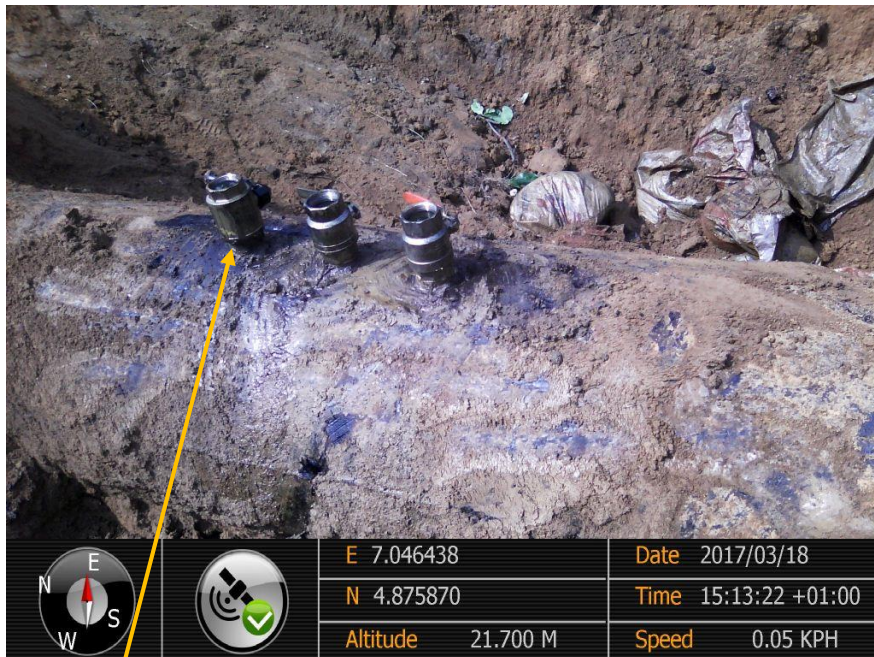
Close-up: Leaking Illegal fitting on 28" Nkpoku-Bomu Pipeline at Elimgbu. Picture was taken during Joint Investigation of 18<sup>th</sup> March 2017.
