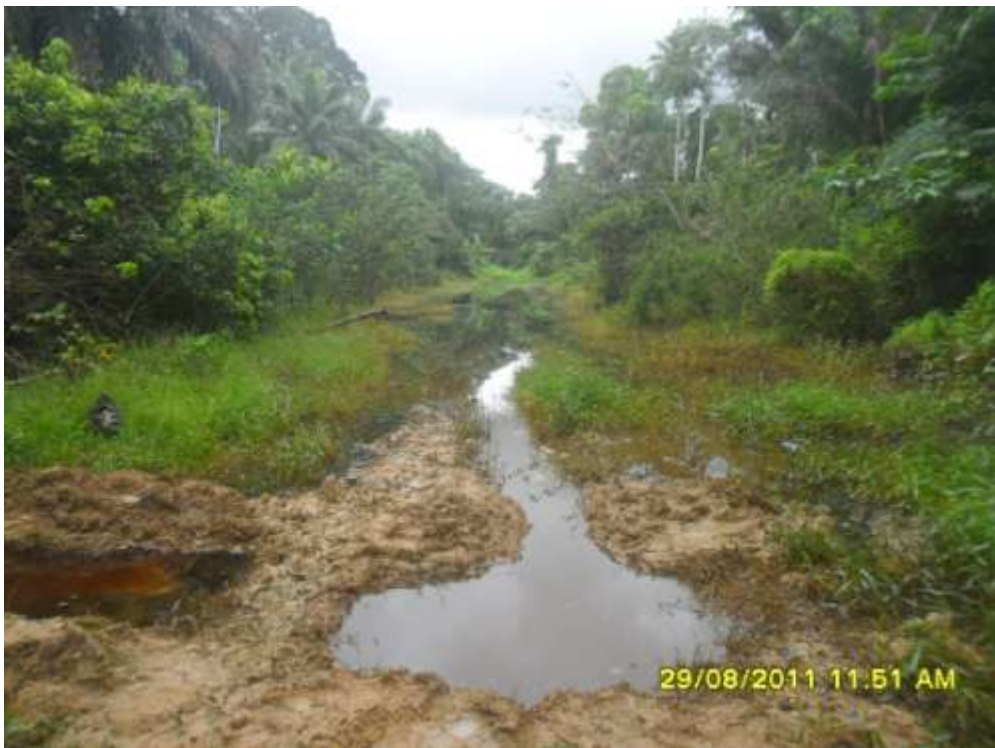
Overview: Part of spill impact on 14" Okordia-Rumuekpe pipeline at Ikarama. Picture taken during Joint Investigation of 29th August, 2011.

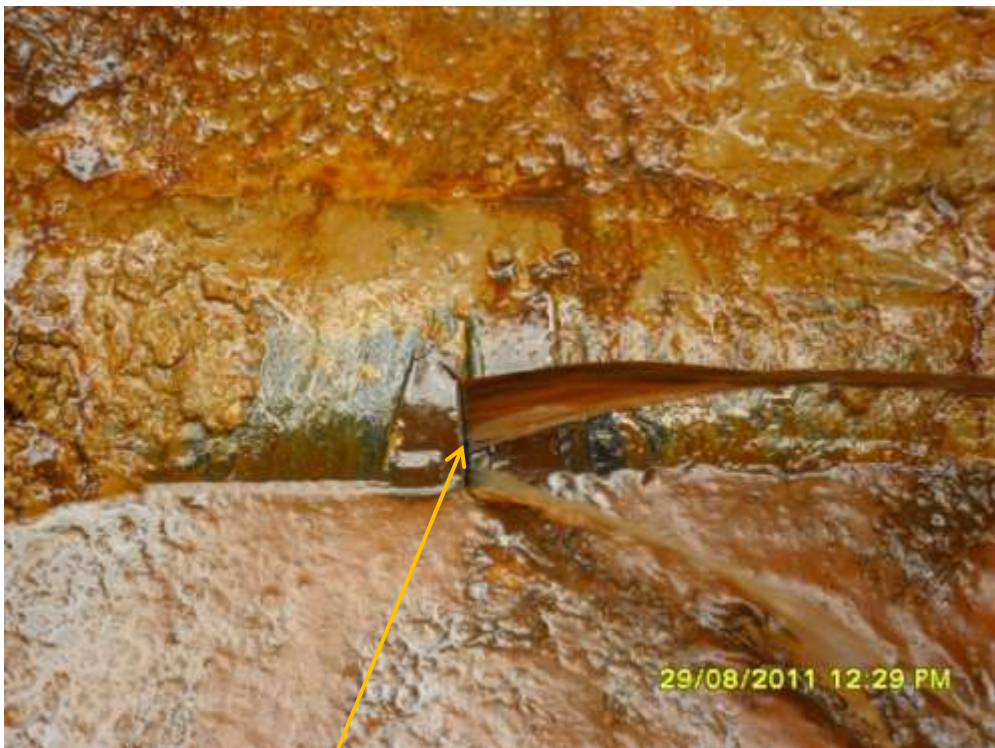
Close-up: Spill due to hacksaw cut on 14" Okordia-Rumuekpe pipeline at Ikarama. Picture taken during Joint Investigation of 29th August, 2011.
