THE SHELL PETROLEUM DEVELOPMENT COMPANY OF NIGERIA LIMITED

JOINT INVESTIGATION REPORT FOR INCIDENT NO: 0007 695700

1. Spill incident Number: 695700 2. Type of incident* SPILL
 3. Name of Location 12" ADIBAWA-OKORDIA PIPELINE
 4. Name of nearest community IKARAMA 5. State: BAYELSA 6. LGA YENAGOA
 7. Type of Production facility/Installation OIL PIPELINE 8. Asset owner/District NESP/LAND 2

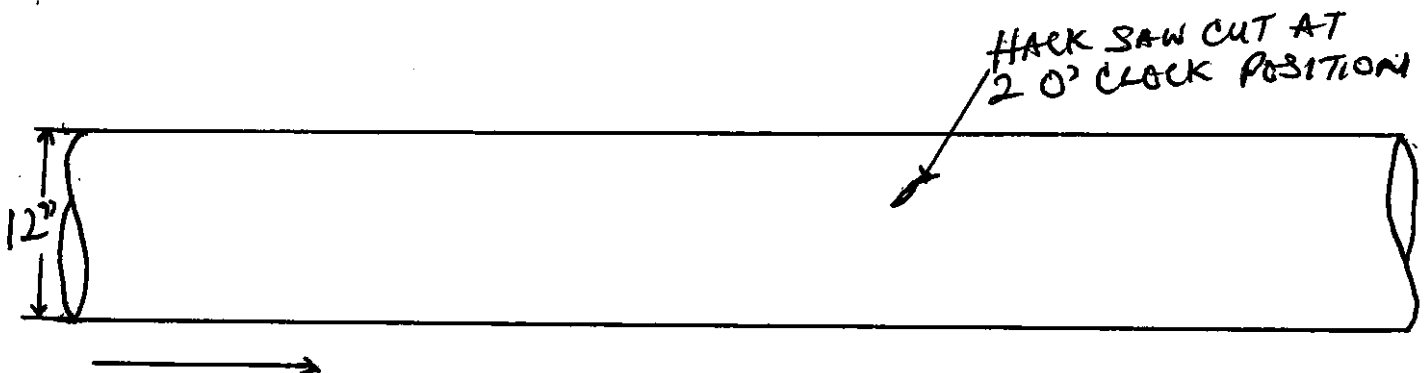
| <input type="checkbox"/> Drilled hole | <input checked="" type="checkbox"/> Hack saw cut | <input type="checkbox"/> Explosive tear, |

A SECTION OF 12" ADIBAWA - OKORDIA PIPELINE

SHOWING HACK SAW CUT AT 2 O'CLOCK POSITION

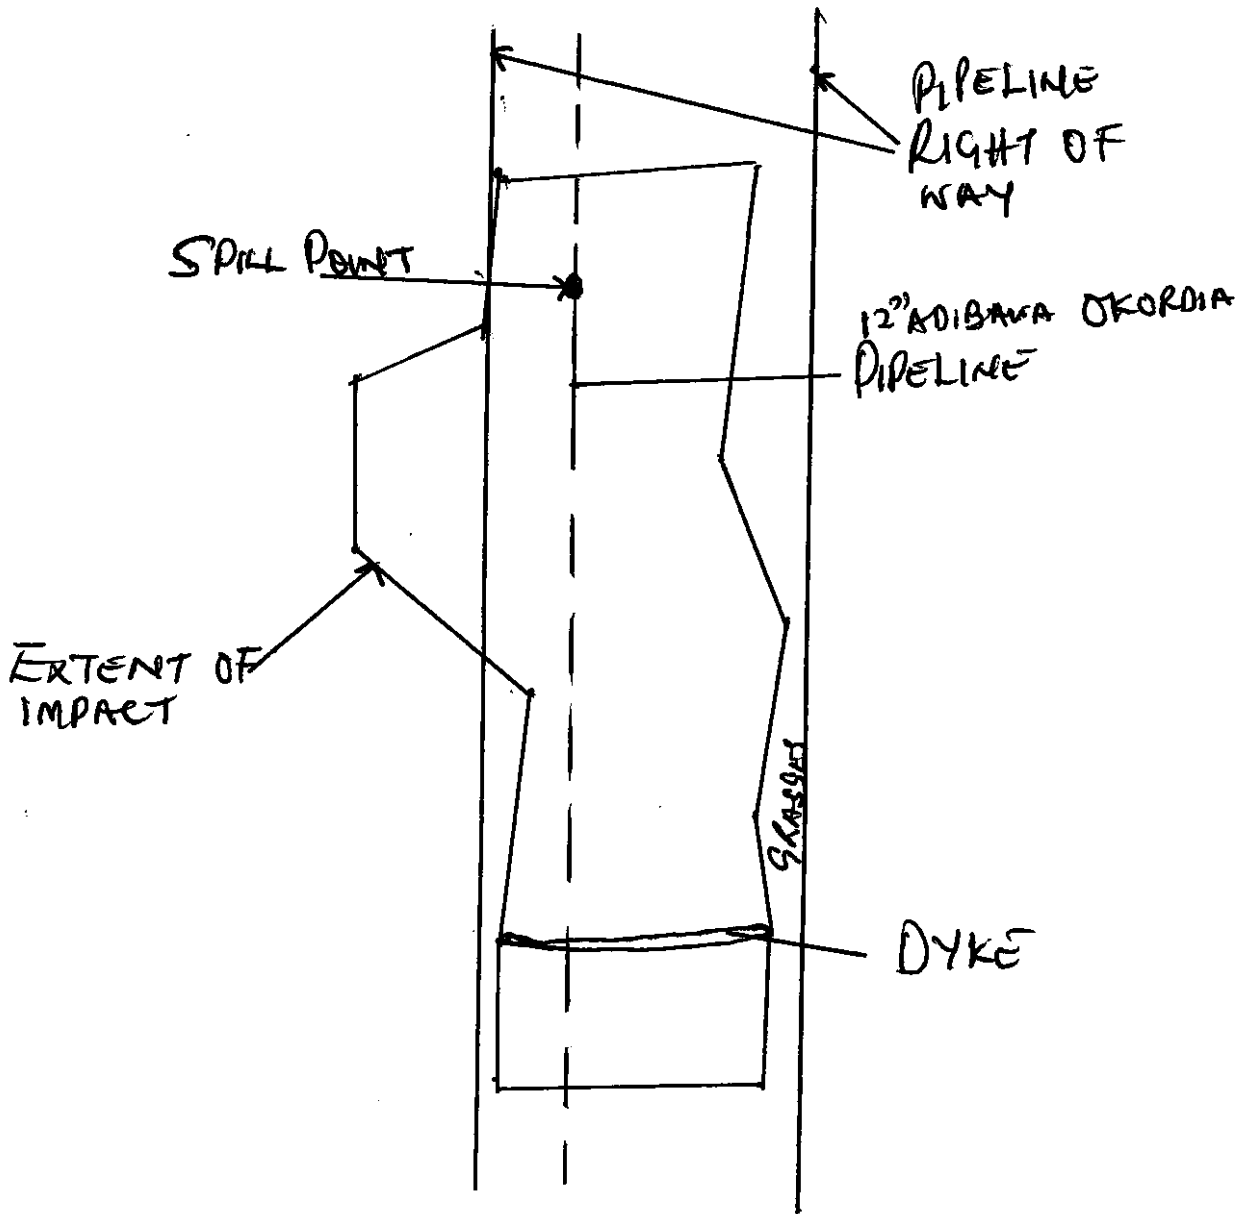
20. Appendix 1: Overview sketch of the site

Location: 12" ADIBAWA-OKORDIA PIPELINE AT IKARAMA
