Overview: Part of spill and fire impact on 14in Okordia-Rumuekpe pipeline right of way at Ikarama. Picture taken during Joint Investigation of 19th August, 2011.

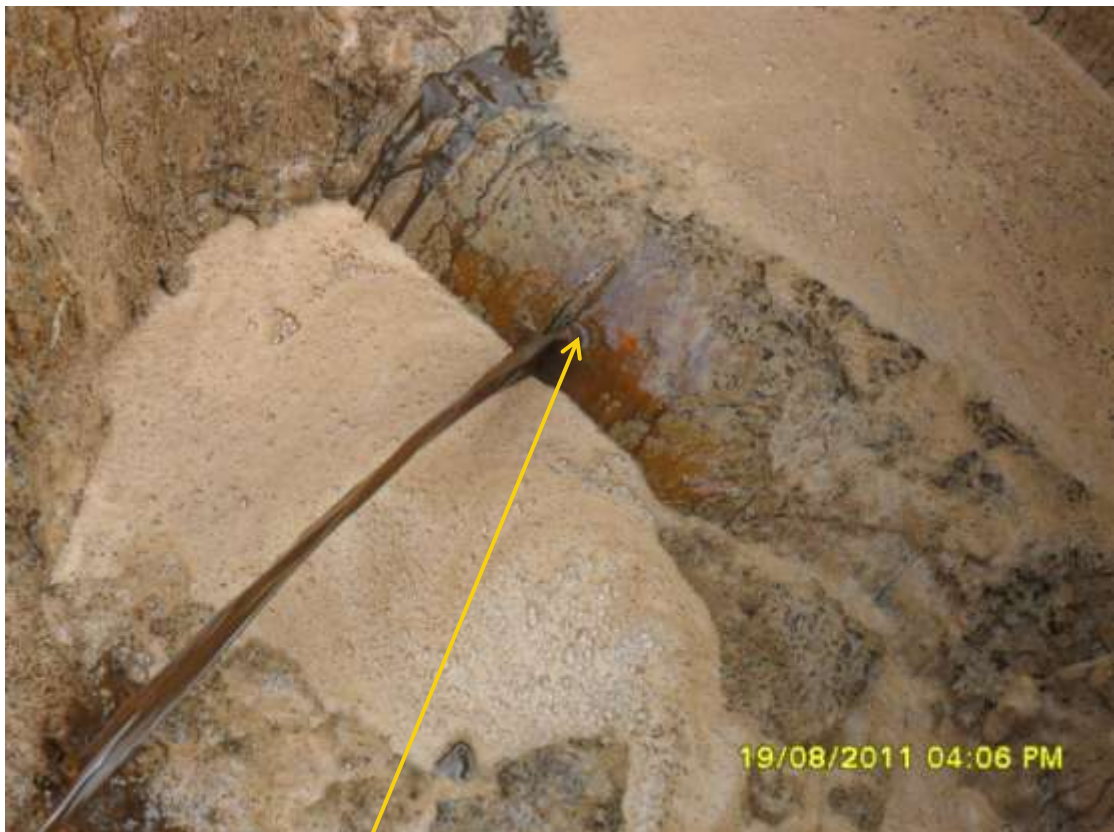
Close-up: Spill due to hacksaw cut on 14in Okordia-Rumuekpe pipeline at Ikarama. Picture taken during Joint Investigation of 19th August, 2011.

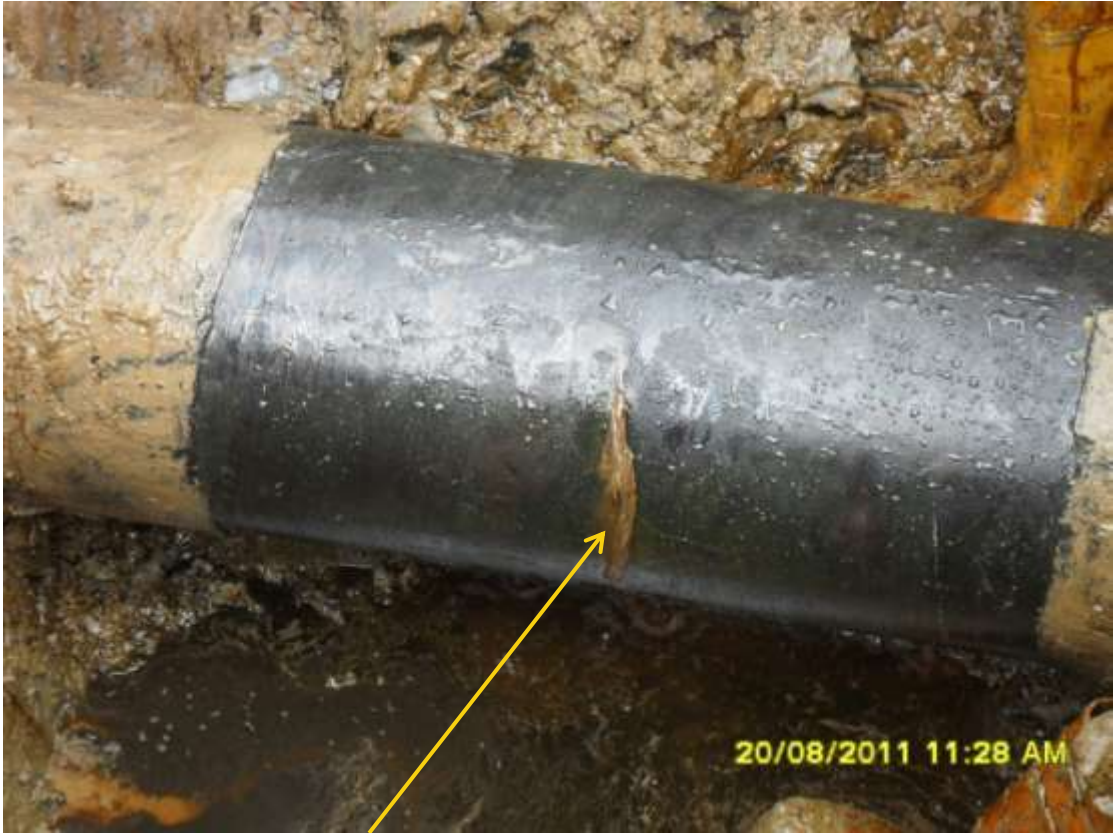
Close-up: Spill due to hacksaw cut on 14in Okordia-Rumuekpe pipeline at Ikarama.
Picture taken during Joint Investigation of 19th August, 2011.
