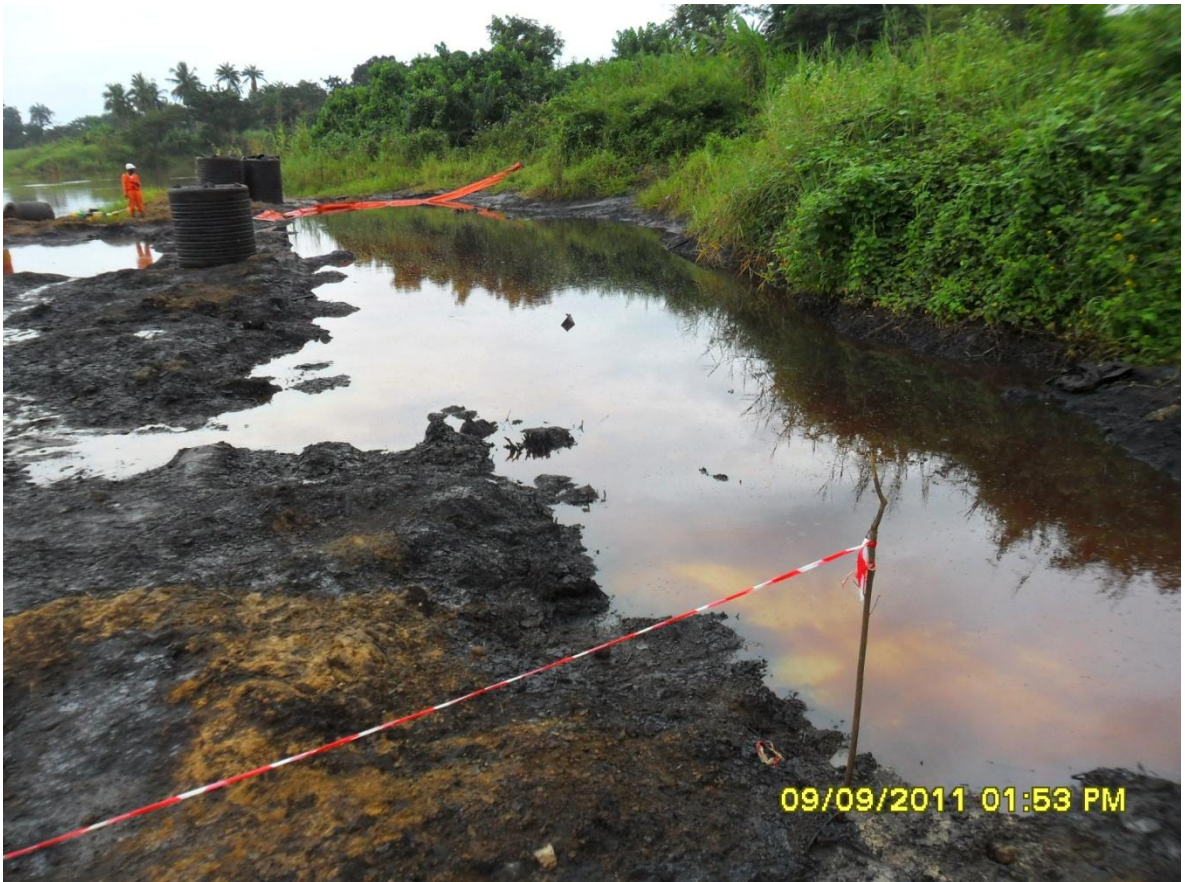
Overview: Part of the spill incident impact at 20" Kolocreek – Rumuekpe Pipeline route in Ogbogolo. Picture was taken during JIV of 4th and 9 – 11th September, 2011.

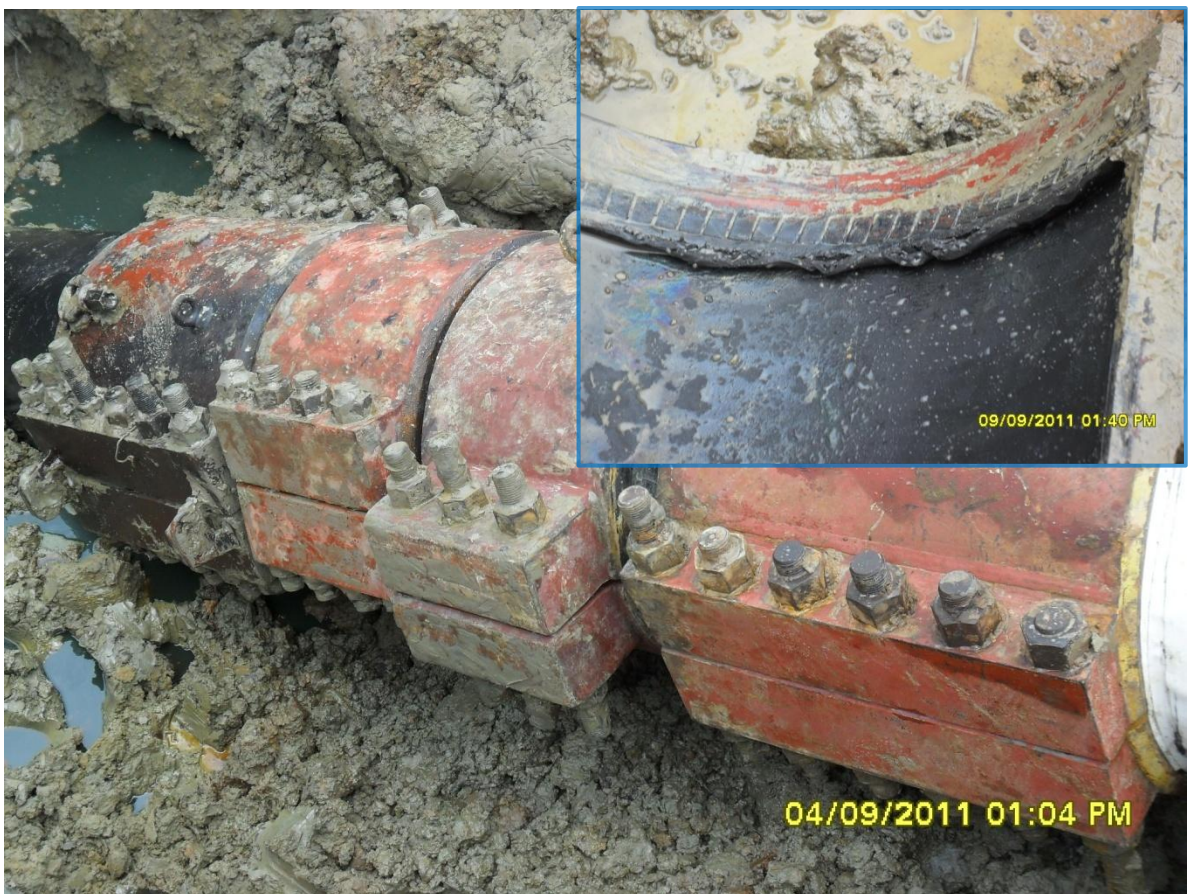
Close-up: Spill due to failed clamp point on 20" Kolocreek – Rumuekpe Pipeline at Ogbogolo. Insert shows broken seal of failed clamp. Pictures were taken during JIV of 4th and 9 – 11th September, 2011.
