Overview: Extent of the spill incident impact at 20" Kolocreek – Rumuekpe Pipeline route in Ogbogolo . Picture was taken during JIV of 12 February, 2011

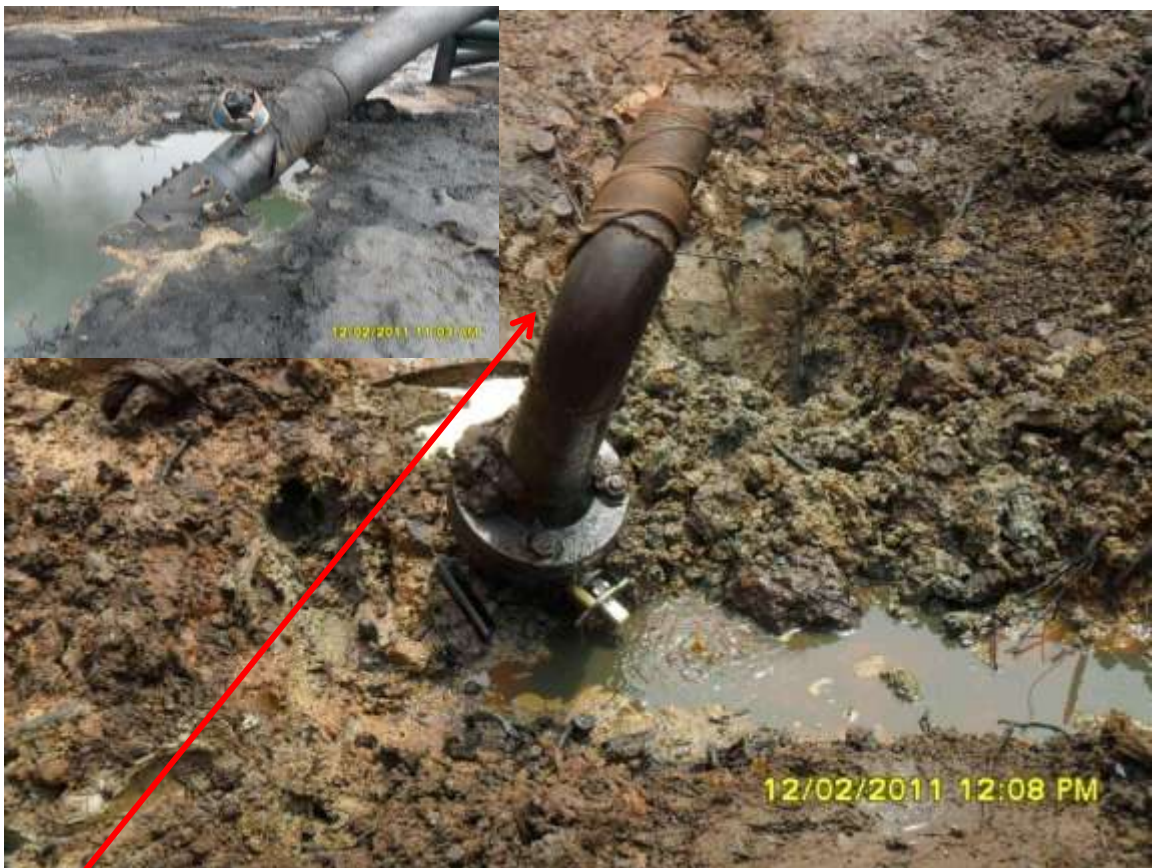
Close-up: Illegally welded points on 20" Kolocreek – Rumuekpe Pipeline in Ogbogolo. Picture was taken during JIV of 12 February 2011
