Overview: Extent of spill impact on the 10in Diebu Creek – Nun river pipeline at Nun river. Picture was taken during JIV of 18 May 2011

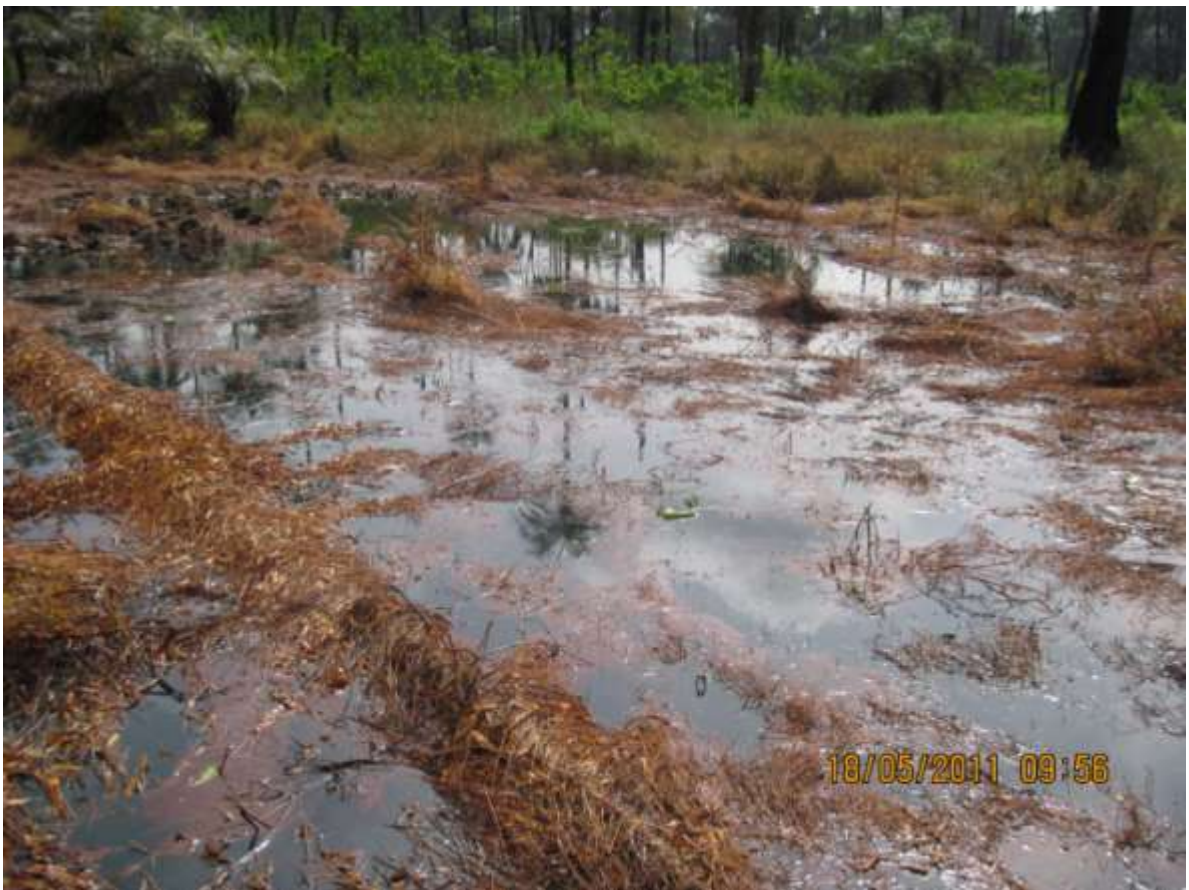
Overview : Extent of spill impact on the 10in Diebu Creek – Nun river pipeline at Nun river. Picture was taken during JIV of 18 May 2011

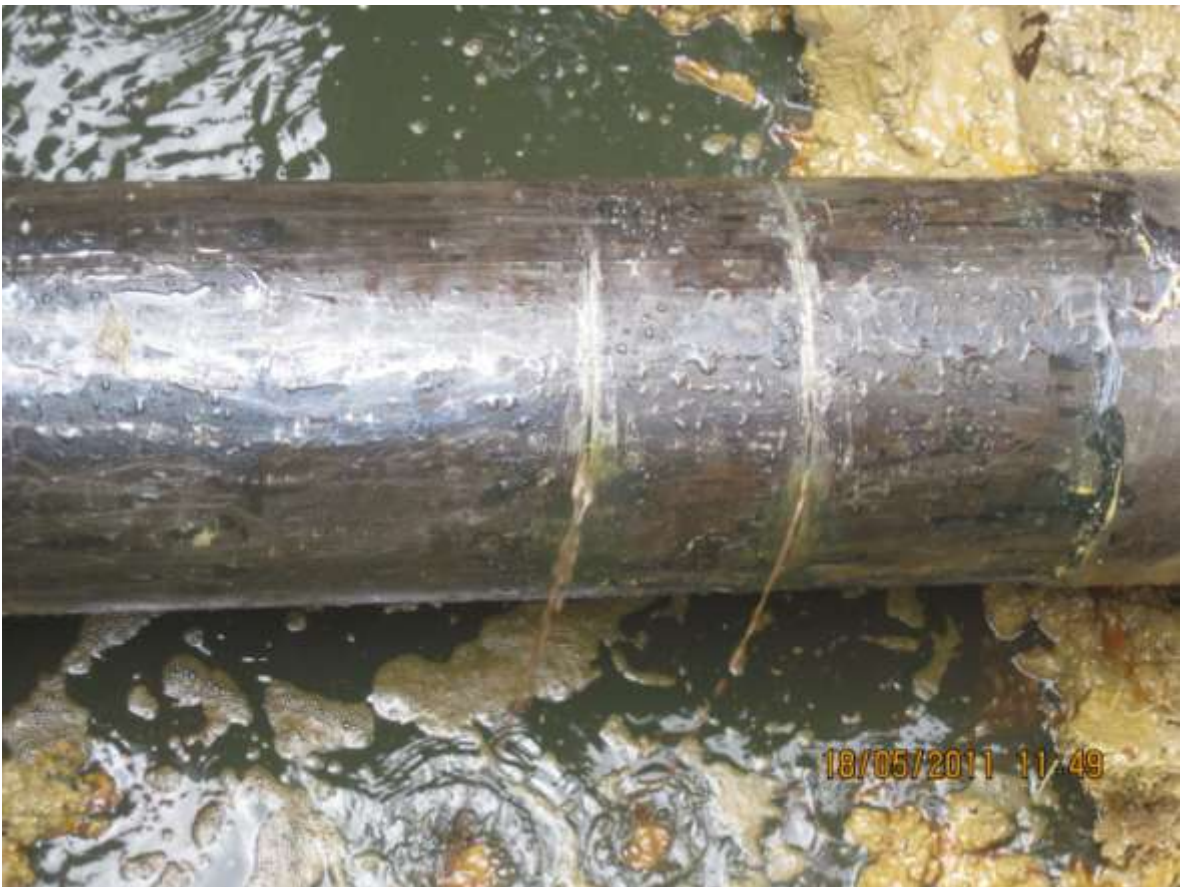
Close-up: Hacksaw cuts on the 10 inch Diebu Creek – Nun river pipeline at Nun river. Picture was taken during JIV of 18 May 2011.

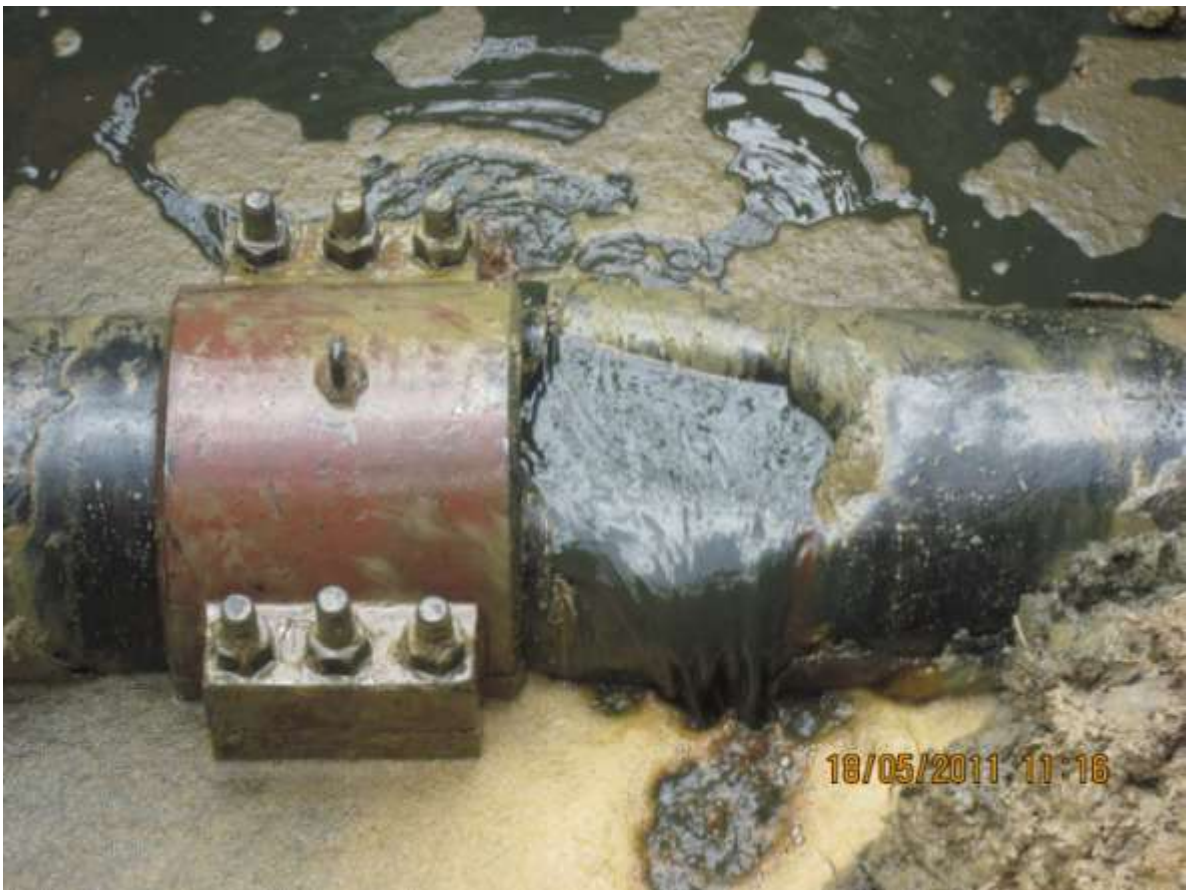
Close-up: Damage due to explosion evident on the 10 inch Diebu Creek – Nun river pipeline at Nun river. The visible clamp is from an earlier spill response.
