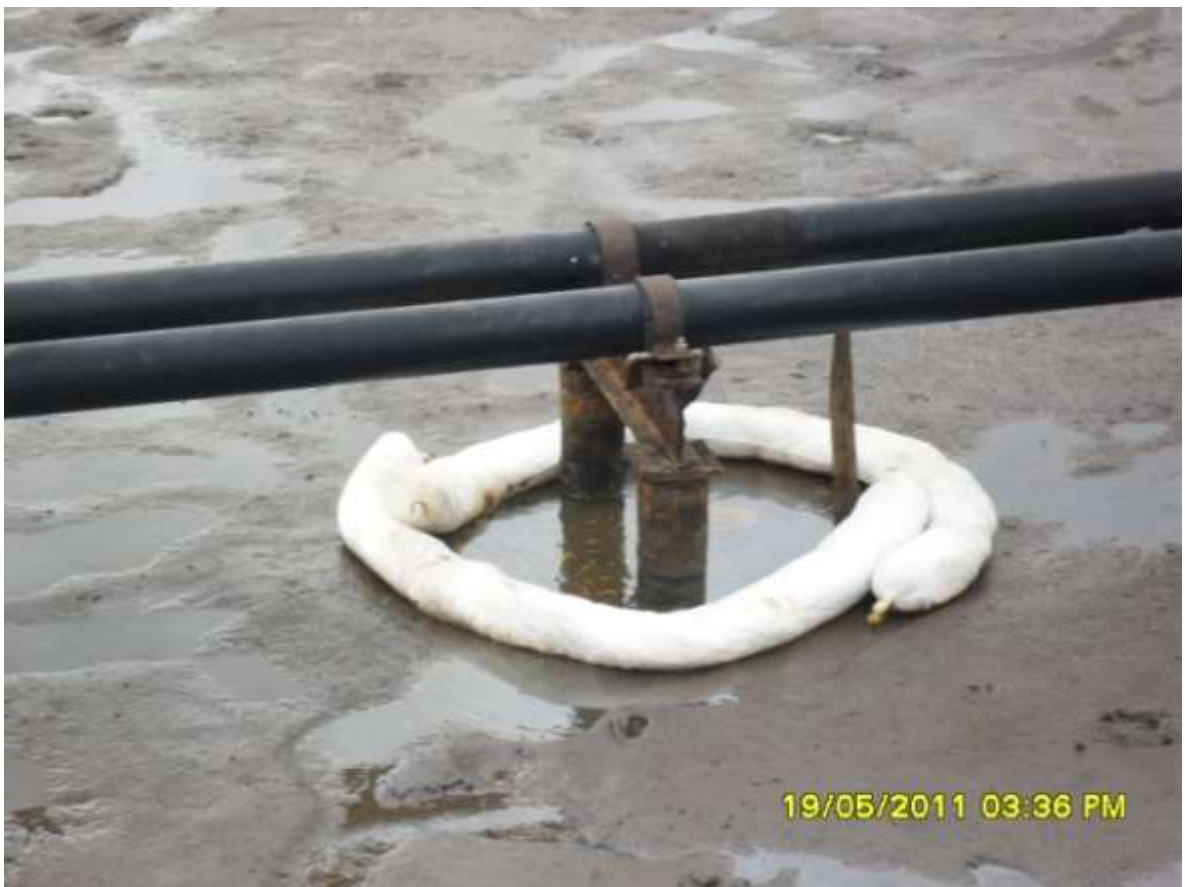
Overview: Extent of the spill incident impact at the 6" Awoba Pipeline route in Owaza . Picture was taken during JIV of 19 May 2011 .

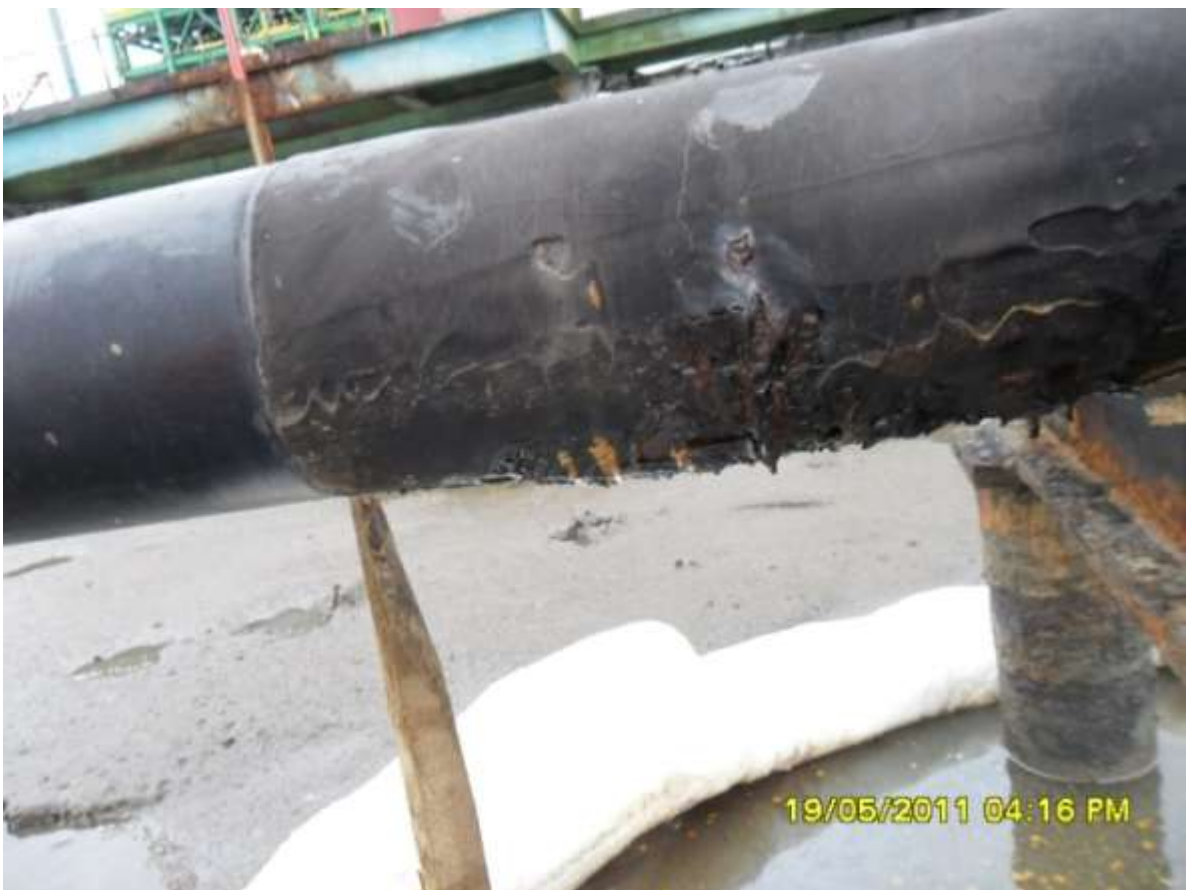
Close-up: Corrosion tear on the 6" Awoba Pipeline at Bille. Picture was taken during JIV of 19 May 2011 .
