Overview: Part of spill impact on 8" North bank Tie-in Manifold. Picture was taken during Joint Investigation of 2nd December, 2011.

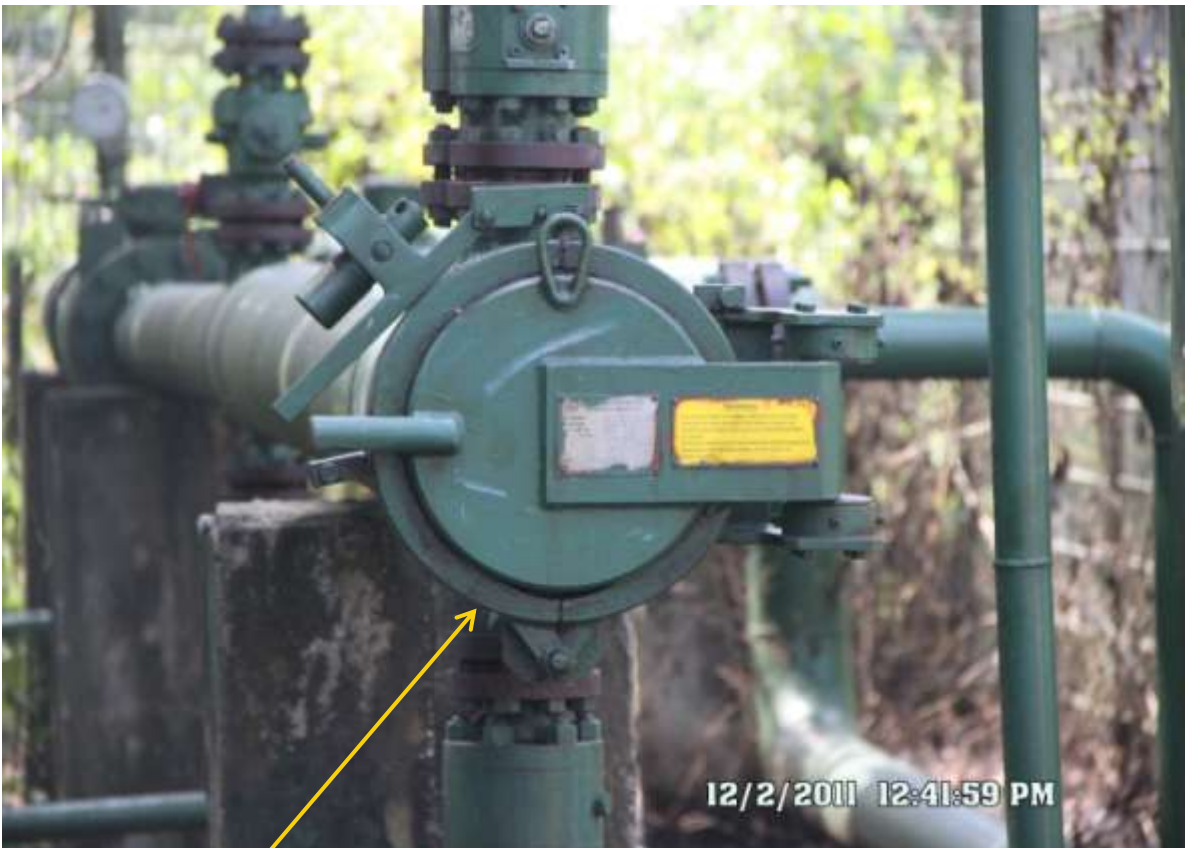
Close-up: Failed barrel door on 8" North bank Tie-in Manifold. Picture was taken during Joint Investigation of 2nd December, 2011.
