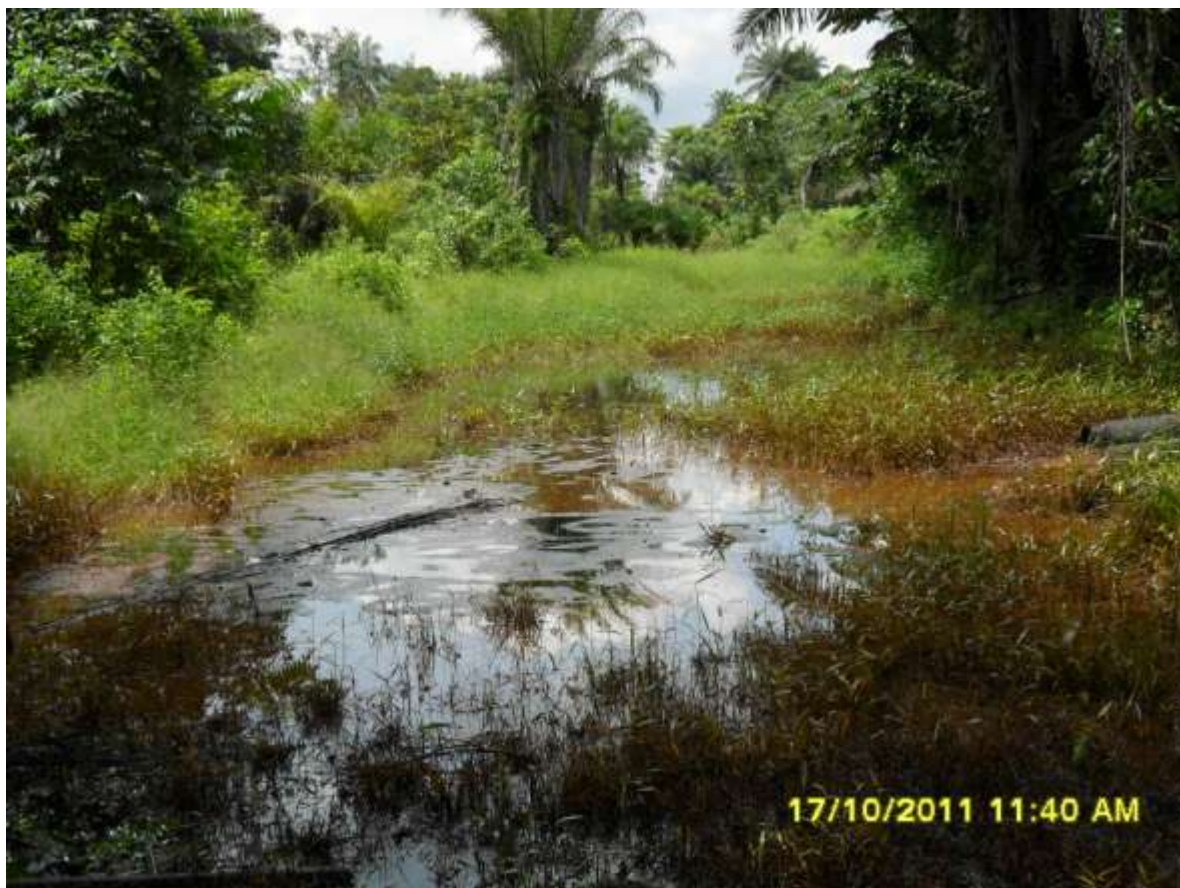
Overview: Part of spill impact on 12" Adibawa-Okordia pipeline at Ikarama. Picture was taken during Joint Investigation of 17th October, 2011.

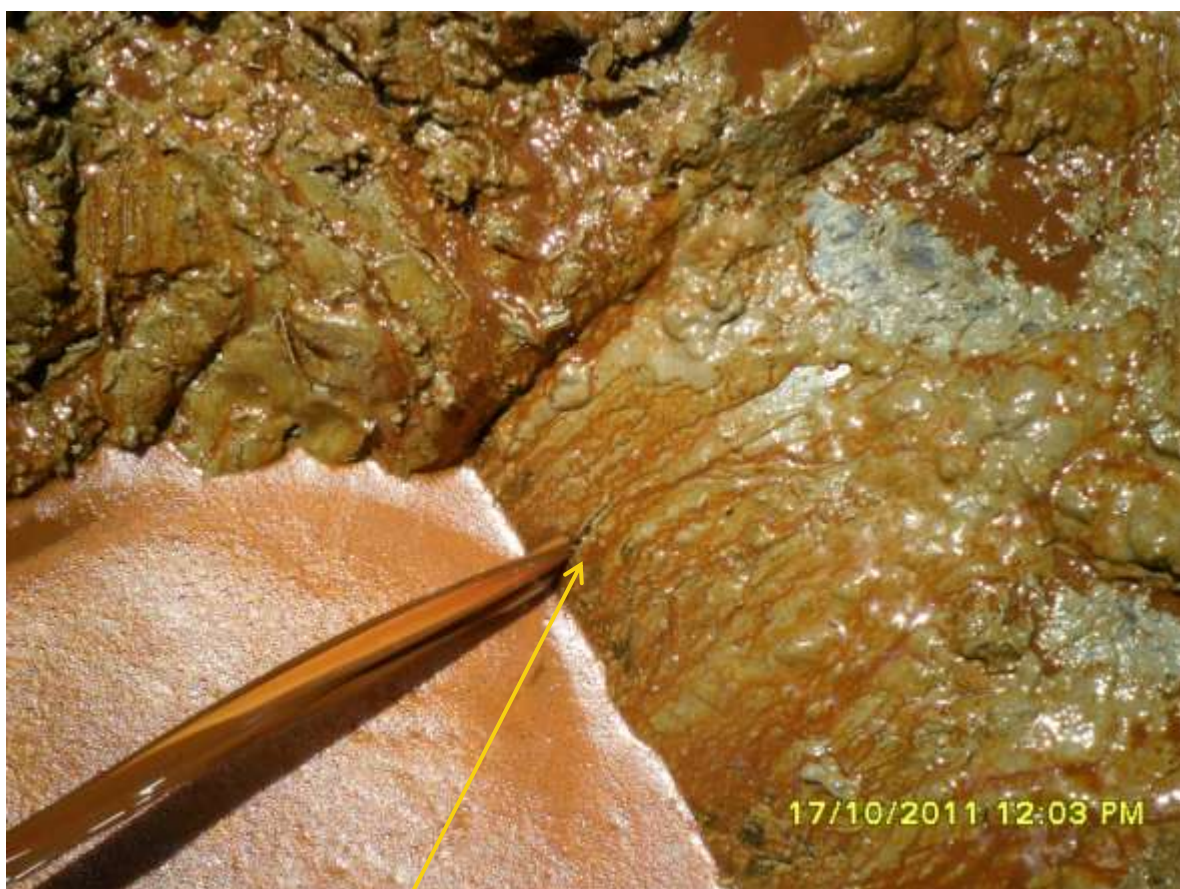
Close-up: Spill due to Hacksaw cut on 12" Adibawa-Okordia pipeline at Ikarama. Picture was taken during Joint Investigation of 17th October, 2011.
