Overview: Part of the spill impact on 6'' Obigbo North-Ogale pipeline right of way at Ogale
Picture taken during Joint Investigation of 22nd September,2011

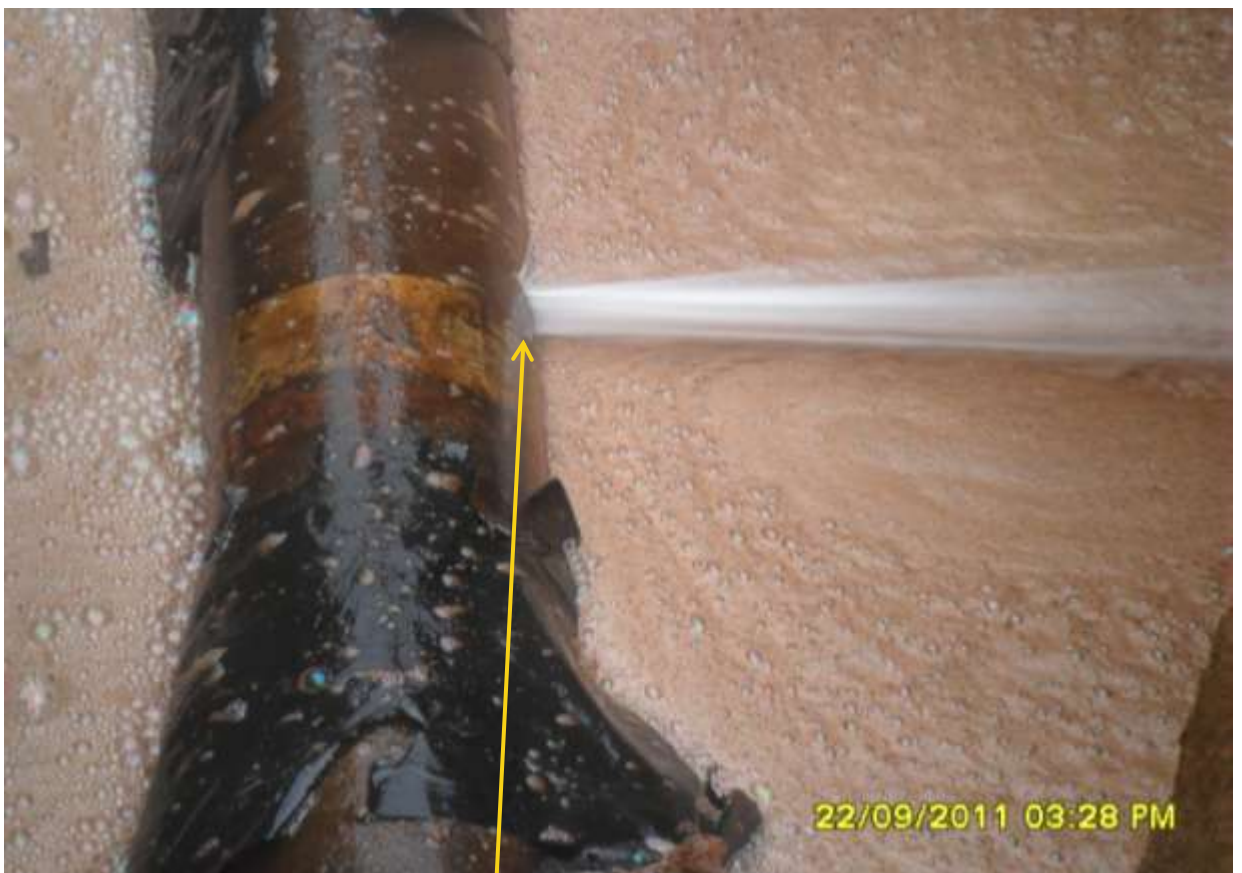
Close-up: Spill point due to hacksaw cut on 6'' Obigbo North-Ogale pipeline at Ogale. Picture taken during Joint Investigation of 22nd September,2011
