Overview: Part of spill impact on 14" Okordia – Rumuekpe Pipeline route at Ikarama . Picture was taken during Joint Investigation of 9th September, 2011 .

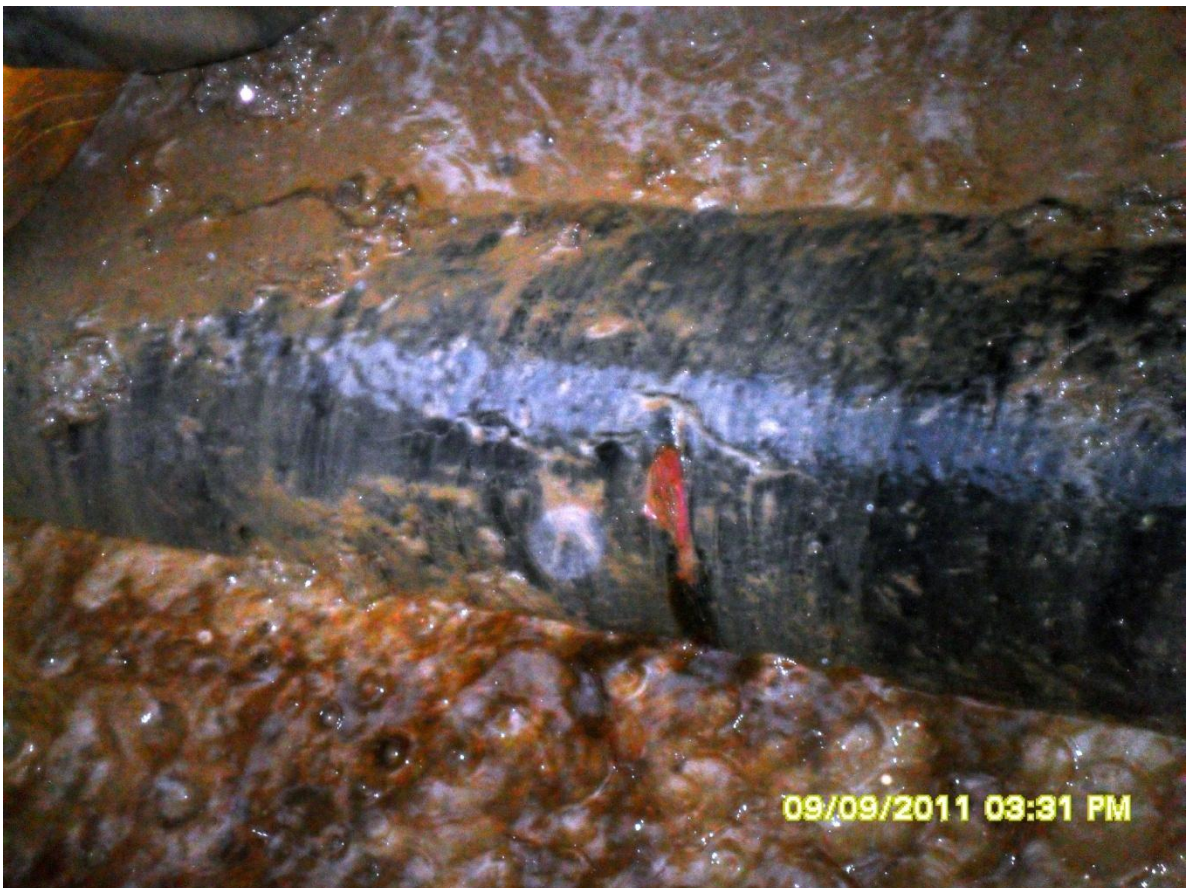
Close-up: Spill due to Hack saw cut on 14" Okordia – Rumuekpe Pipeline at Ikarama. Picture was taken during Joint Investigation of 9th September, 2011
