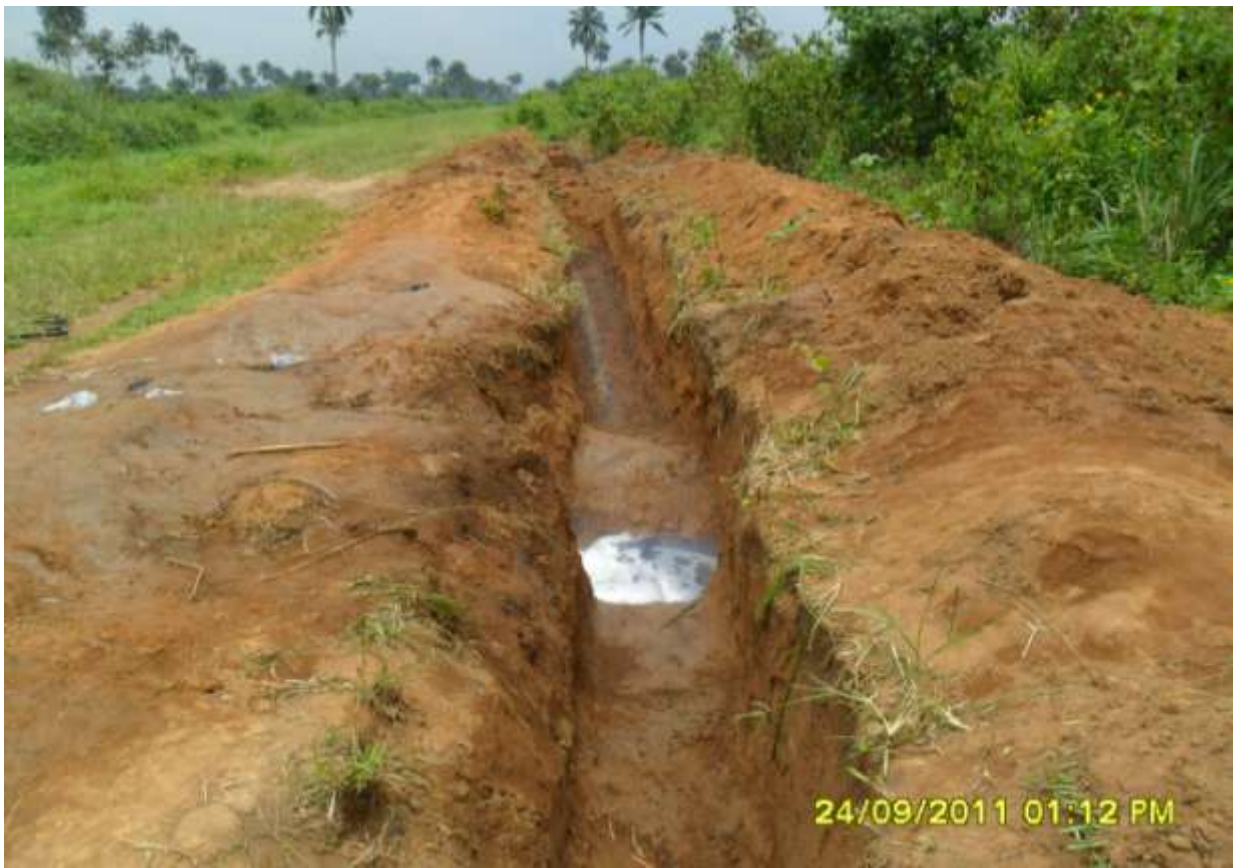
Overview: Part of the spill impact on 6'' Obigbo North-Ogale pipeline right of way at Ogale  
Picture taken during Joint Investigation of 24<sup>th</sup> September,2011

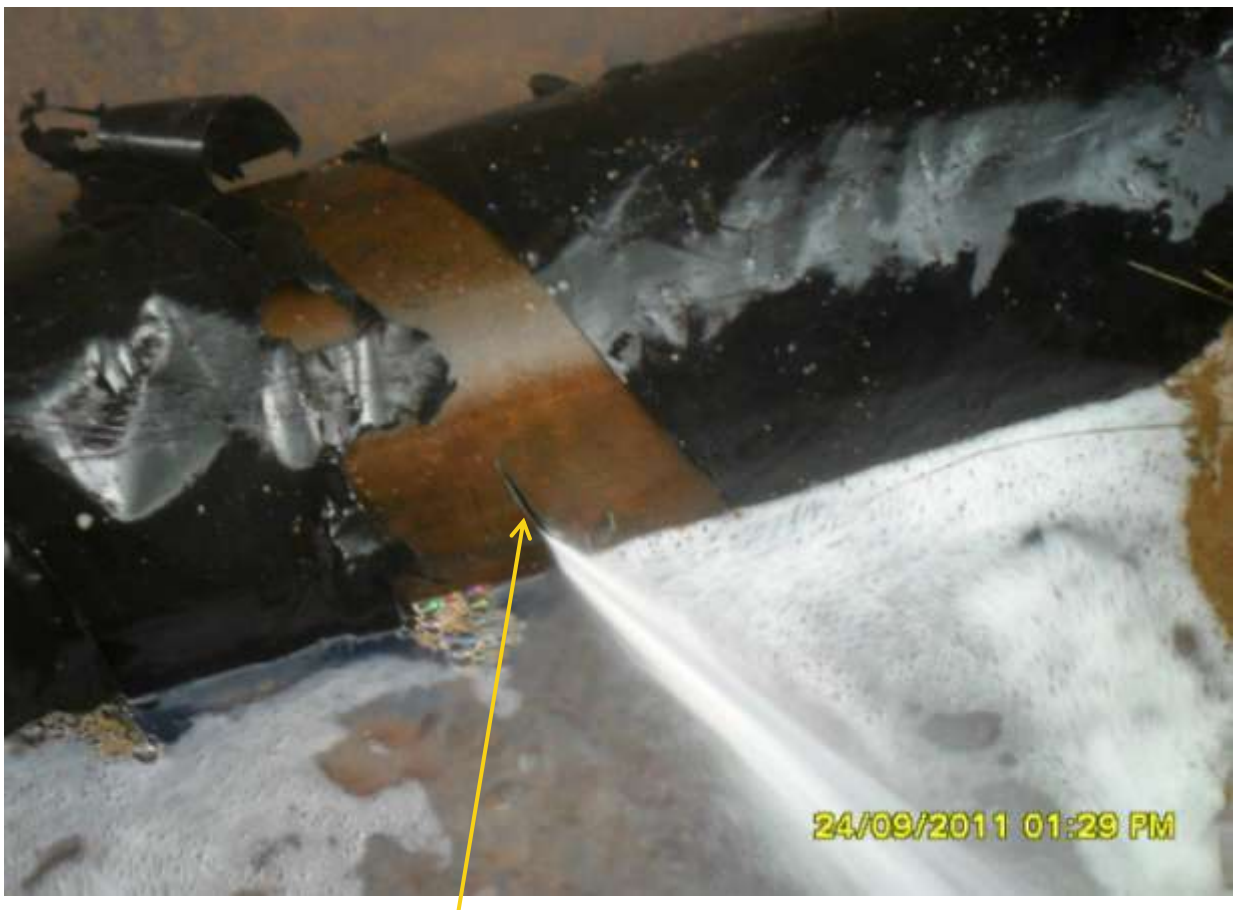
Close-up: Spill point due to hacksaw cut on 6'' Obigbo North-Ogale pipeline at Ogale. Picture taken during Joint Investigation of 24<sup>th</sup> September,2011
