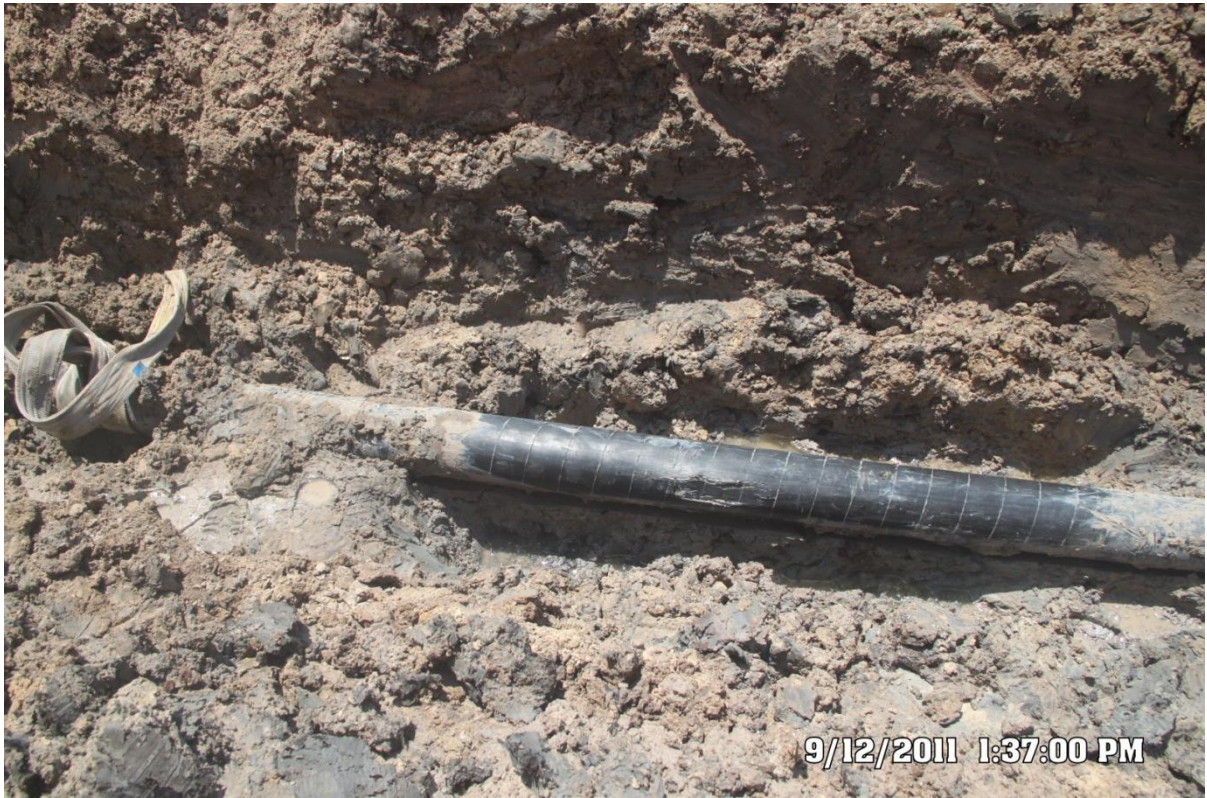
Overview: Part of spill impact on Batan Well 4T 6" Flowline at Batan. Picture taken during Joint Investigation of 12th September, 2011

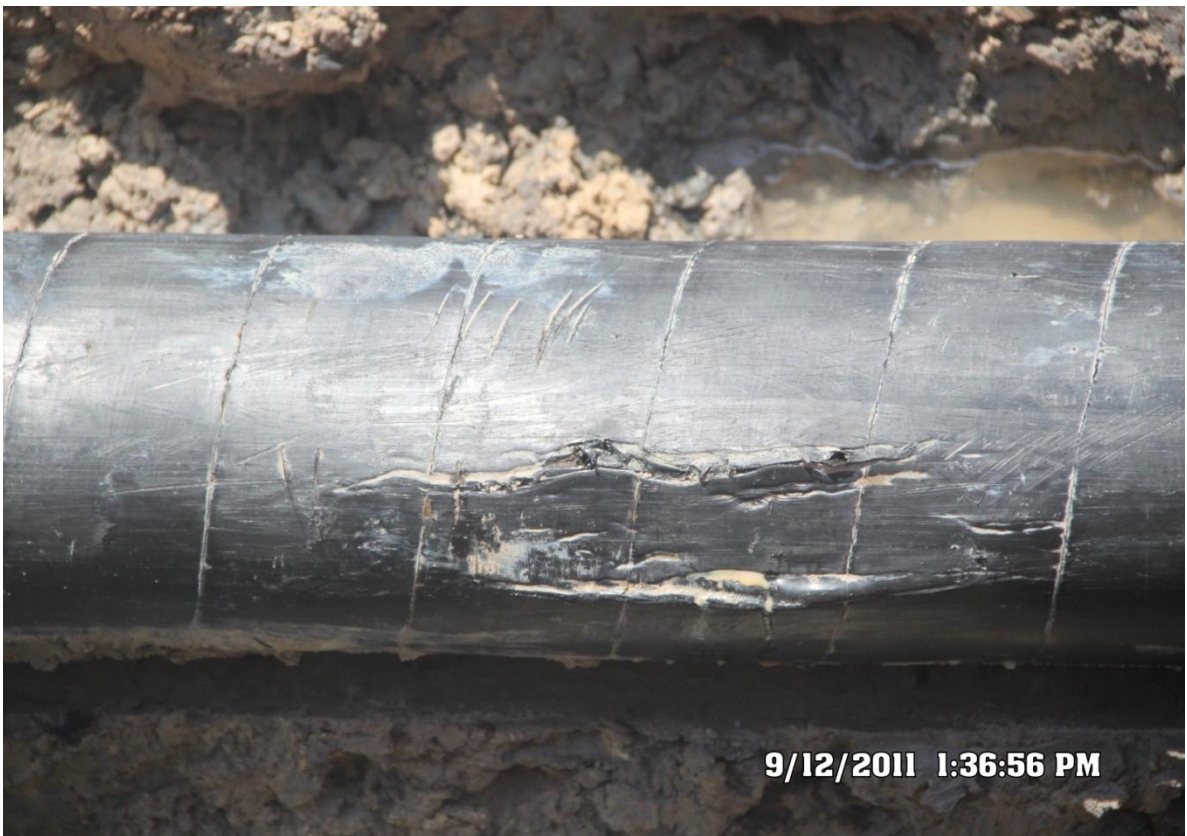
Close-up: Spill due to corrosion on Batan Well 4T 6" Flowline at Batan. Picture was taken during Joint Investigation of 12th September, 2011
