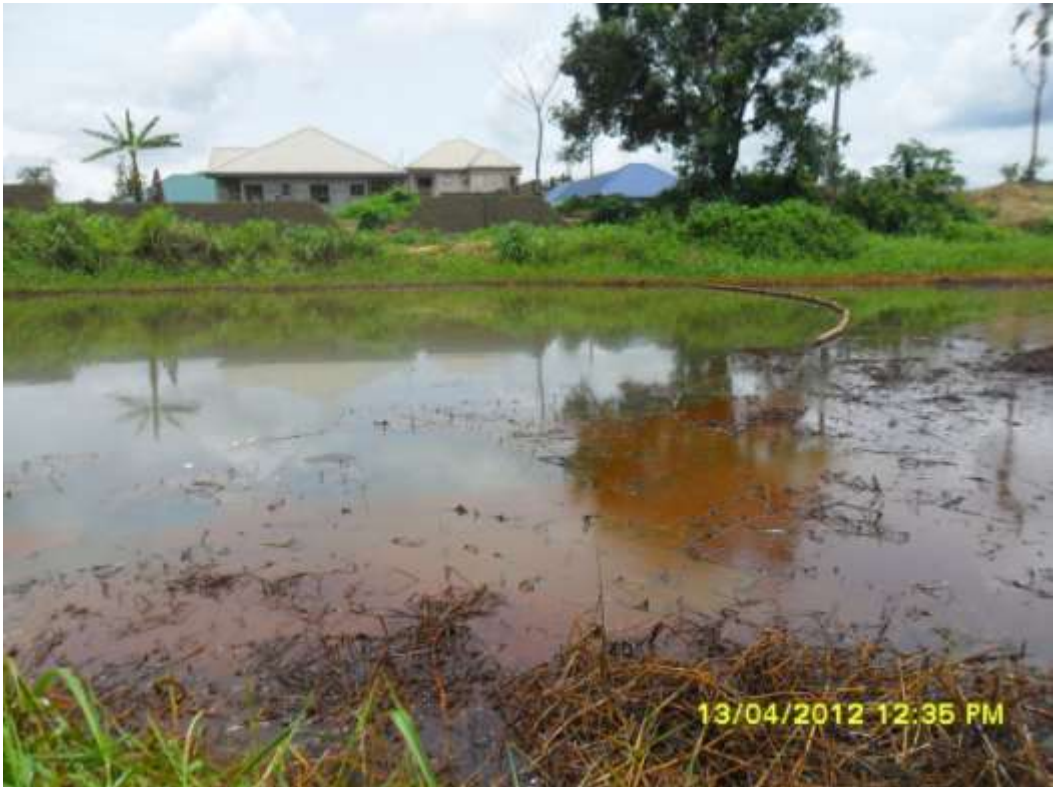
Overview: Part of spill impact on 8" Etelebou-Kolocreek pipeline right of way at Biogbolo. Picture was taken during Joint Investigation of 13<sup>th</sup> April 2012.

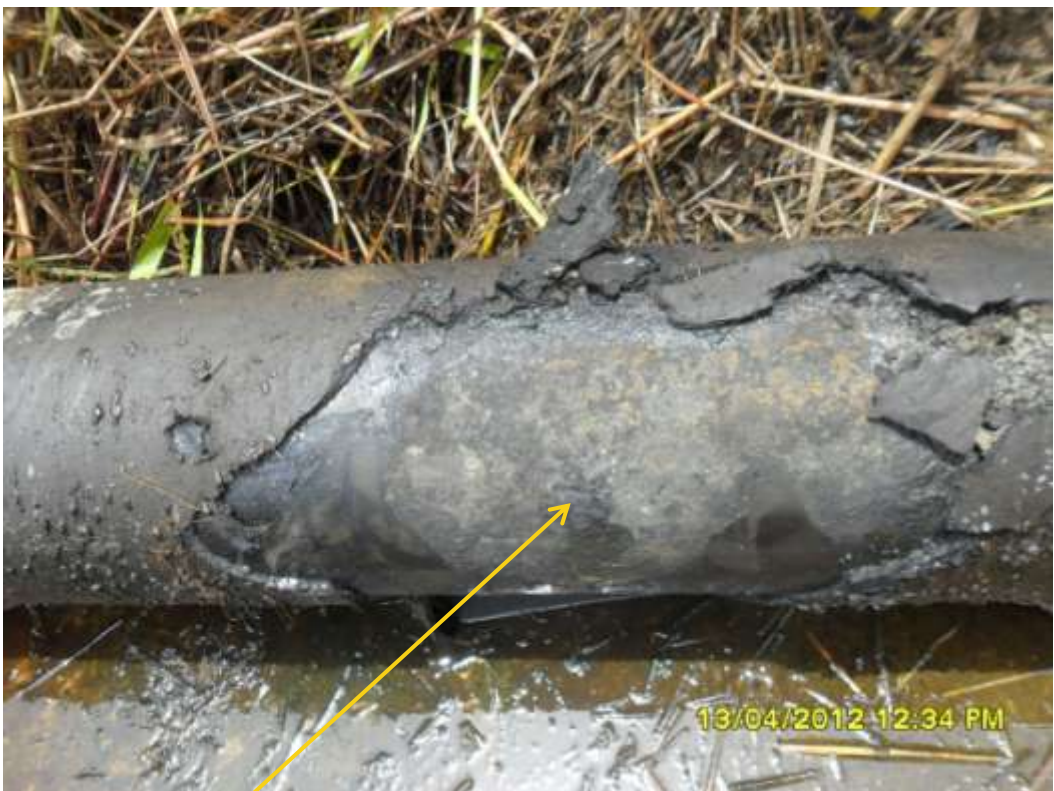
Close up: Evidence of corrosion on 8" Etelebou-Kolocreek pipeline at Biogbolo. Picture was taken during Joint Investigation of 13<sup>th</sup> April 2012.
