THE SHELL PETROLEUM DEVELOPMENT COMPANY OF NIGERIA LIMITED

JOINT INVESTIGATION REPORT FOR INCIDENT NO: 0404853943

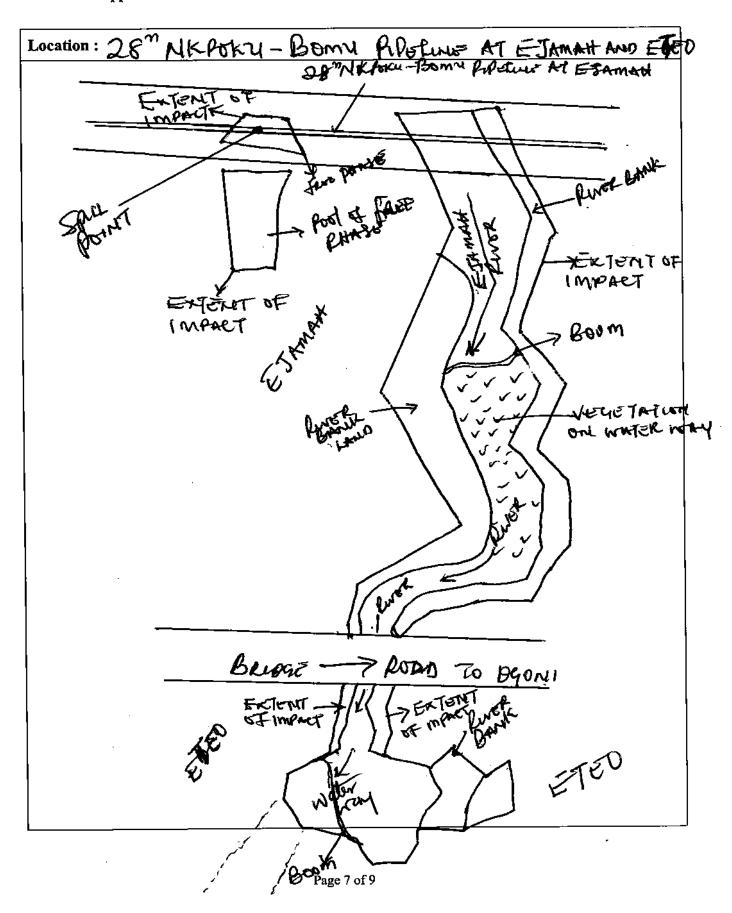
27. Appendix 1: Overview sketch of the site

+ Section of 28" MKPOFU-BOMY PUELING AT EJAMAN EBUBY SHOWING

THE DAMAGE BY ATHIED PARTY DEED GIVE HEAVY EQUIPMENT AT 1 O'CLOCK

LEAKING DEPRESSION MITH CUTE/2000)

AND LEAKING DEPRESSION

NON LEAKING CUTSE ON

THE PROTUNE
