THE SHELL PETROLEUM DEVELOPMENT COMPANY OF NIGERIA LIMITED

JOINT INVESTIGATION REPORT FOR INCIDENT NO: 0432 852067

1. Spill incident Number: 852067 2. Type of incident \* OIL SPILL  
 3. Name of Location MORIVER L WELL 57L FLOWLINE  
 4. Name of nearest community IGIRIUKWU 5. State: ABIA 6. LGA UKWA-WEST  
 7. Type of Production facility/Installation OIL FLOWLINE 8. Asset owner/ District NEL 1/PH 2

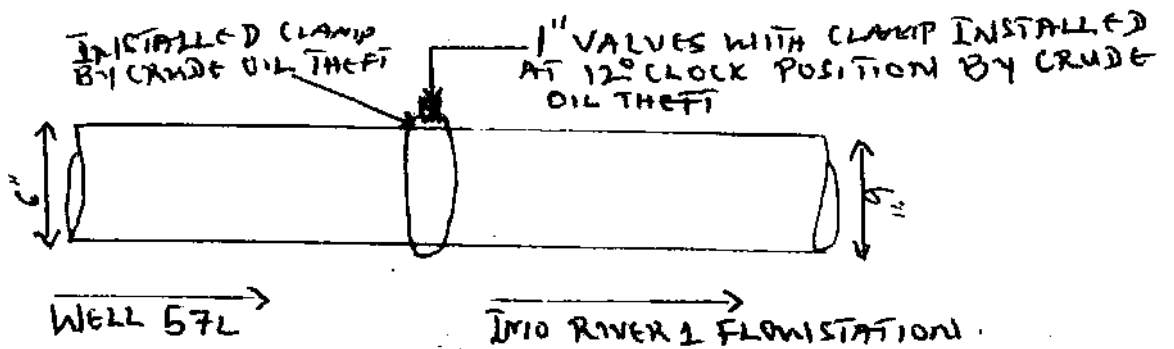
e. Description of leak point (tick as applicable);  
 Drilled hole  Hack saw cut  Explosive tear,  
 Complete Rupture  Inward dent,  Well head tampering  
 Failed Weld-on illegal hot tap valve,  Missing Pipeline/Flowline)  
 Crude oil theft (illegal) bunkering) point,  Third party tampering with Clamp  
 Third party tampering with valve setting,  Third party tampering with flange,  
 Corrosion  Saver-pit over flow,  Surge vessel overflow  
 Outward dent  Flare System/Bund wall failure  
 Valve Failure  com unit failure  Cold vent  
 Relief valve failure  Others (specify) \_\_\_\_\_

f. Incident caused by:  
 Third party interference  Operational  Mystery \_\_\_\_\_

SECTION OF 6" IMORNERI FLOWLINE AT IGIRIUKWU SHOWING 1" VALVES WITH CLAMP INSTALLED AT 12 O'CLOCK POSITION
