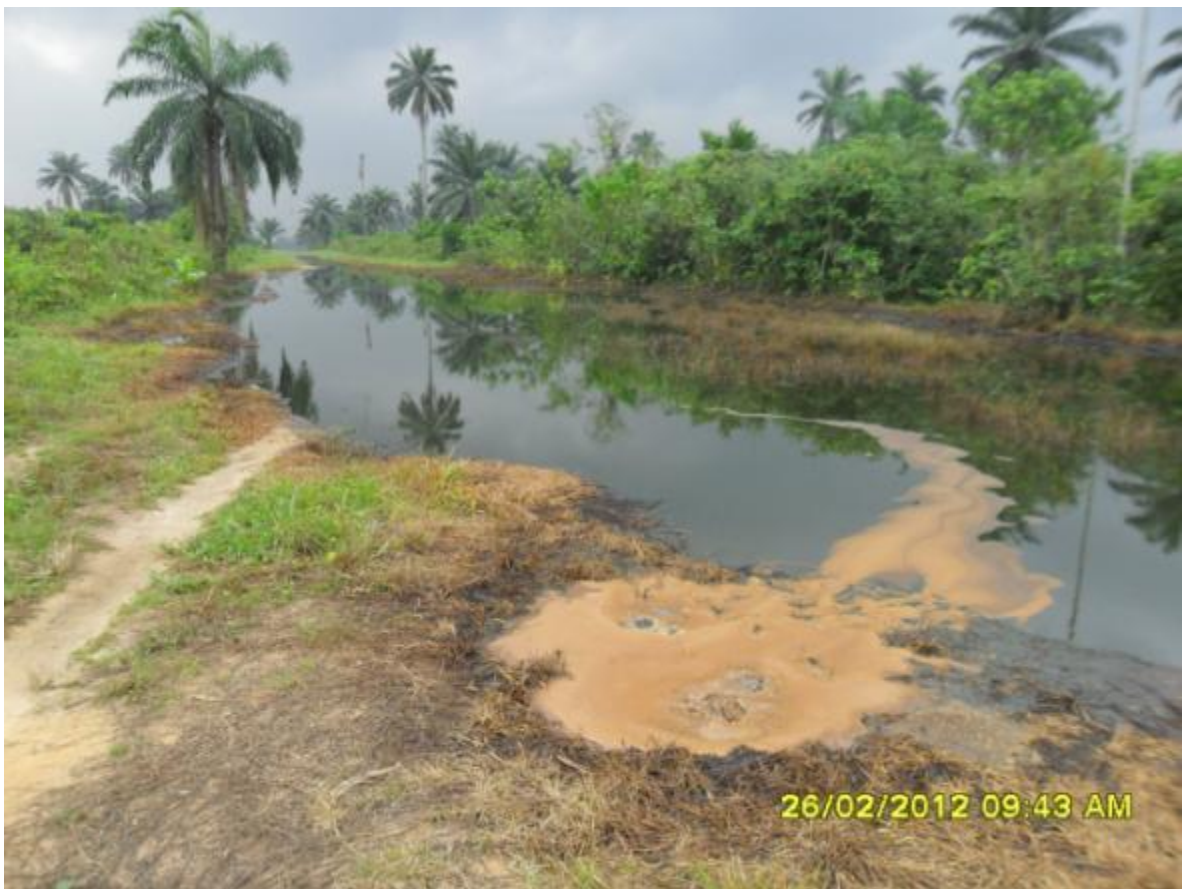
Overview: Part of spill impact at 28" Nkpoku – Bomu Pipeline route in Aleto-Nchia-Eleme. Picture was taken during Joint Investigation of 26 February 2012.

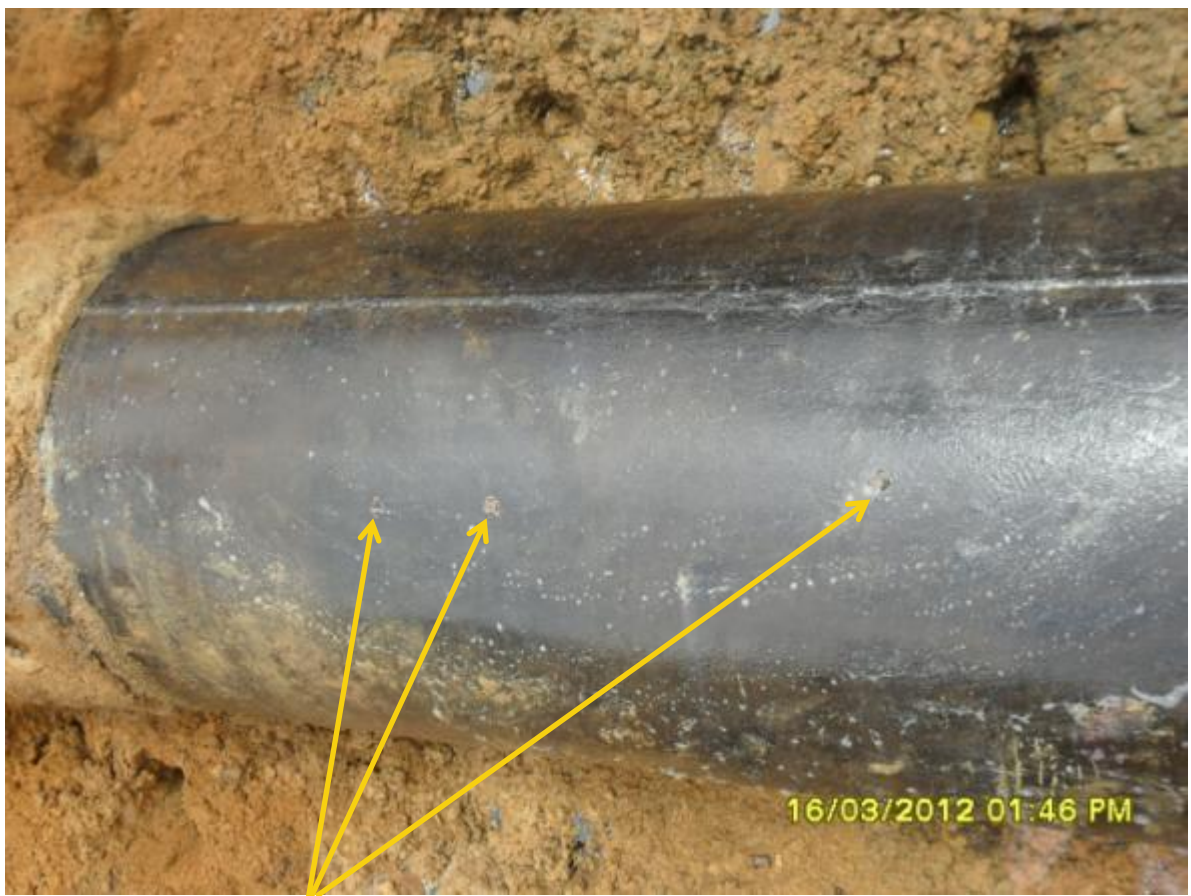
Close-up: Drilled holes on 28" Nkpoku – Bomu Pipeline at Aleto-Nchia-Eleme. Picture was taken during Joint Investigation of 16 March 2012.
