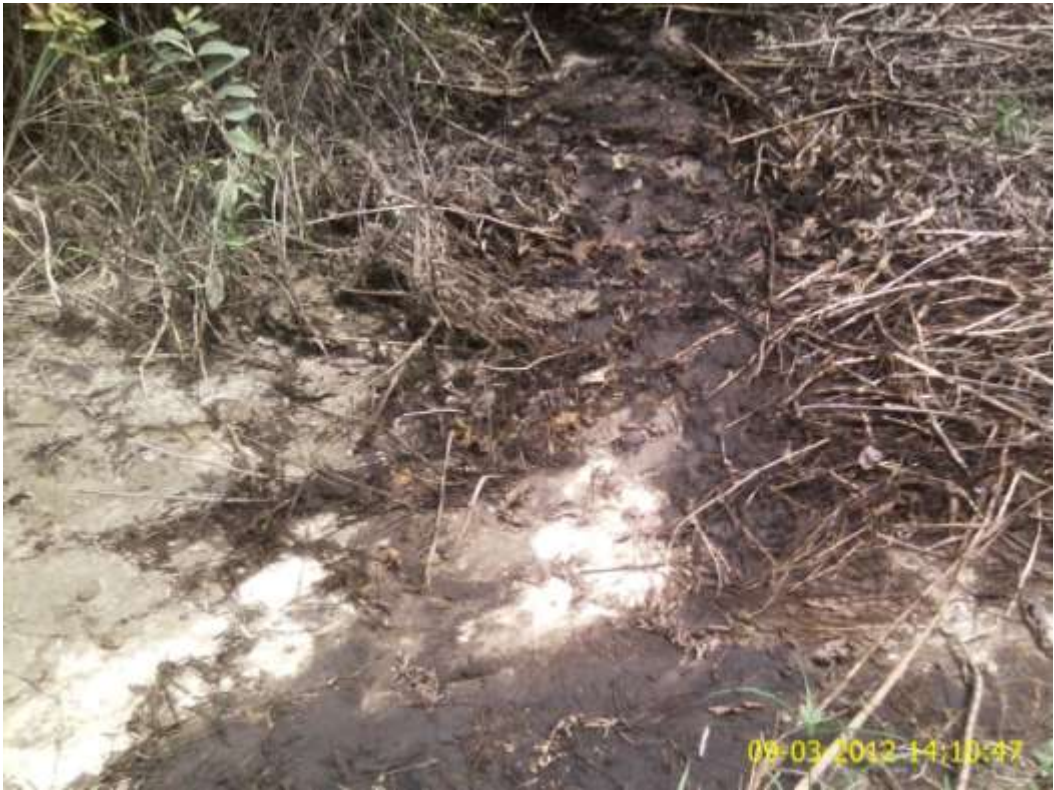
Overview: Part of spill impact on 12" Adibawa-Okordia pipeline right of way at Edagberi-Betterland. Picture was taken during Joint Investigation of 9<sup>th</sup> March 2012.

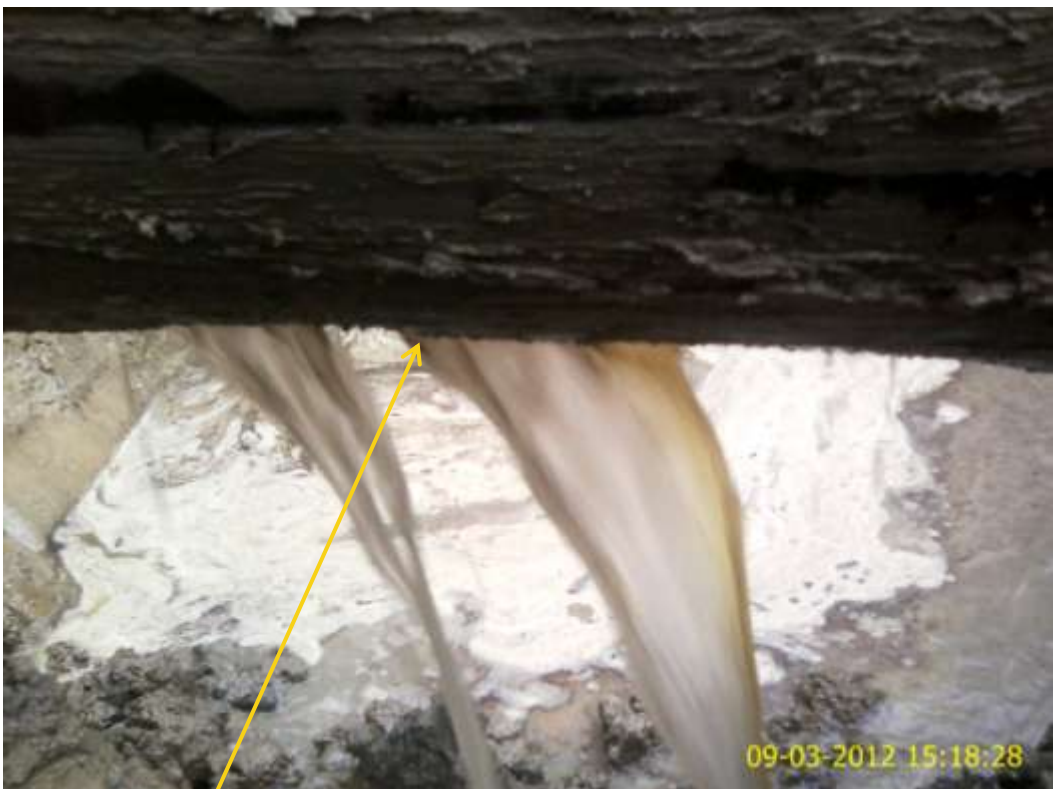
Close up: Tear at 6 o'clock position on 12" Adibawa-Okordia pipeline at Edagberi-Betterland. Picture was taken during Joint Investigation of 9<sup>th</sup> March 2012.
