THE SHELL PETROLEUM DEVELOPMENT COMPANY OF NIGERIA LIMITED

JOINT INVESTIGATION REPORT FOR INCIDENT NO: 0153 780528

1. Spill incident Number: 780528 2. Type of incident* Oil Spill
 3. Name of Location 10" EKULAMA 2 PIPELINE
 4. Name of nearest community SANBARTH/LUCKY LAND State: RWERS 6. LGA AKUKUTORU
 7. Type of Production facility/Installation ON PIPELINE 8. Asset owner/District NESP/SWAMP

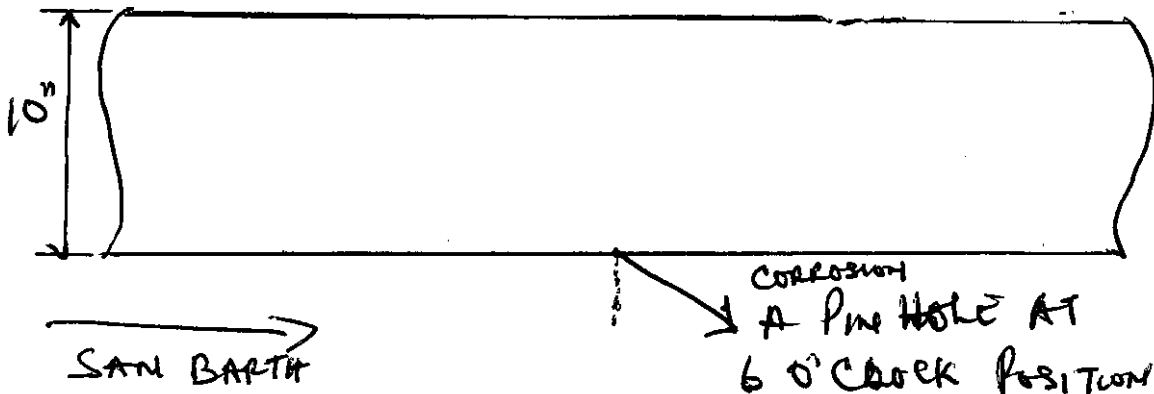
E. GRAPHIC DESCRIPTION OF LEAK POINT (Overview sketch of the site should be added as an appendix)

A SECTION OF 10" EKULAMA 2 PIPELINE AT SAN BARTH/LUCKY LAND SHOWING A CORROSION PINHOLE AT 6 O'CLOCK POSITION

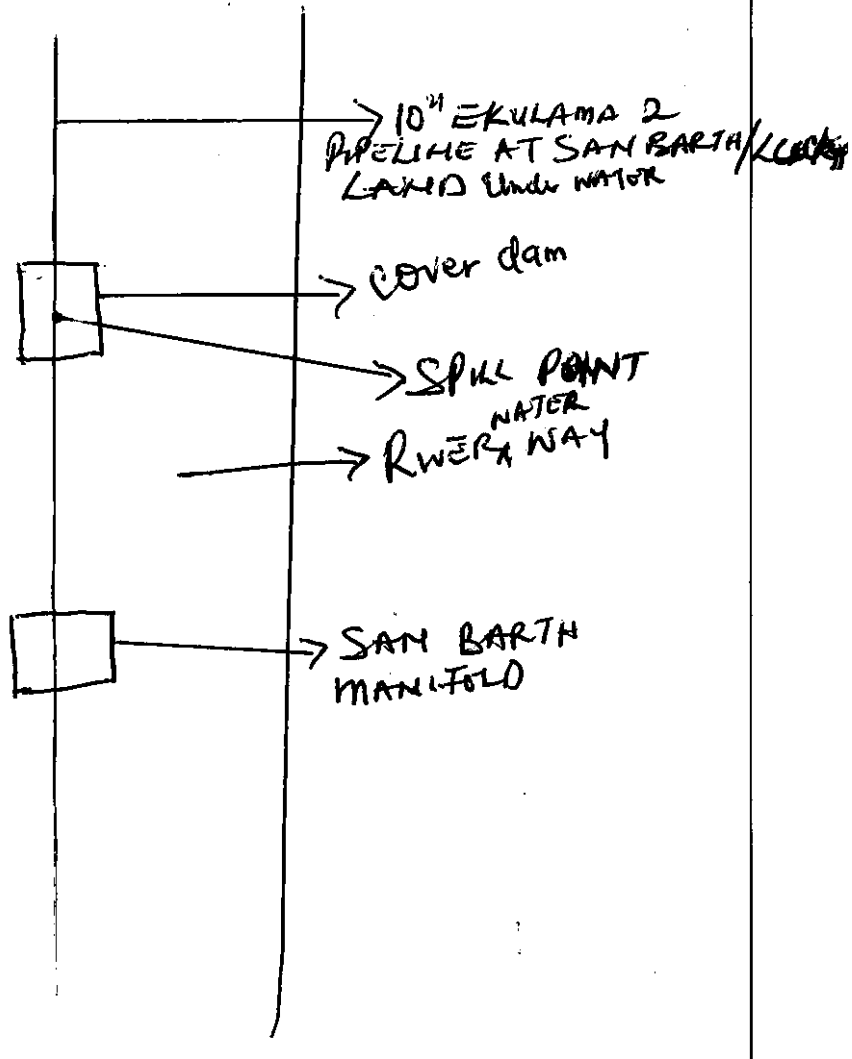
20. Appendix 1: Overview sketch of the site

Location : 10" EKULAMA 2 PIPELINE AT SAN BARTH / LUCKY LAND
