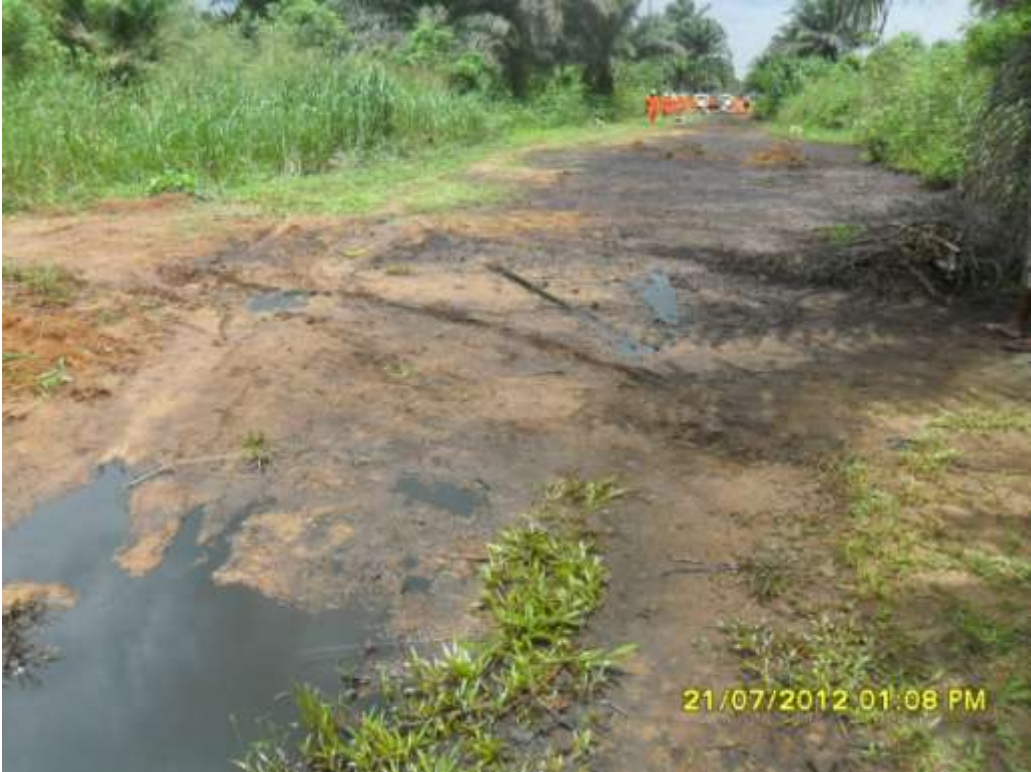
Overview: Part of spill impact on 8" Umuechem-Nkpoku delivery line right of way at Umuechem. Picture was taken during Joint Investigation of 21st July 2012.

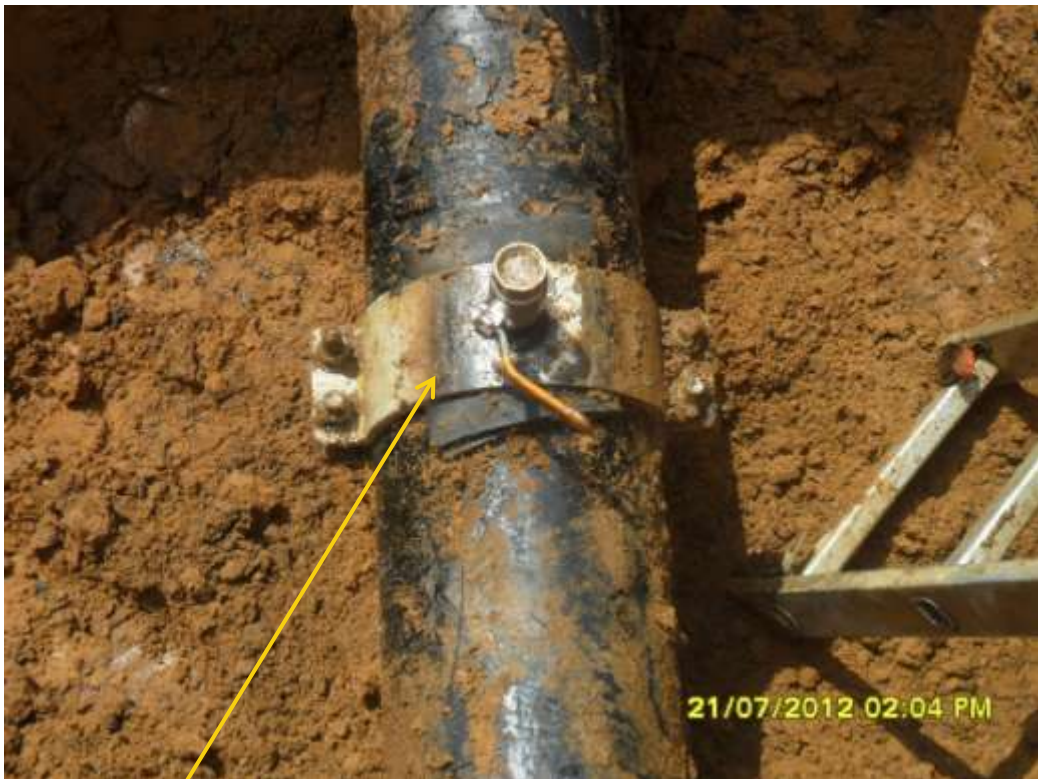
Close up: Illegal fitting on 8" Umuechem-Nkpoku delivery line at Umuechem. Picture was taken during Joint Investigation of 21st July 2012.
