Overview: Part of spill impact on Opukushi Well24T flowline right of way at Agbemo-Angalebiri. Picture was taken during Joint Investigation of 30th June 2012.

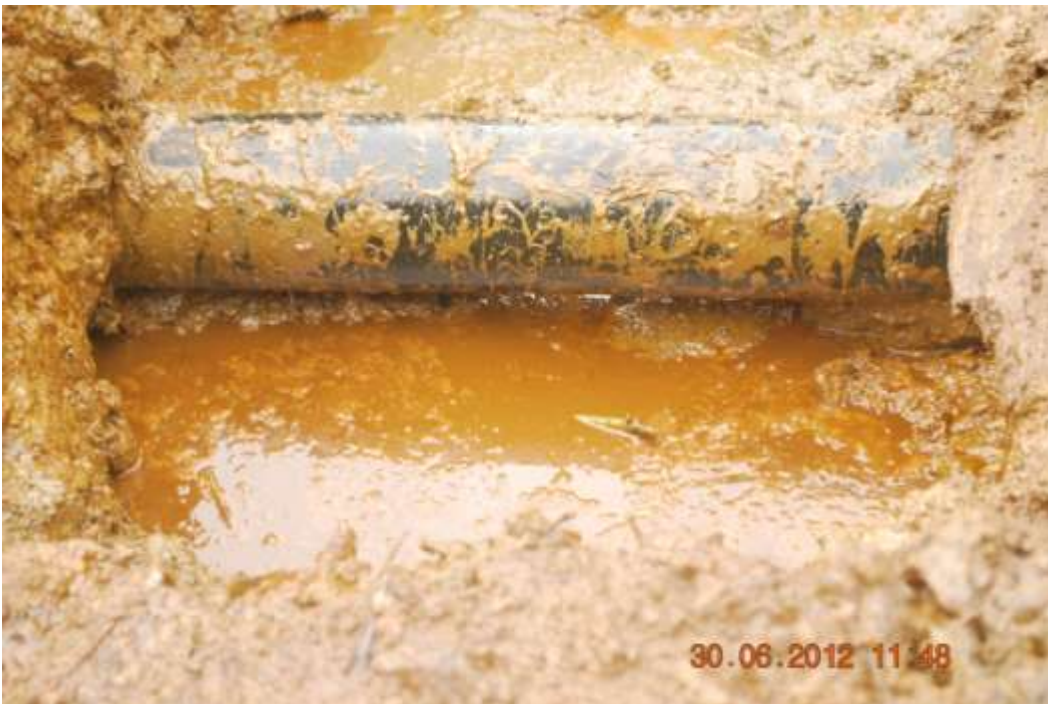
Close up: Spill due to corrosion on Opukushi Well24T flowline at Agbemo-Angalebiri. Picture was taken during Joint Investigation of 30th June 2012.

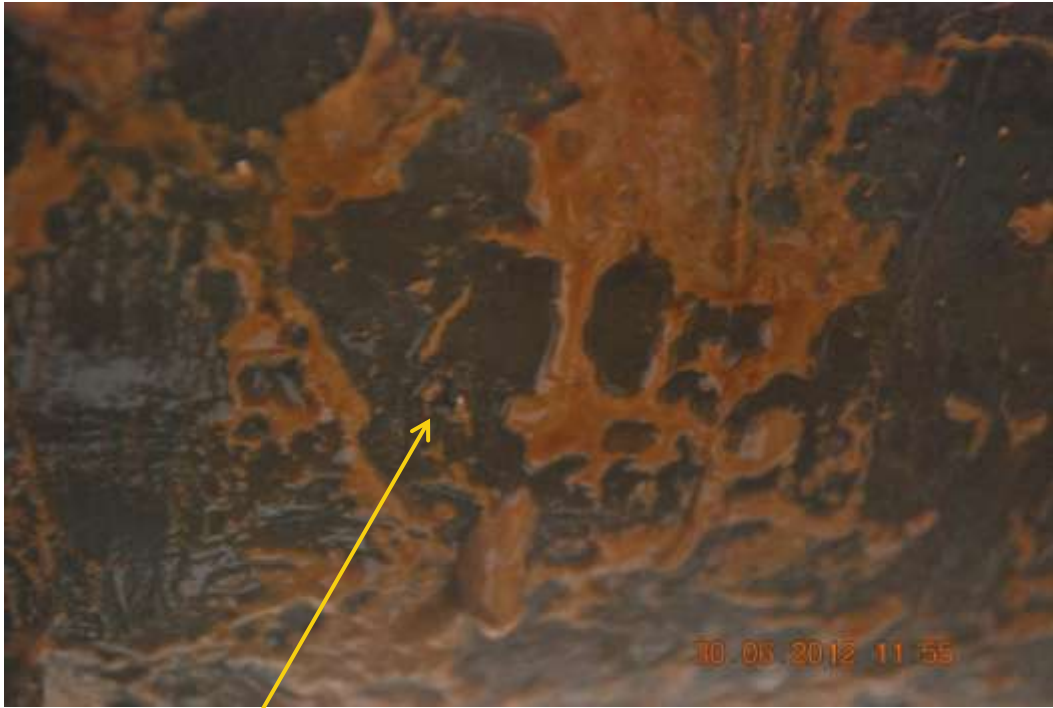
Close up: Spill due to corrosion at 6 o'clock position on Opukushi Well24T flowline at Agbemo-Angalebiri.
