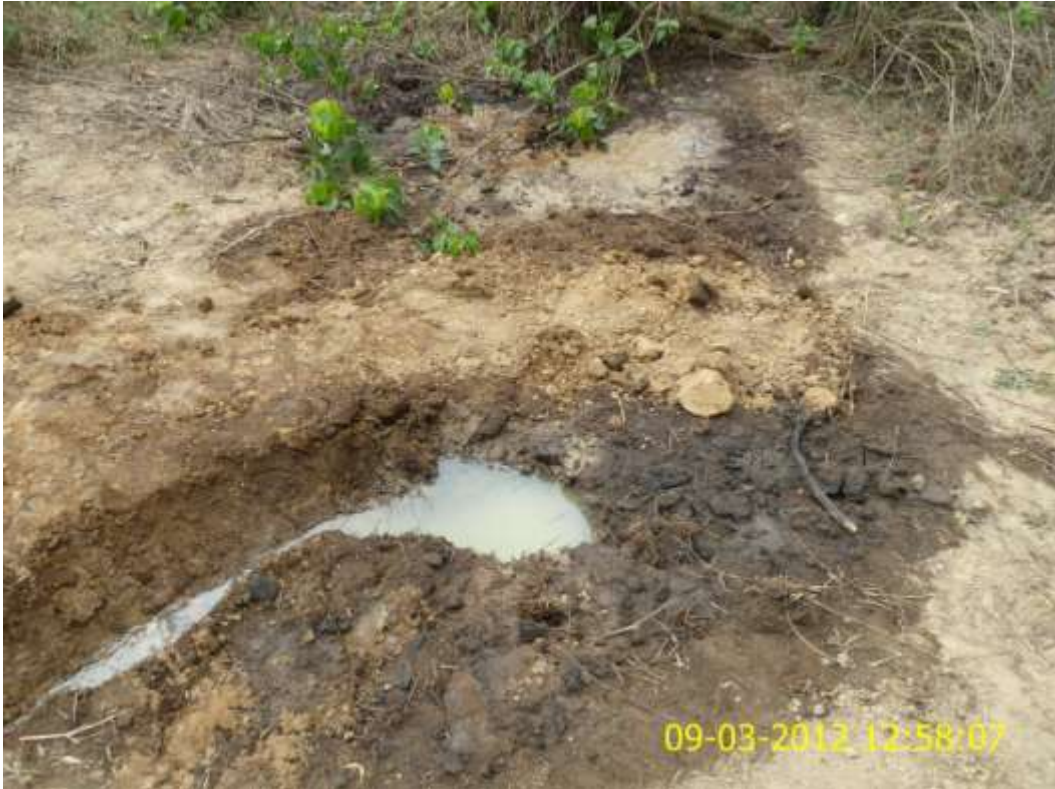
Overview: Part of spill impact on 24" Nkpoku-Bomu pipeline right of way at Egballor. Picture was taken during Joint Investigation of 9th March 2012.

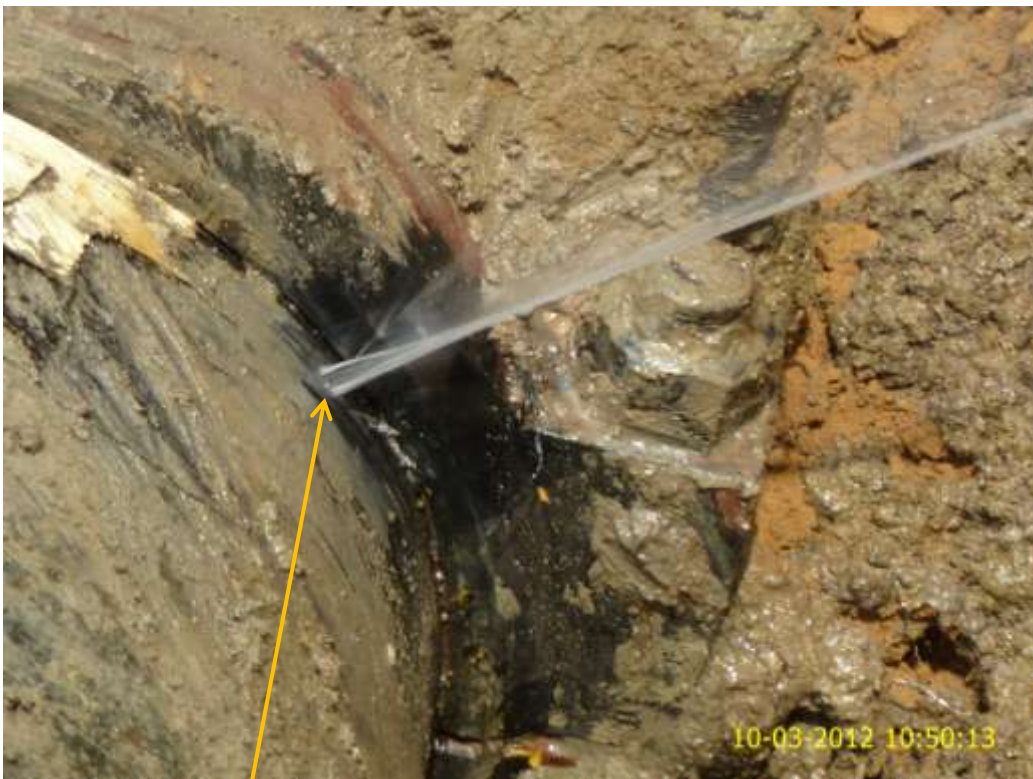
Close up: Hacksaw cut on 24" Nkpoku-Bomu pipeline at Egballor. Picture was taken during Joint Investigation of 10th March 2012.
