JOINT INVESTIGATION REPORT FOR INCIDENT NO: 0448 891646

A. GENERAL INFORMATION:		
1. Spill incident Number: 8916	2.Type	of incident* OIL SPILL
3. Name of Location $8''$ 081	GBO NORTH	L - KOMKOM PIPELINI
4. Name of nearest community LIMUO	Kolobo 5. State: Ri	VERS 6. LGA <u>OYIGBO</u>

SECTION (SHOWING PLAN) OF 8" OBIGBO NORTH -KOMKOM PIPELINE AT UMUOKOLOBO SHOWING POSITION OF CRUDE OIL THEFT FITTING.

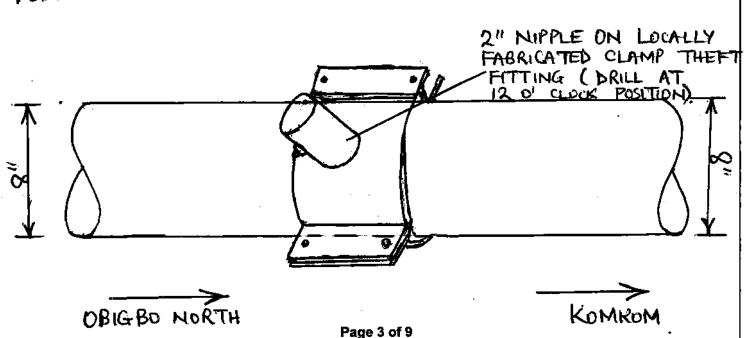
E. GRAPHIC DESCRIPTION OF LEAK POINT While detail report of the leak point should be contained in the Leak report, overview sketch of the site should be added as an appendix 1)

f. Incident caused by: Third party interference	Operational	□ _{Mystery}
g. Spill point coordinates Measuring unit Northing: 96194.		ID BELT Easting: 519285.25m
