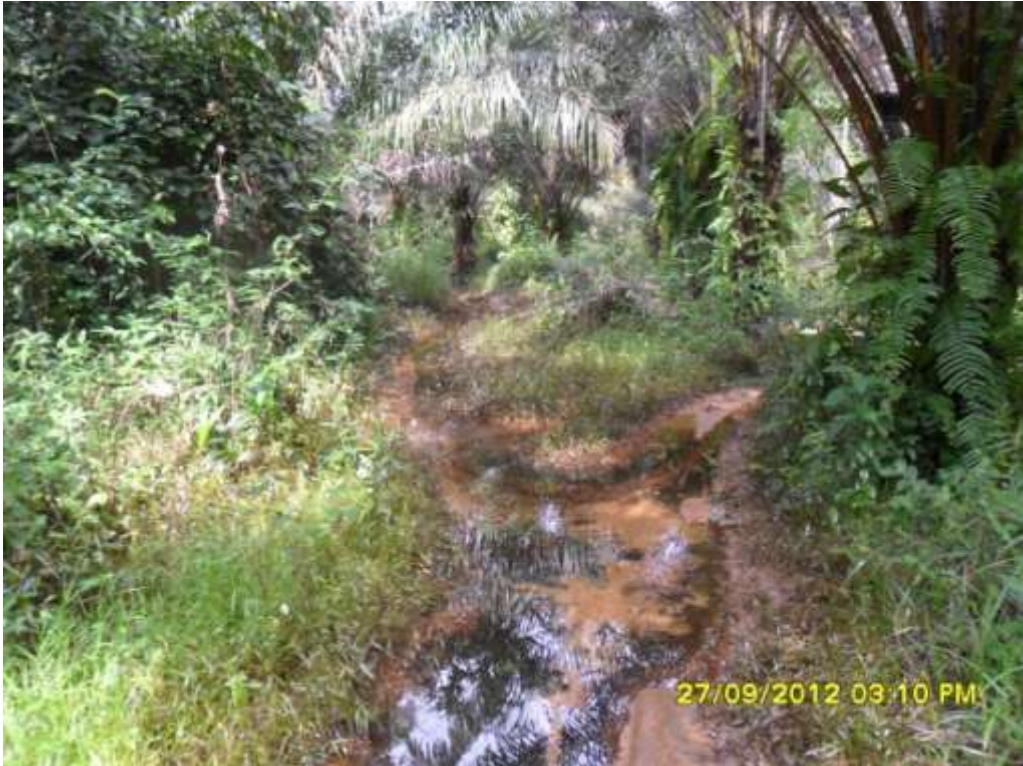
Overview: Part of spill impact on 4" Obelle-Ibaa pipeline right of way at Ibaa. Picture was taken during Joint Investigation of 27th September 2012.

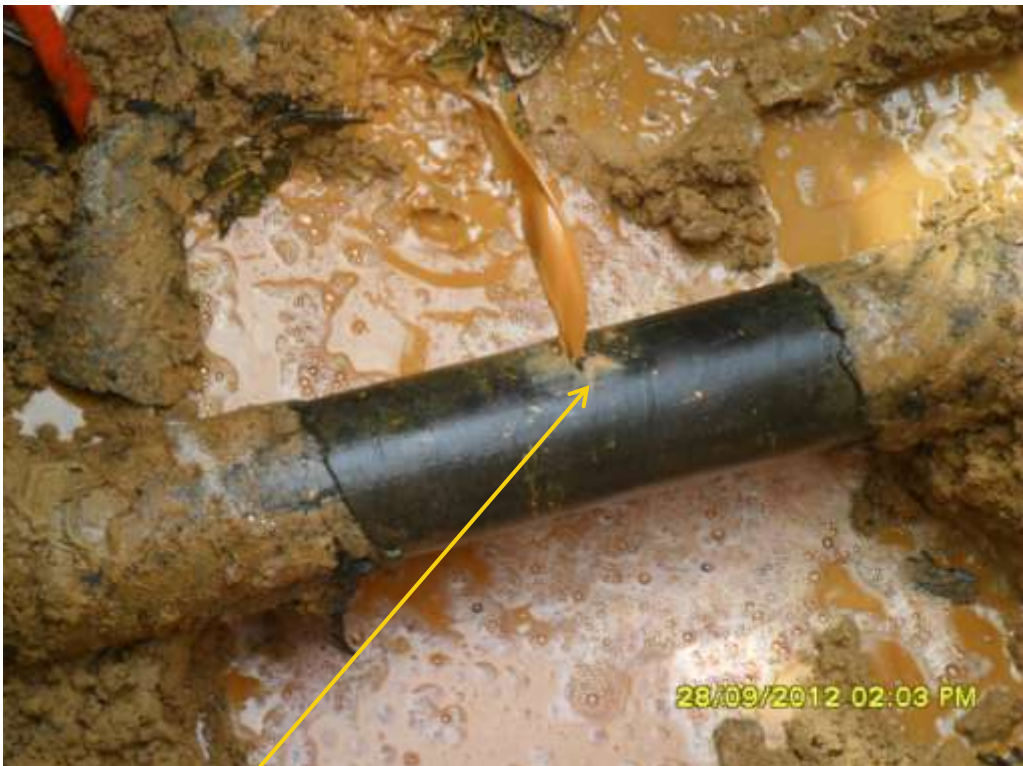
Close up: Hacksaw cut on 4" Obelle-Ibaa pipeline at Ibaa. Picture was taken during Joint Investigation of 28th September 2012.
