THE SHELL PETROLEUM DEVELOPMENT COMPANY OF NIGERIA LIMITED JOINT INVESTIGATION REPORT FOR INCIDENT NO: $\underline{0355-8}67427$

Page 1 of 9

JOINT INVESTIGATION REPORT FOR INCIDENT NO: 0355 - 267427

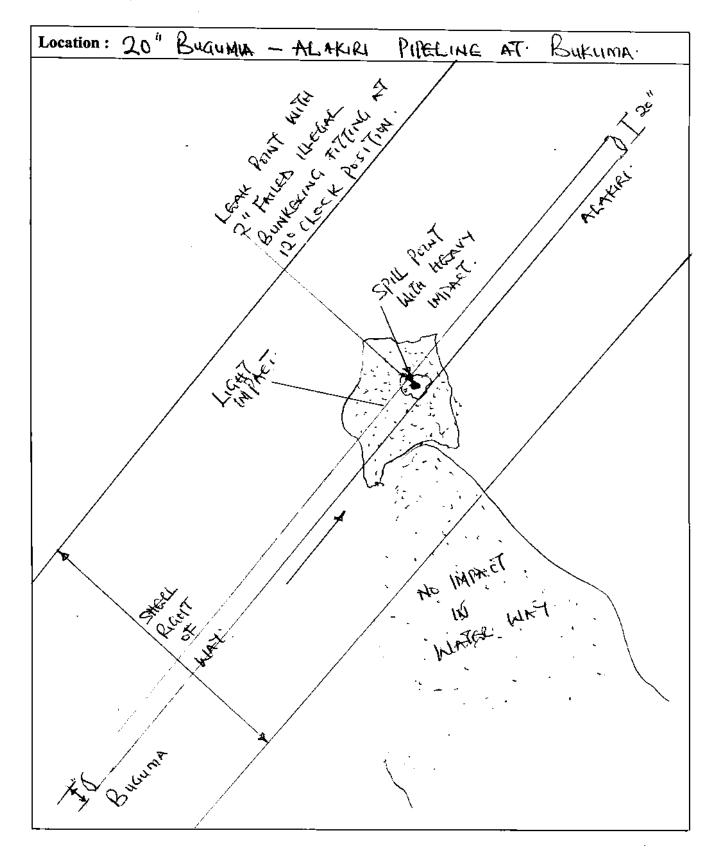
27. Appendix 1: Overview sketch of the site

SECTION (SECTION (PLAN) VIEW OF 20" BURGUMA.

- ALAKARI PIRELINE AT BUKUMA.

1112-CAL BUNKERING THEFT

FITTING AT 12° CLOCK POSITION

A.	Joint investigation of the incident site found that there is no residual impact after the initial response and therefore recommend that the site be closed out
₿.	Investigation of the incident site showed that there is residual impact on site requiring further works
