## THE SHELL PETROLEUM DEVELOPMENT COMPANY OF NIGERIA LIMITED JOINT INVESTIGATION REPORT FOR INCIDENT NO: $\frac{0337867208}{}$

JOINT INVESTIGATION REPORT FOR INCIDENT NO: 0337867208

A'S ECTION OF 4" SANTA BARBARA WELL IIT FLOWLINE SHOWING LEAK CRUBE OU LEAK FROM A NELDED FOUNT AT 5 O'CLOCK POSITION

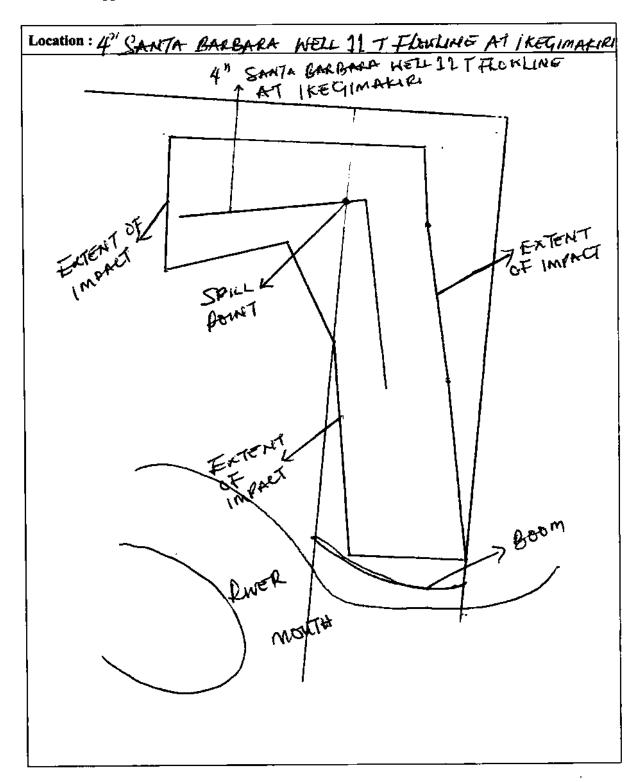
27. Appendix 1: Overview sketch of the site

WELL -> LEHE POINT FORM
HEAD

AT 5 D'ELECE POSITION.
