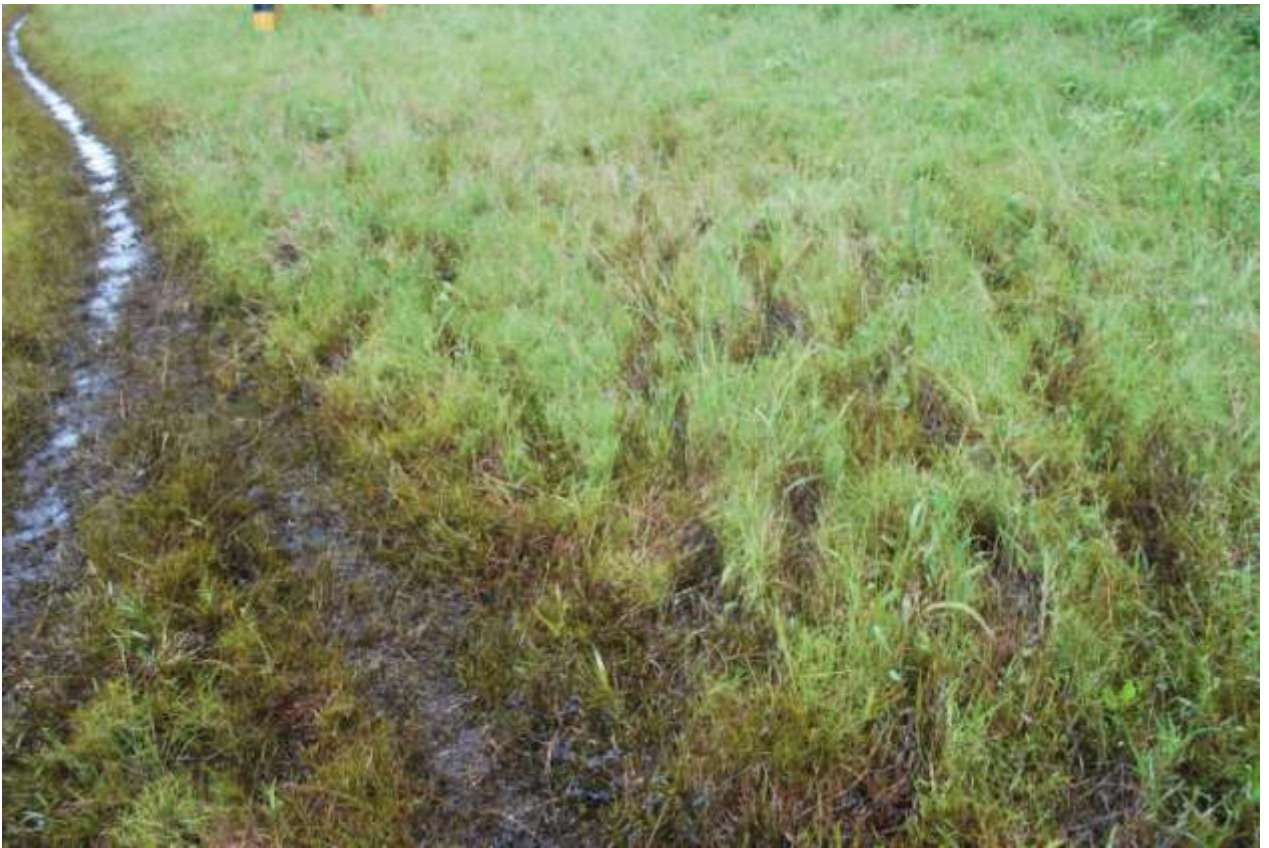
Overview: Part of spill impact on 16" Uzere - Eriemu Trunkline at Iyede. Picture was taken during Joint Investigation of 18th Sept. 2012.

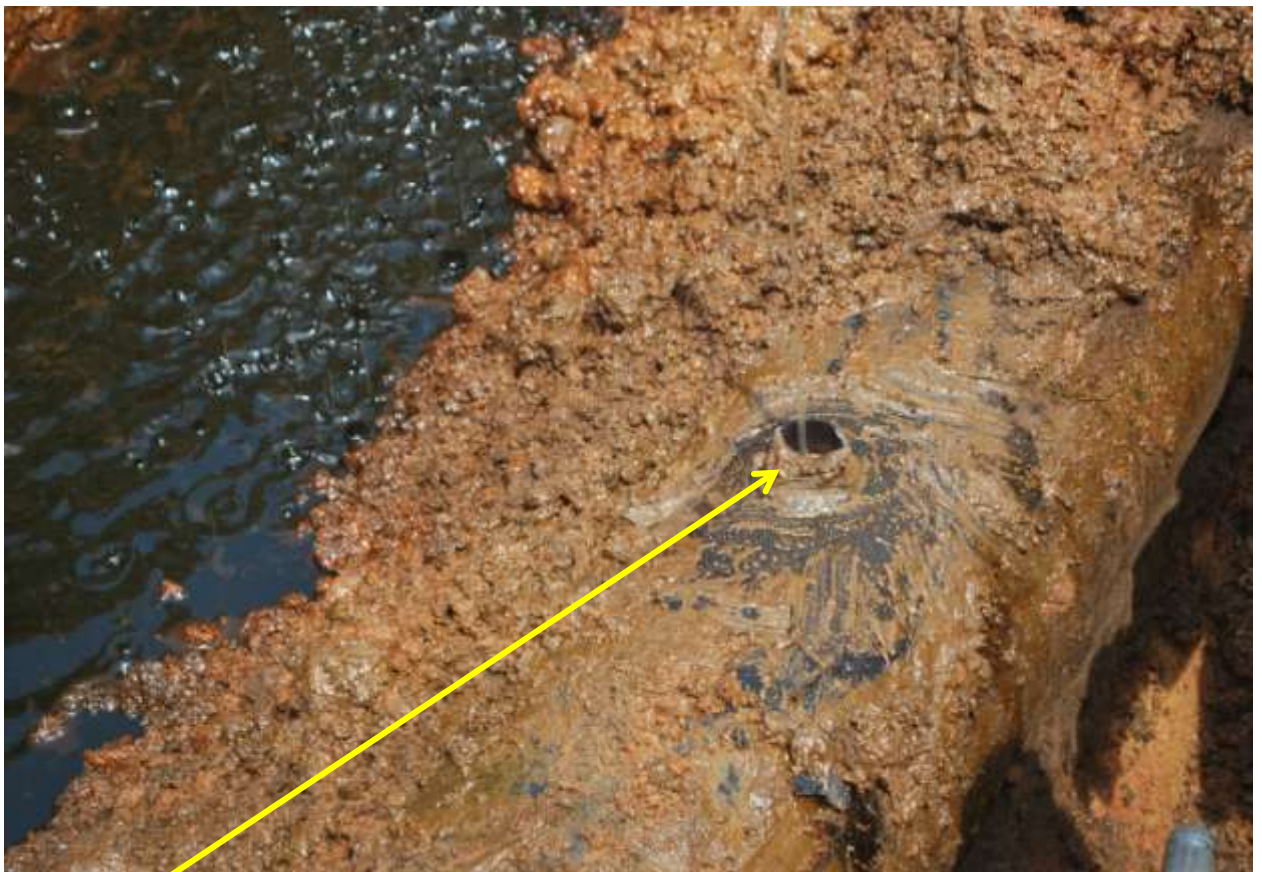
Close-up: Drilled hole on 16" Uzere - Eriemu Trunkline at Iyede. Picture was taken during Joint Investigation of 18th Sept. 2012.
