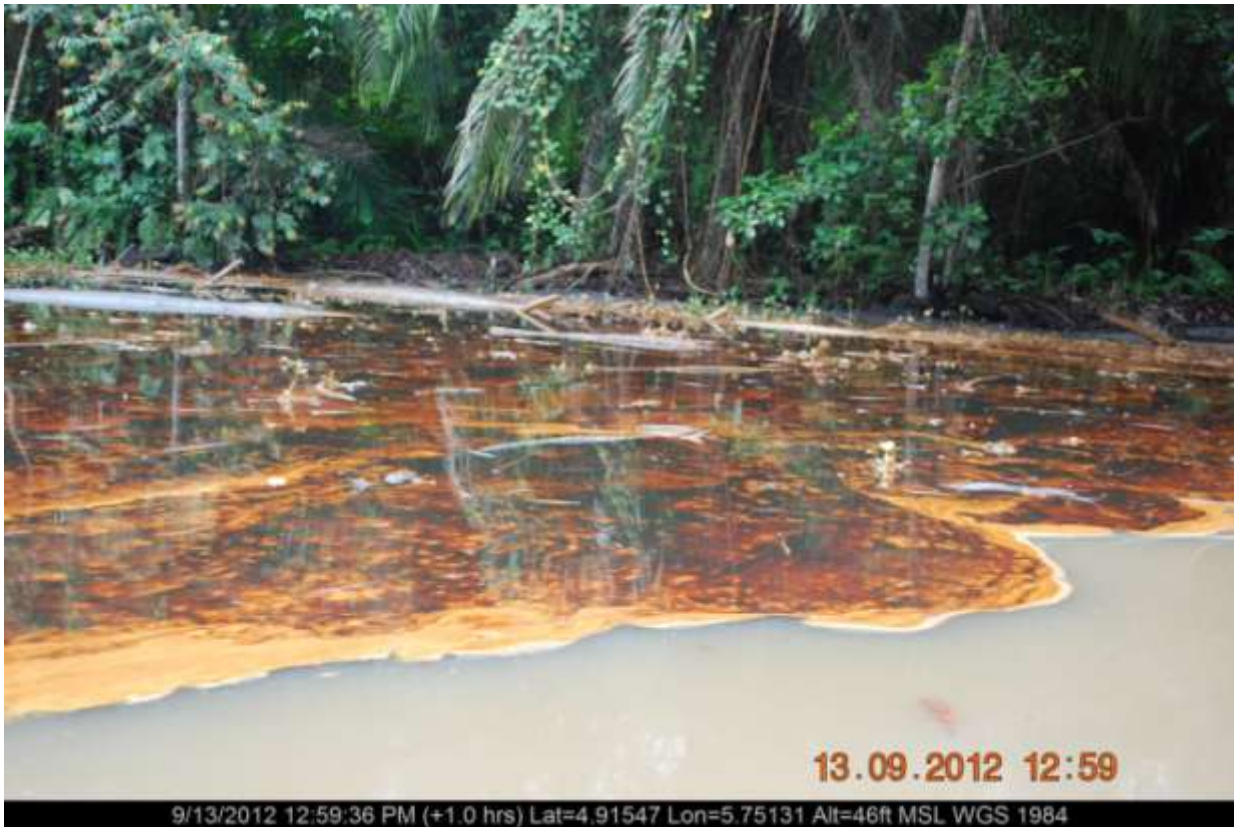
Overview: Part of spill impact on Opukushi Well 25 at Agbediama. Picture was taken during Joint Investigation of 13th Sept. 2012.

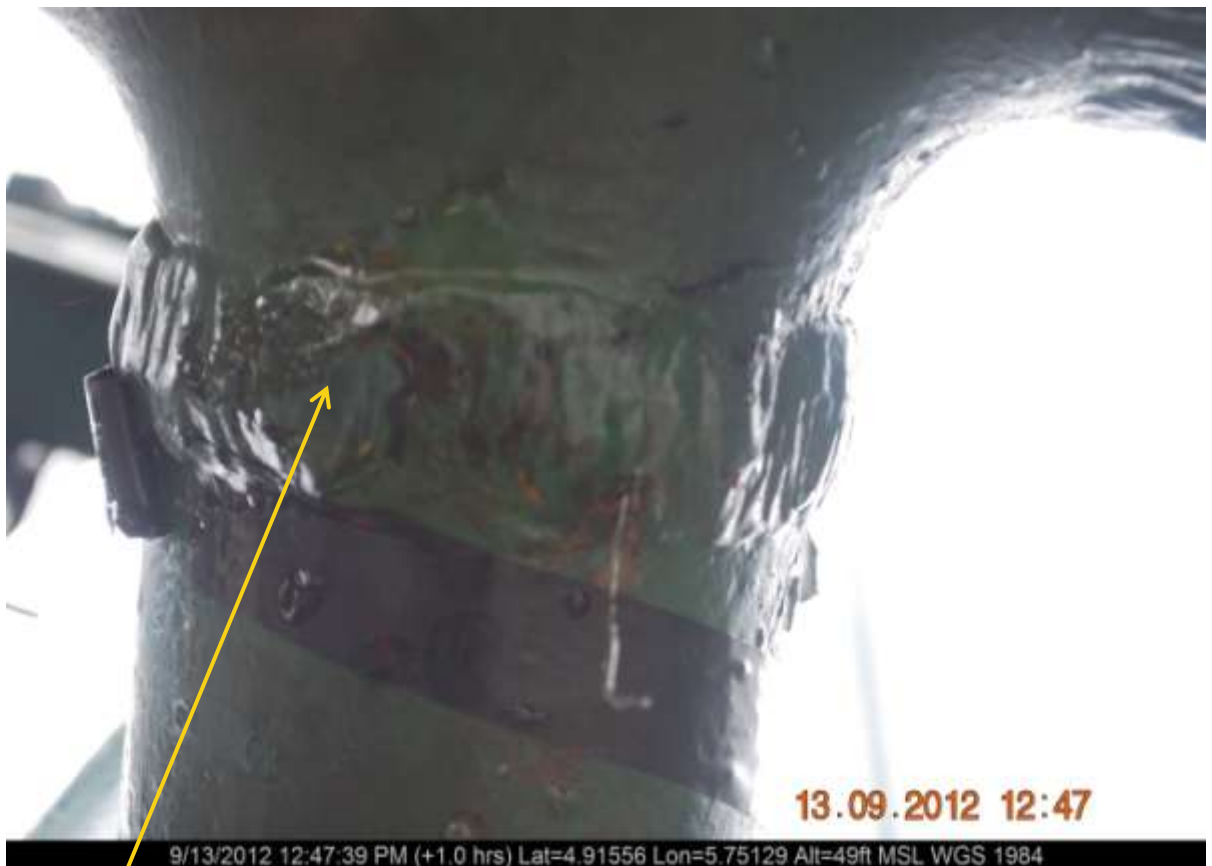
Close-up: Internal corrosion on Opukushi Well 25 at Agbediama. Picture was taken during Joint Investigation of 13th Sept. 2012
