THE SHELL PETROLEUM DEVELOPMENT COMPANY OF NIGERIA LIMITED.

JOINT INVESTIGATION REPORT FOR INCIDENT NO: 1024199 JIV report S/N: 0132

1. Spill incident Number: 1024199 2. Type of incident* OIL SPILL
 3. Name of Location AWOBAWELLE 3S FLOWLINE
 4. Name of nearest community BILLE 5. State: RIVERS 6. LGA DEGEMA
 7. Type of Production facility/Installation OIL FLOWLINE 8. Asset owner/District SWAMP 1

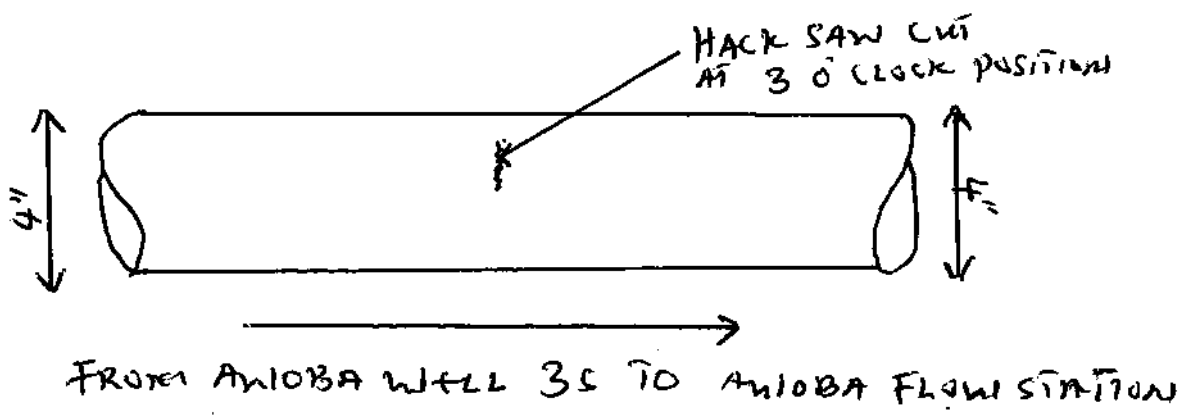
SECTION OF ANIOBA WELL 35 FLOWLINE AT BILL #
SHOWING POSITION OF HACK SAW CUT AT 3 O'CLOCK POSITION.

e. Description of leak point (tick as applicable);
 Drilled hole Hack saw cut Tear (_____),
 Complete Rupture Inward dent, Well head tampering
 Failed Weld-on illegal hot tap valve, Failed Clamp Missing Pipeline/Flowline
 Crude oil theft (illegal bunkering) point, Third party tampering with Clamp
 Third party tampering with valve setting, Third party tampering with flange,
 Corrosion Saver-pit over flow, Surge vessel overflow,
 Bulging Outward Flare System/Bund wall failure Accidental 3rd party equipment
 impact Valve Failure com unit failure Cold vent
 Relief valve failure Others (specify) _____

- Third party interference (Sabotage ; crude theft ; Line theft ; Accidental 3rd party damage
 Operational Others (including Mystery spills) _____

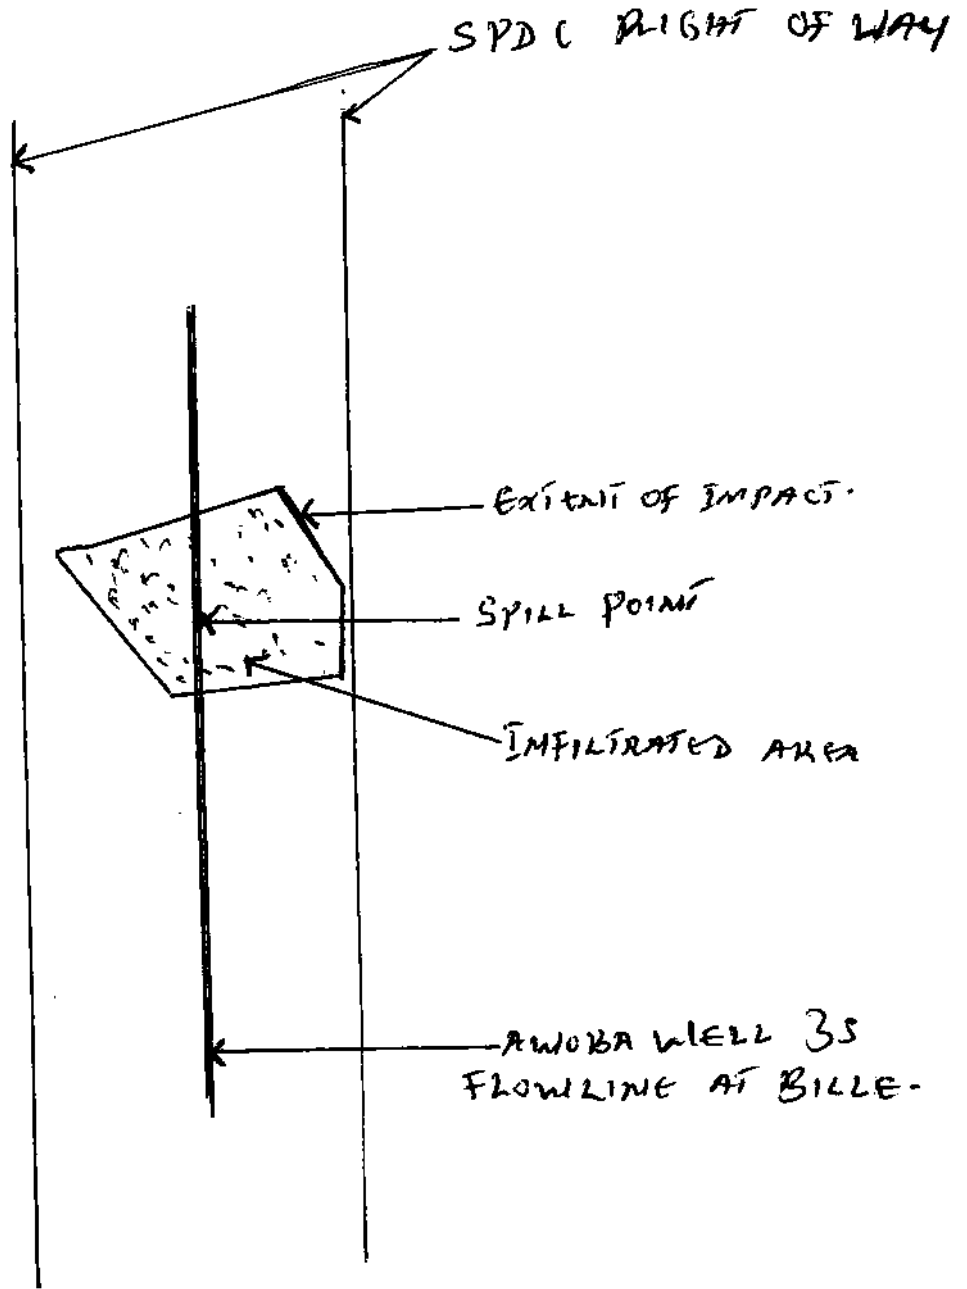
28. Appendix 1: Overview sketch of the site

Location: AWOBA WELL 3S FLOWLINE AT BILLE
