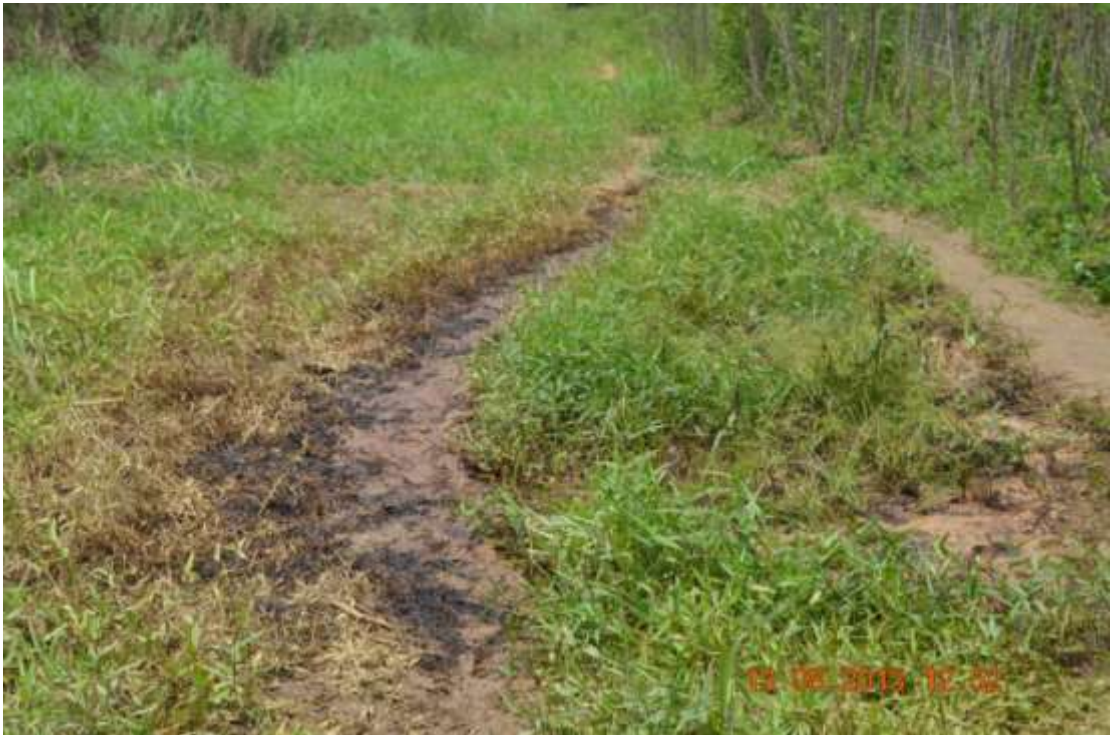
Overview: Part of spill impact on 14" Okordia-Rumuekpe pipeline right of way at Ikarama. Picture was taken during Joint Investigation of 13<sup>th</sup> August 2013.

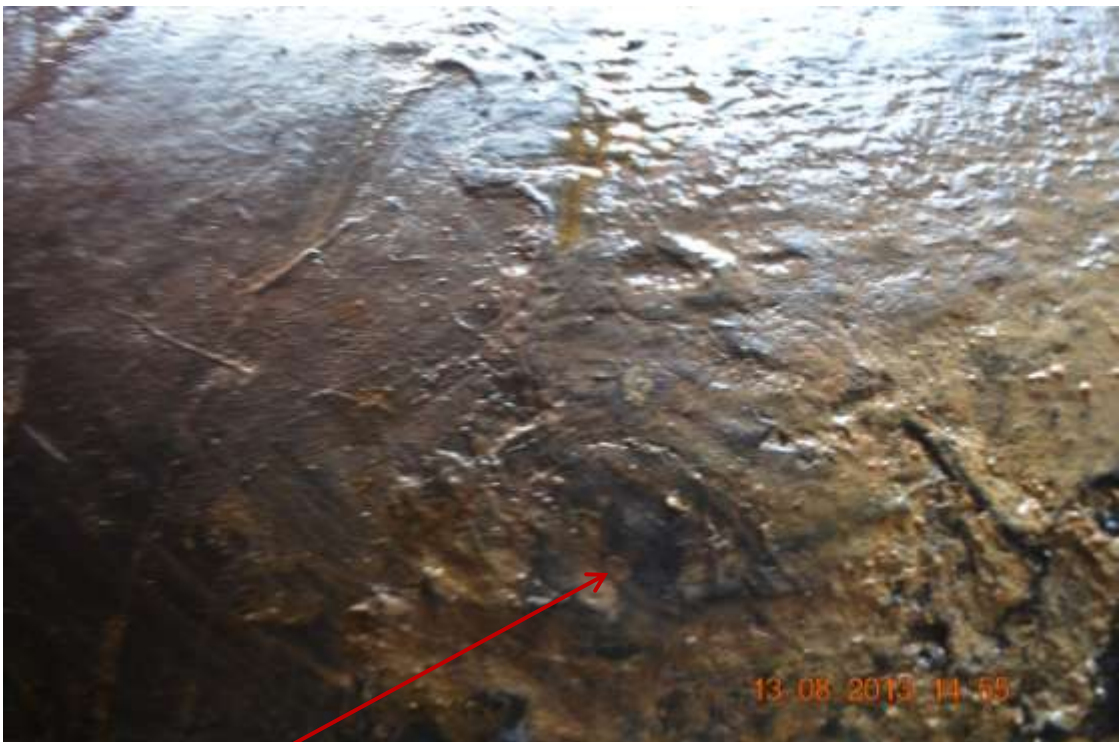
Close up: Leak due to corrosion at 6 o' clock position on 14" Okordia-Rumuekpe pipeline at Ikarama. Picture was taken during Joint Investigation of 13<sup>th</sup> August 2013.
