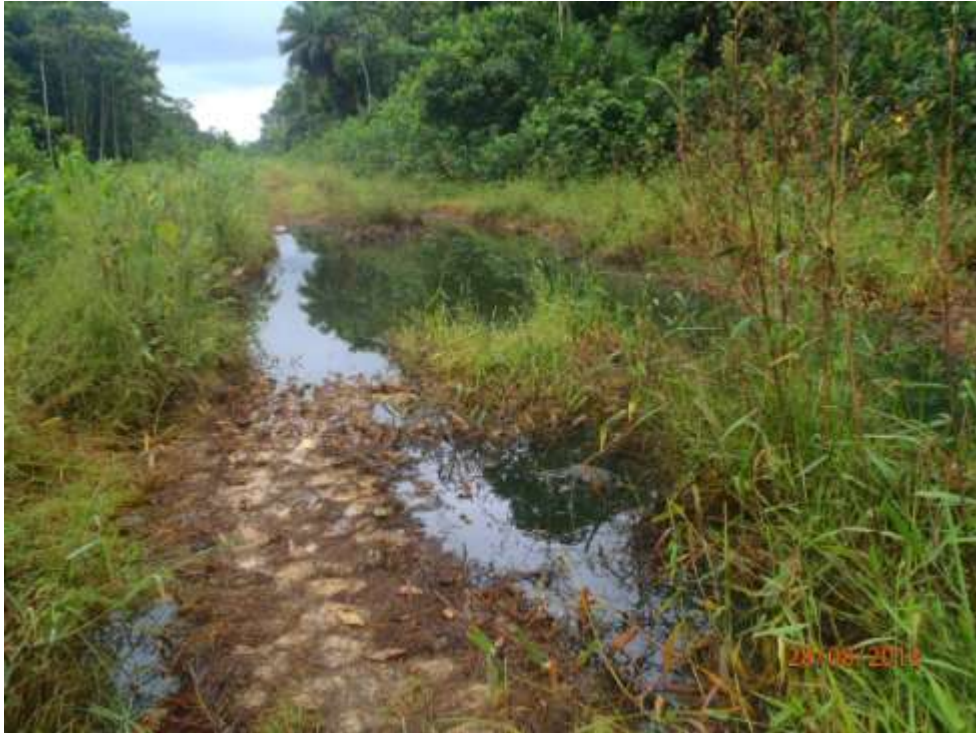
Overview: Part of spill impact on 16" Nun River – Kolocreek pipeline right of way at Igiebiri. Picture was taken during Joint Investigation of 28th August 2013.

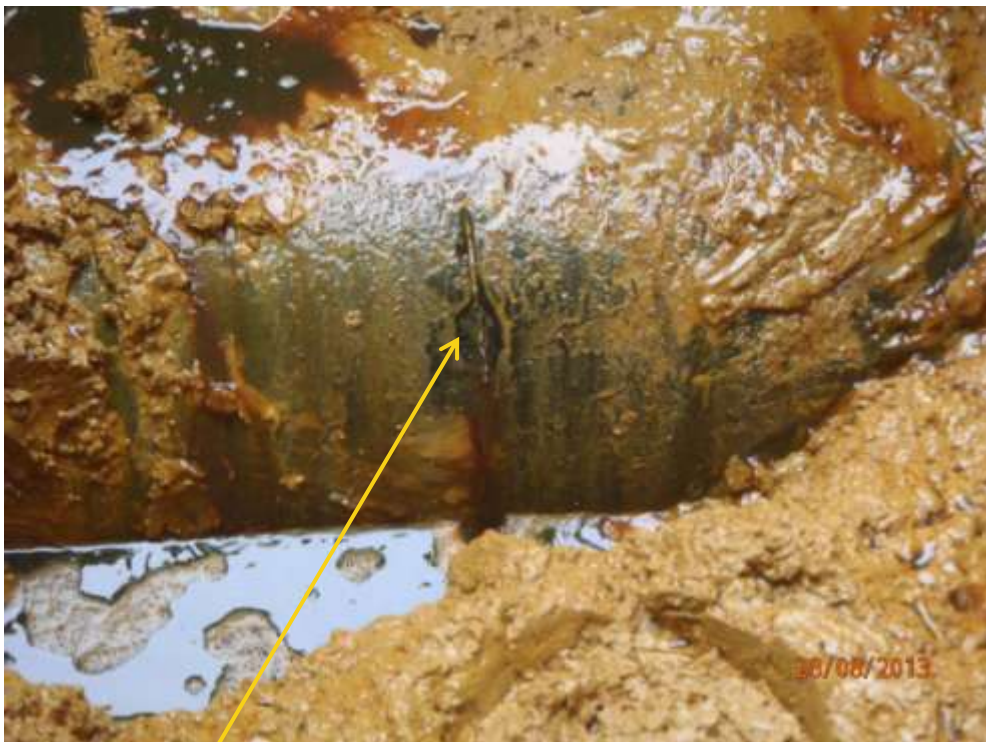
Close upHacksaw cut on 16" Nun River – Kolocreek pipeline at Igiebiri. Picture was taken during Joint Investigation of 28th August 2013.
